## THE SEISMIC VULNERABILITY OF TOWERS' BRICK MASONRY SPIRES: LEARNING FROM HISTORY

Daniele Ferretti<sup>1</sup> and Eva Coisson<sup>2</sup>

**Keywords:** Spire, tower, masonry, seismic vulnerability.

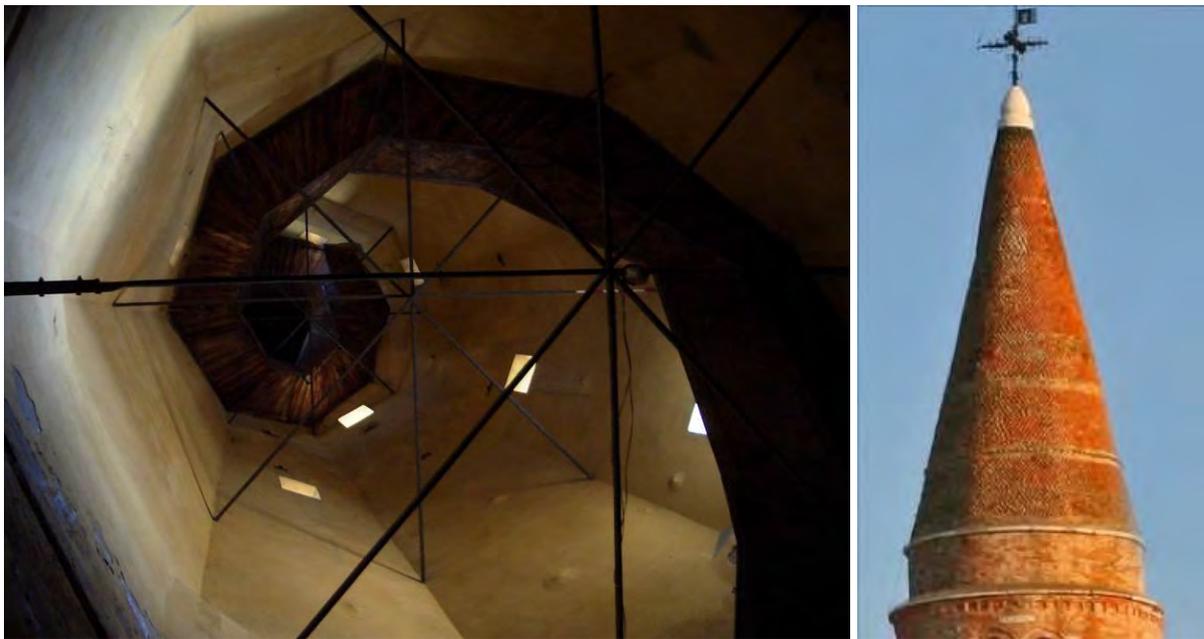
Figure 1: Traditional strengthening techniques for masonry spires: radial tie rods in the Ghirlandina tower in Modena (left), iron rings in the Caorle Cathedral (right).

Considering the very low tensile strength of the masonry, the spires end up thrusting on the supporting structures, as vertical cracks develop dividing the cone or pyramid in separate, inclined radial elements. Therefore, often strengthening elements have been inserted – since the beginning or added during centuries – particularly focused on the possible opening of the separate “slices”. Some examples are the Ghirlandina tower, in Modena, which presents three levels of radial iron tie rods, and the bell tower of the Caorle Cathedral, which has iron rings in the lower part (fig. 1).

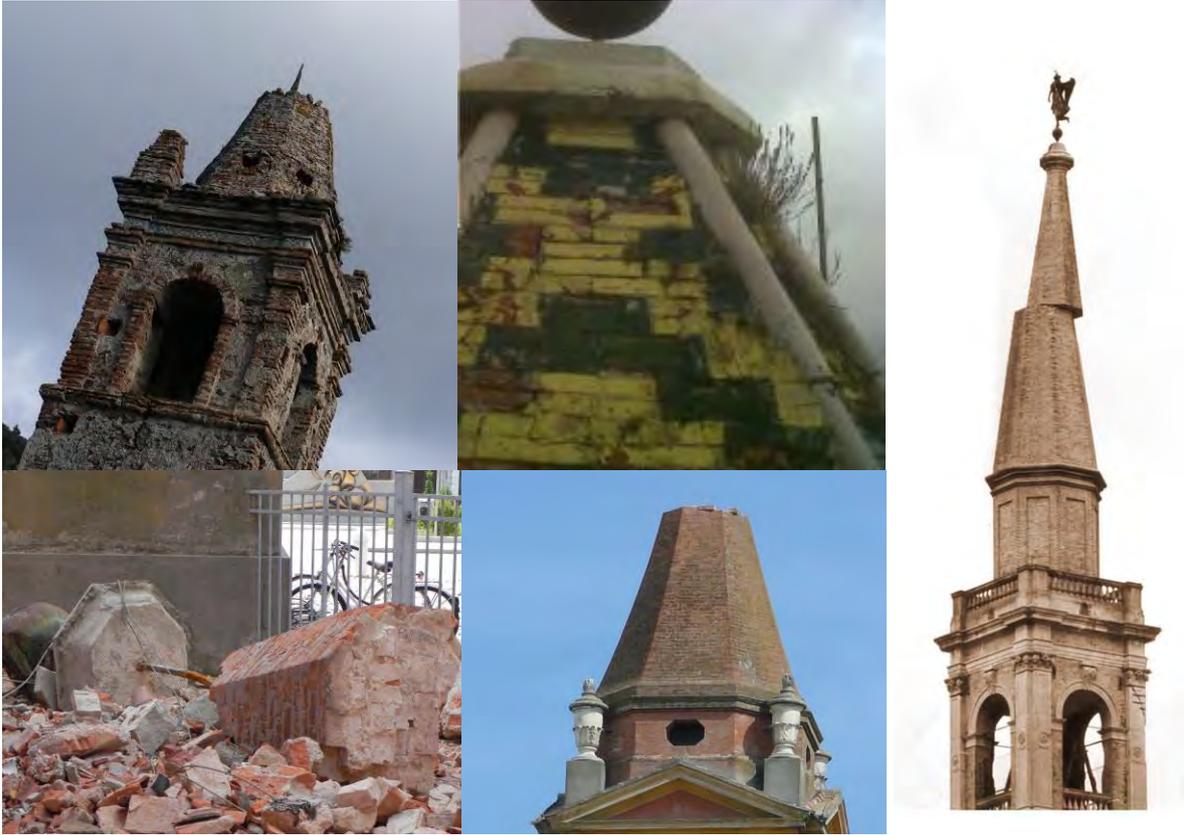
Figure 2: Some examples of seismic collapses of spires in different areas and at different levels. From top left, clockwise: Madonna dell'Alica di Pietrapennata (Calabria), Campobasso (Molise), Cordenons (Friuli - photo by Gigi Cozzarin), Sant'Agostino (Emilia), with the detail of the collapsed top element.

The recent earthquake of May 2012 in the Emilia area highlighted the extreme vulnerability of these elements to the horizontal actions but, opposite to what could be a first thought, the vulnerability does not concern the further increase of the vertical cracks and the separation of the slices, but the loss of the top part of the spire, either for overturning or for shear collapse. Nearly all the masonry spires in the epicentral area showed this type of collapse, sometimes limited to the top stone decorative element, sometimes including a part of the brick masonry cone (fig. 2). There were reports of similar damages in other areas, with different earthquakes, like Friuli and Calabria, with different distances from the epicenter (fig. 2).

The existing studies seem to indicate collapse mechanisms which are not completely adherent with the real collapse cases previously analyzed, at least for brick masonry spires: the experimental evidence indeed shows horizontal cracks which are compatible with shear failure (as clearly happened in the Cordenons case shown in figure 2) or with an overturning with horizontal failure plane. To inspect further these possible mechanisms, compatibly with the experimental evidence, some numerical analyses on models of a brick masonry Italian spire have been carried out.

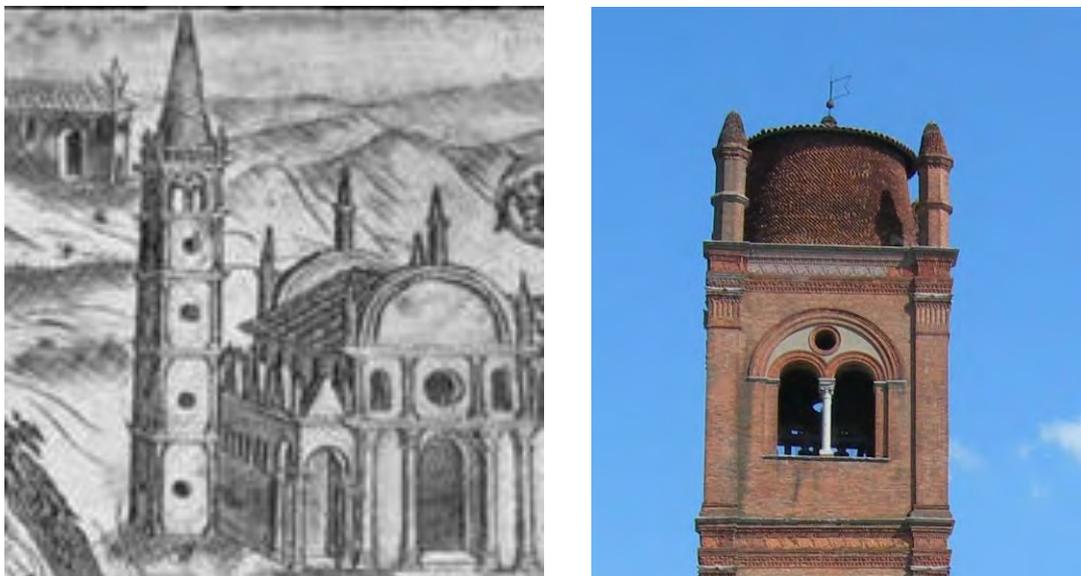
Figure 3: Other spires damaged by earthquakes during history: San Giorgio fuori le mura in Ferrara (on the left a drawing of its original shape) lost its spire in the 1570 earthquake and was then covered by a circular roof.

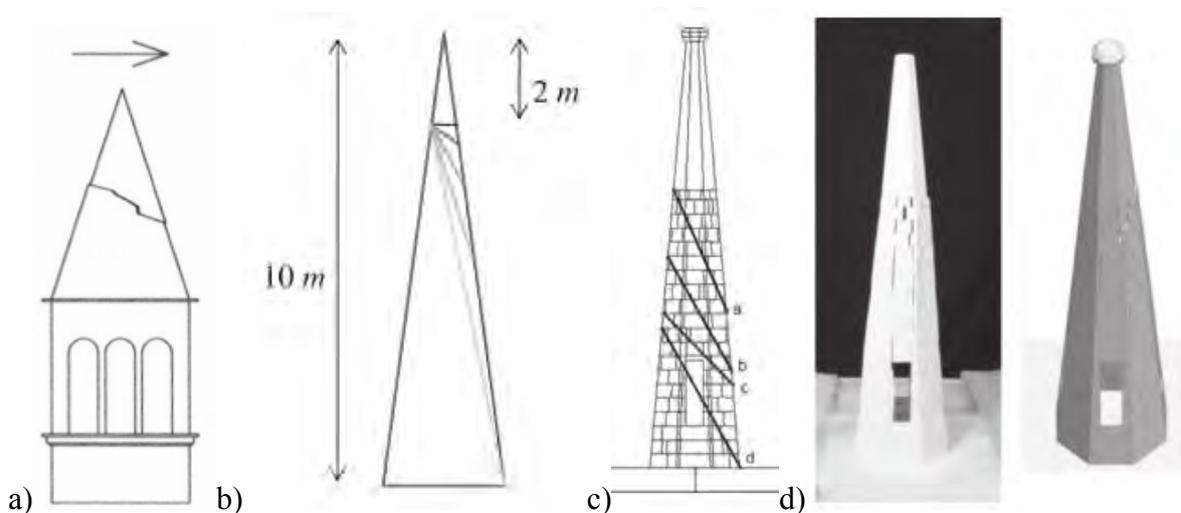
Figure 4: The damage mechanism indicated in the Italian law for the protection of cultural heritage from the seismic risk (a [1]) and the mechanisms analyzed by De Jong and others (b [2], c [3], d [3]).

The Italian technical law for the protection of cultural heritage from the seismic risk [1] indicates, among the 28 possible damage mechanisms to the macro-elements of churches and bell-towers, the possible rotation or shear damage to protruding elements. In particular, the drawing n. 26, which illustrates the bell-towers' spires expected mechanism (fig. 4a), shows an inclined crack, relatable either to an overturning mechanism or to a diagonal shear damage. The indicated stabilizing elements are the good quality of masonry, the limited dimensions, and the presence of anchor bolts or other connections, while the vulnerability is increased in particularly slender elements. These indications have the merit of focusing the attention of practitioners to this often neglected element, but the experimental evidence of some Italian earthquakes, shown only in part in figure 2, highlights one major difference in the damage mechanism: the tilt angle of the collapse plane is always horizontal or semi-horizontal rather than inclined, as indicated in Fig. 4a. Moreover, in many cases, only the top stone element collapsed, detaching from the brick masonry.

Some scientific studies have also been carried out on stone masonry spires, reporting both analytical and experimental modeling [2,3]. The uplift, rocking and collapse of stone spires is investigated, considering varying diagonal crack height below a solid tip (fig. 4b,c). Of course the results can vary with the geometry of the real element (fig. 4d), but in most cases, the horizontal crack is not related to the most probable collapse mechanism. This difference from the real cases shown in figure 2 can also be related to the different building techniques: the clay bricks have usually a smaller height to width ratio, compared to the stone blocks, thus can hinder the diagonal propagation of cracks along the joints in favor of a horizontal shear failure.

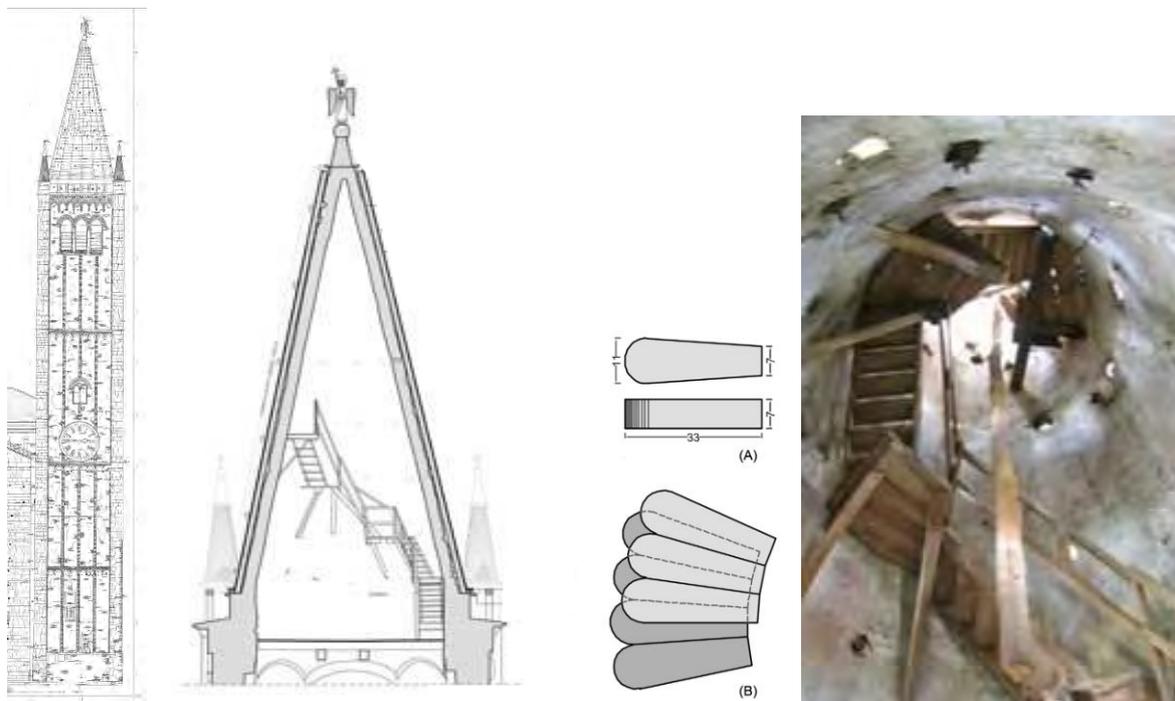
Figure 5: The Parma Cathedral's bell tower. From left to right: front view, vertical section of the spire, geometry and texture of the bricks ([4]), timber log inside the spire (during the restoration works).

To inspect the selected aspects of the seismic response of brick masonry spires, the bell-tower of the Parma Cathedral was chosen as a case study. The bell tower was built between 1284 and 1294, close to the south corner of the cathedral's façade, with an approximately square cross-section up to 58 m and topped by a 15 m high conical spire. The square part is made of a 1.62 m thick three leaf masonry, with a regular brick masonry cladding and a less organized infill. To increase the waterproofing, the spire was covered in 1596 by lead sheets over a wooden structure, which caught fire in October 2009 when hit by a lightning. Despite the damages, this event allowed to unveil the structure of the spire, which had been hidden for centuries. The spire is made with petal shaped clay bricks made on purpose and externally glazed, organized radially as shown in figure 5, connected by a good quality lime mortar. A stone element with the shape of a cone topped by a sphere constitutes the point of the spire and sustains a golden angel-shaped weather vane.

This case study was chosen not only because of the amount of information and researches which were gathered consequently to the lightning and following restoration, but mainly because of the presence of a very particular element: the weather vane is indeed stabilized by the presence of a long timber log, connected by an iron chain and hanging inside the spire. Although this element had been clearly inserted with the aim to keep the angel vertical even in case of strong winds, its weight can also play a role in the seismic behavior of the top of the spire, increasing the shear strength and the stabilizing bending moment against the possible overturning in this area characterized by low vertical stresses. Indeed, since its construction, this bell-tower has been subjected to many earthquakes, five of which hit Parma with an estimated intensity of 7 or more on the Mercalli scale (very strong to destructive) and there were no reports of damages to the top of the spire [5].

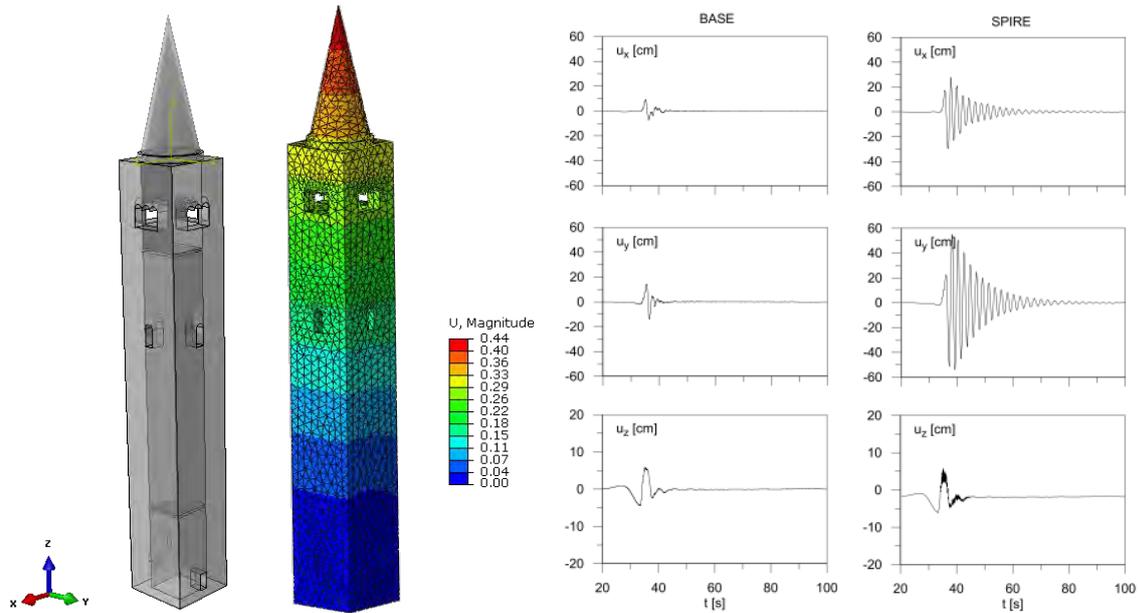
Figure 6: Global model (left, with displacements) to identify the filter effect (right: comparison between input at the base of the tower and output at the base of the spire in terms of displacements).

An implicit dynamic analysis was then developed, integrating the motion equations, adopting as a seismic input at the tower's base the Mirandola earthquake previously described. The output at the base of the spire was then recorded, in the form of the three components of both acceleration and displacements (fig. 6).

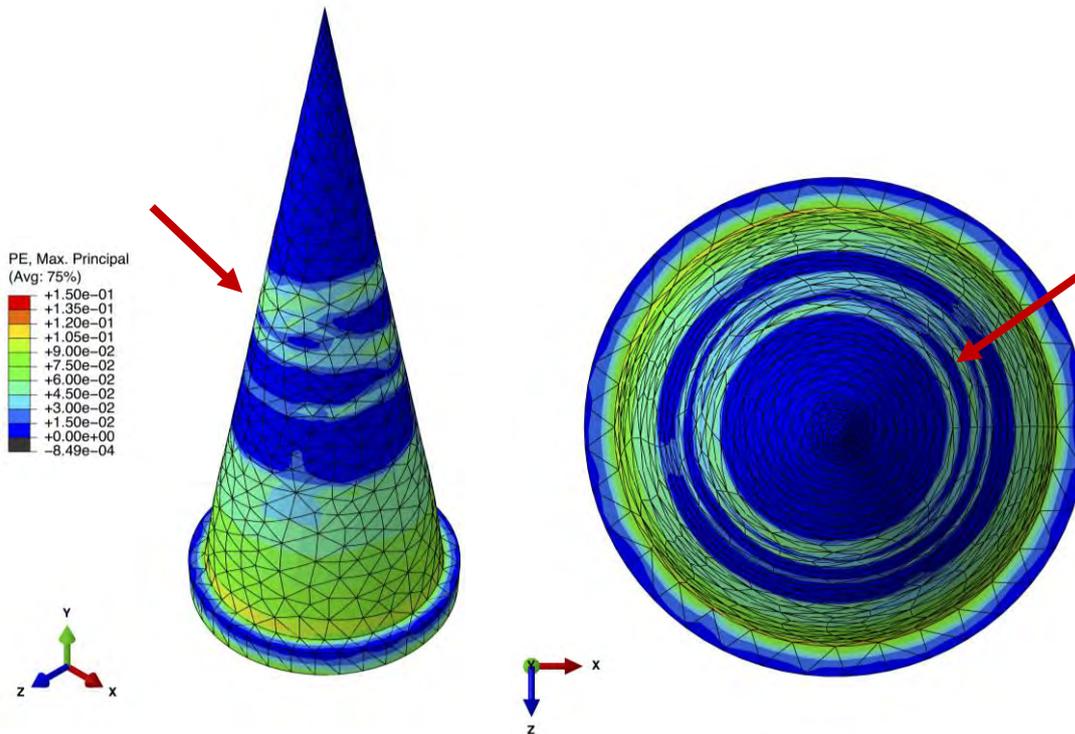
Figure 7: 3 D finite element model of the spire with damage plasticity material model: the shape and position of the damaged areas are clearly identified.

The results show a widespread damage at the base of the spire and a more concentrated damaged area at about two thirds of the full height, as shown in figure 7.

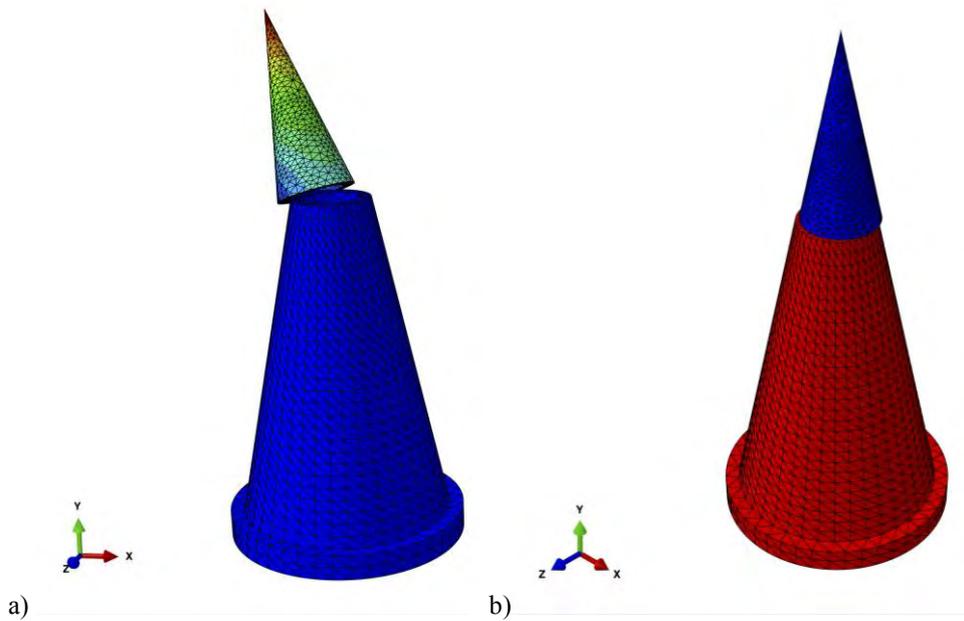
Figure 8: Comparison between discrete crack models with (a) and without (b) vertical accelerations: in both cases the top of the spire shows shear damage, but only when vertical accelerations are considered the collapse occurs.

The results show clearly a translation of the top of the spire caused by a shear failure. When the center of pressure then moves close to the border, thus decreasing the contact surface, first rocking and then overturning take place and at last the top falls down (fig. 8a).

The analysis was then repeated without the vertical component of the seismic action, thus simulating the effects of an earthquake to a larger distance from the epicenter, with respect to the examined Mirandola earthquake but equal pga. In this case, the continuous presence of the vertical loads increases the friction forces and, although the mechanism is similar to the previous case, the sliding is smaller (fig. 8b), the top of the spire does not fall and no rocking or overturning phenomena occur.

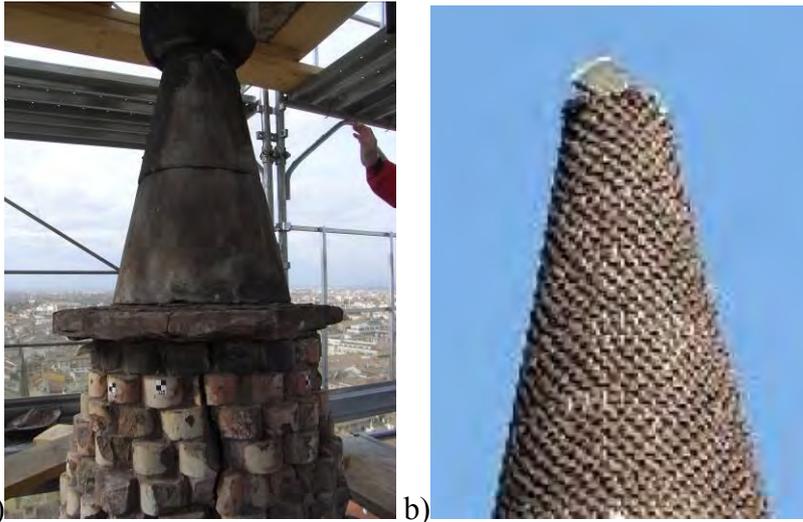
a) b)  
 Figure 9: The stone element at the top of the analyzed spire of the Parma Cathedral's bell-tower (a) and the collapse of a similar element on the bell-tower of San Benedetto Po (Mantova) after the Emilia earthquake (b).

On the block identified in the previous section (4 m high) the effects of the timber log are expected to be negligible, since its weight is very small compared to the block's weight. Nevertheless, its effect can be much more interesting if we consider the possible collapse of the stone element at the top of the examined spire (fig. 9a), whose weight is comparable to the log's one. This type of collapse has also been observed in several cases in the Emilia earthquake (fig. 9b). Thus, the previous model has been modified, moving the contact elements from the area within the spire to the interface between the brick masonry spire and the stone top. The results of this analysis is reported in fig. 10a, showing the sliding of the top stone element. The analysis was then repeated introducing the presence of the log. In both cases the collapse is reached, given the high intensity of the considered earthquake, but the results reported in fig. 10b for the same time step show the stabilizing effects of the timber log, which delays the shear failure. More analyses will be made to define the exact increase of the safety index (in terms of pga ratio) which is given by the presence of the log.

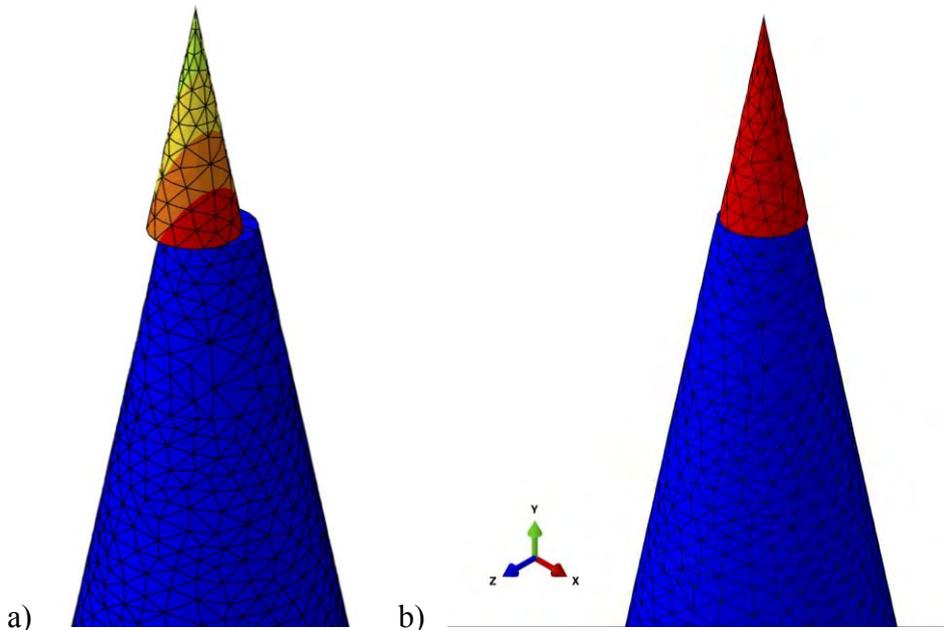
a) b)  
 Figure 10: The deformed shape of the spire without the timber log (a) and with the log (b), at the same time step.
