## SEISMIC SAFETY EVALUATION OF HOKKEDO HALL IN TODAI-JI TEMPLE, WORLD HERITAGE

### PART 2 SEISMIC DIAGNOSIS OF BUILDING STRUCTURE

Toshikazu Hanazato<sup>1</sup>, Yuki Fujita<sup>2</sup>, and Masayuki Morii<sup>3</sup>

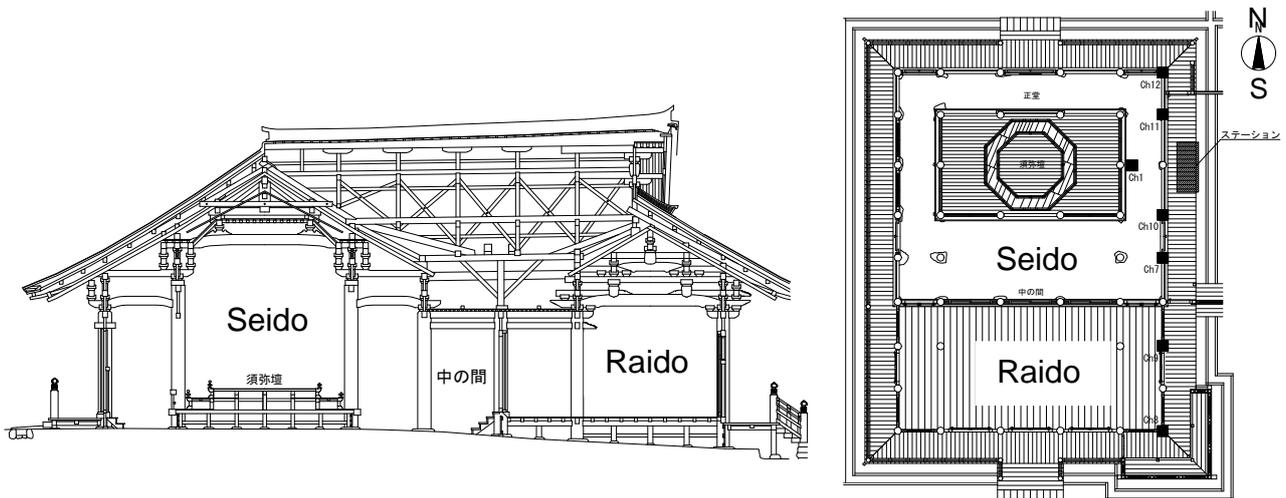
Fig.2 Elevation Section and Plan

Introduced in the previous section, Hokkedo-hall is a unique structure characterized by composing of two different period's constructions by sophisticated combining technique with a roof structure. Fig. 2 shows section and plan of the building. The building is 13m in height

with a rectangle plan of 25m by 18m. There had been a total of 16 images of Buddha in ‘Sei-do’ meaning a main hall constructed in 8<sup>th</sup> century. Another hall, ‘Raido’ meaning worship hall was reconstructed in 1264. Both timber buildings were structurally connected and combined by the roof structure, when ‘Raido’ was reconstructed. Shown in Photo.1, the roofing materials were tiles. From an earthquake point of view, the horizontal in-plane rigidity at the ceiling level (or the roof structure) is an important factor that must affect seismic performance and safety. Gotenjyō, a ceiling structure of which stiffness was enough to transfer the horizontal seismic force to the bearing walls, was employed in this building (See Fig.3 and Photo.2). This effect was ensured by the microtremore measurements, presented in the following section. One of the structural characteristics of ancient timber building in Japan is to utilize large diameter columns. When Hokkedo-hall was subjected to large earthquakes, its large diameter columns must have resisted against seismic force by column rocking resistance. Furthermore, the mud wall that is a major earthquake-resistant element of traditional timber building in Japan also have resisted as shear panel. Structural survey was conducted to measure such earthquake-resistant members for seismic diagnosis of the building, described in Section 4.

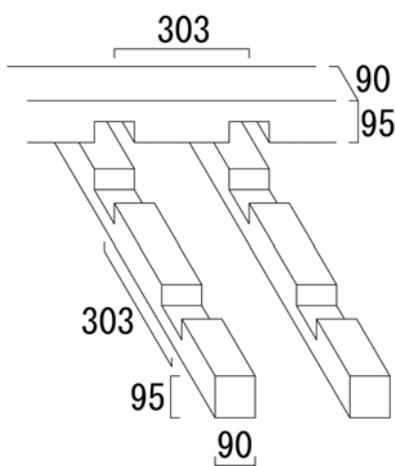
Fig.3 Rigid ceiling, Gotenjyō

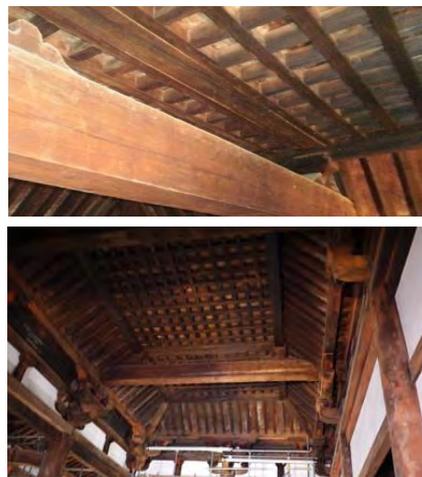
Photo.2 Rigid ceiling, Gotenjyō

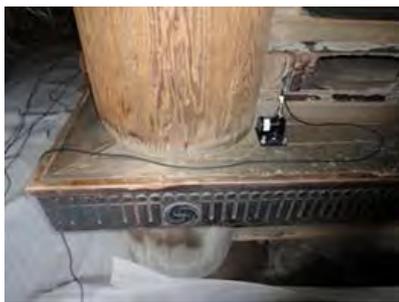
Photo.4 Sensors on the base beam

Microtremor measurements can be a useful method to know fundamental dynamic properties such as natural periods, modes and damping characteristics of building structures. To investigate those dynamic performances, microtremor measurements were performed at the first stage of the present study. Utilizing SPC-51 system with a dozen of sensors of VD-15 (See Photo.4), Tokyo Sokushin Ltd., we measured microtremors of both the structure and the ground with sampling frequency of 100Hz. Fig. 4 shows the transfer function of the building from the base to the beam in EW direction. Here, the sensors were installed on the beam on the mud walls which would resist seismic horizontal force and behave as shear panels. The natural frequency of 1<sup>st</sup> translational mode in each direction was evaluated as ; 1.51 Hz and 1.72Hz, in EW and NS direction, respectively. In addition to microtremor measurements, free vibration tests were performed to evaluate the damping ratio, shown in Photo.5 and Fig.5. The damping ratio for 1<sup>st</sup> translational mode in each direction was evaluated as ; 1.9% and 2.0% in EW and NS direction, respectively. Fig. 6 describes the vibration mode for 1<sup>st</sup> translational mode in each direction. It should be noticed in Fig.6 that the structural deformation in EW direction showed irregular, i.e., the amplitude of the southern end frame in “Raido” was 5.5 times as large as that of northern end frame in “Seido”. This eccentricity was mainly

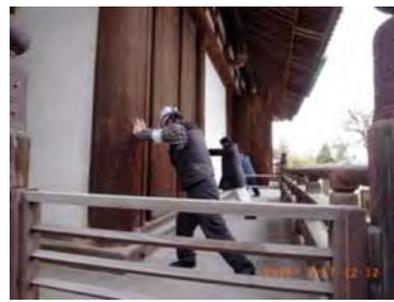
Photo.5 Free-Vibration test by man-power

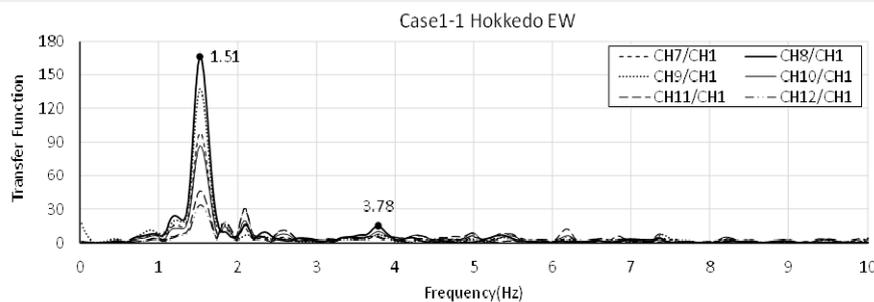
Fig.4 Transfer function from Top of seismic elements to base

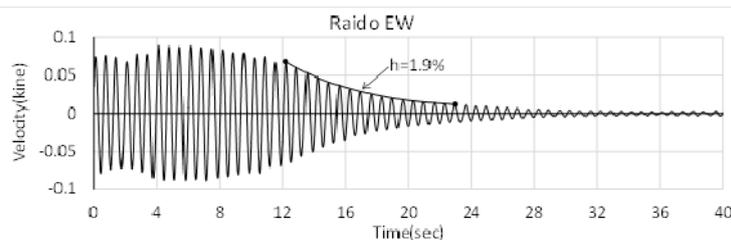
Fig.5 Wave Form by Free Vibration test

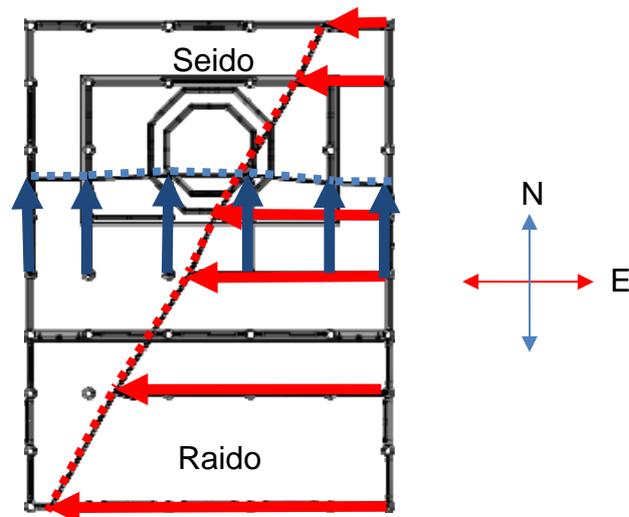
Fig.6 Vibration mode in both EW and NS direction

caused by the layout of the mud-walls, i.e., unbalance arrangement of shear walls, that must affect the horizontal deformation. The southern room of “Raido” was used as entrance and characterized by large opening with lack of walls, therefore, the amplitude became much larger. On the other hand, “Seido” was surrounded by the mud walls, in particular, the building had double walls in the northern structure, which caused larger stiffness with small amplitude. This dynamic behaviour should be considered in the seismic safety assessment from an earthquake engineering point of view. On the other hand, the amplitude in NS direction showed almost uniform without irregularity, described in Fig.6. No eccentricity was found in NS direction, indicating that the mud walls (shear walls) were well arranged in NS direction.

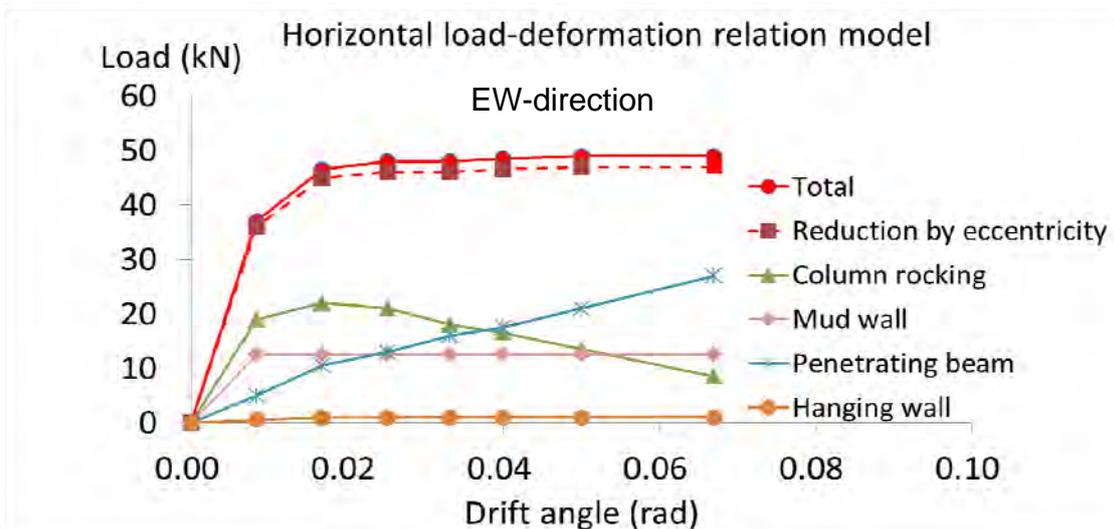
Fig.7 Load-deformation relation model in EW direction

The timber structure was idealized by a single degree of freedom model on the assumption that horizontal in-plane rigidity of the roof structure including the ceiling frame was stiff enough. The weight of the model was estimated from the structural survey and the literature[2]. The horizontal load-deformation relation was evaluated by sum of resistance by anti-seismic elements. Hence, the anti-seismic elements of this traditional timber structure were semi-rigidity joints of penetrating beams, mud walls, hanging walls, and column rocking resistance. The architectural site survey of Hokketo hall gave us both the dimension of the structural members and the structural condition of the joints, which enabled us to calculate the load-deformation relation of each anti-seismic element listed above. Fundamental load-deformation relations of various anti-seismic elements used for seismic design and seismic diagnosis of the traditional timber buildings have been available in Japan[2,3]. Utilizing these mechanical models of the anti-seismic elements, non-linear horizontal load-deformation relation of the timber structure in each direction (EW, NS) was finally modelled. Fig. 7 shows the load-deformation relation model in EW direction. Shown in Fig.6, irregular deformation due to eccentricity was found in EW direction, therefore, load-displacement relation of the total was reduced as described in Fig.7.

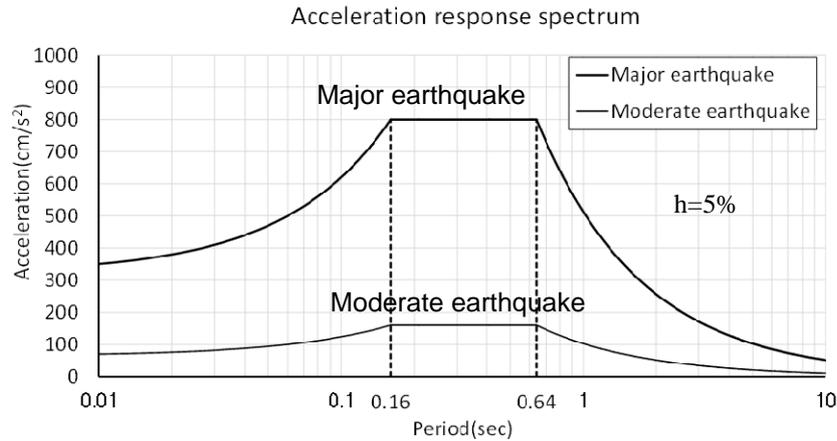
Fig.8 Acceleration response spectra defined in Japanese Building Code

As the seismic load for the present diagnosis, the acceleration response spectrum to assess safety limit, prescribed in Japanese Building Code, was referred, shown in Fig.8. The response spectrum of “major earthquake”, i.e. the extremely strong ground motion, was utilized for seismic safety evaluation. The seismic load given by the response spectra, shown in Fig.8, is corresponding to earthquake motions at the engineering bedrock of which shear velocity is larger than 400m/s. Hence, if surface layers exist on the engineering bedrock, soil response of surface layers should be taken into account. However, Hokketo-hall was constructed on rocky stiff soils at the mid-slope of the mountain. Therefore, no amplification due to soil response was considered in this seismic diagnosis. On the basis of the load-deformation model shown in Fig.7 and the required spectra shown in Fig. 8, seismic performance in Equivalent Linearization Method can be described in Fig.9. From this figure, story drift angle at the performance point in EW direction was calculated to be 1/40 for the major earthquake. In Japan, story drift of 1/30 has been recommended at safety limit for seismic evaluation of timber heritages designated as important cultural properties[2]. This calculation therefore indicated that Hokketo-hall would be structurally safe against the major earthquakes defined in Japanese Building Code. Furthermore, it verified the historical record that the building have survived against large earthquakes during its long centuries.

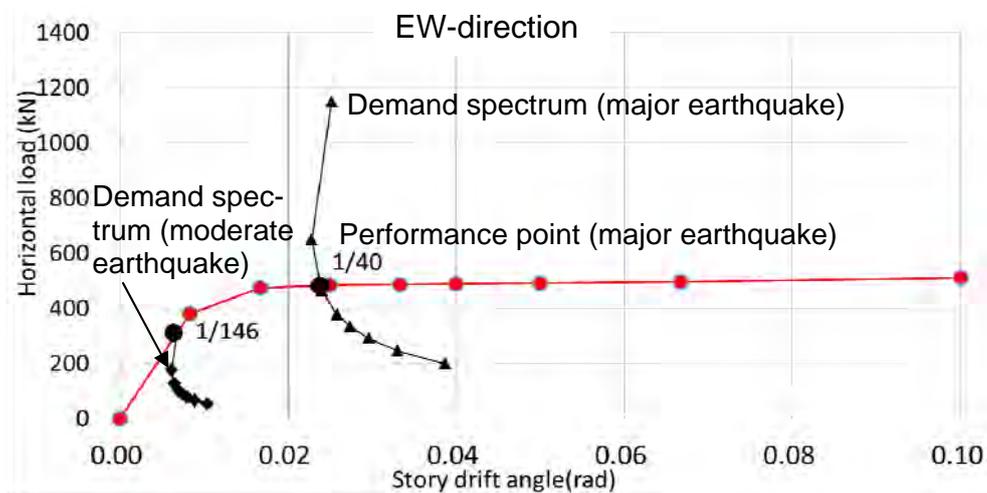
Fig.9 Earthquake performance evaluation in EW direction

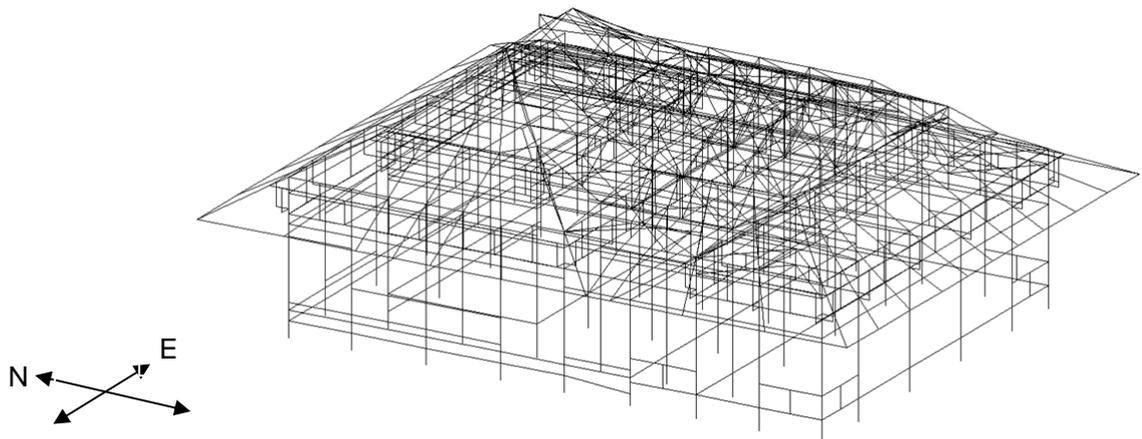
Fig.10 3-dimensional frame model

Fig. 10 shows the 3-dimensional analysis model with a total of 2773 joints and 2227 members. Mud walls and hanging walls were idealized by elastic shell elements. Figs. 11 and 12 describe non-linear mechanical models of a joint of a penetrating beam and column and column-rocking resistance, respectively. Fig. 13 describes load-deformation relation of the mud-wall proposed in the past studies.

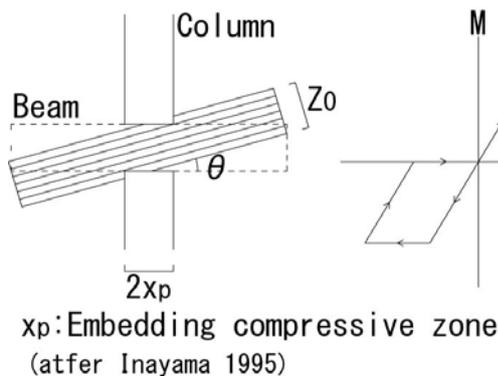
Fig.11 Model of joint of penetrating beam and column

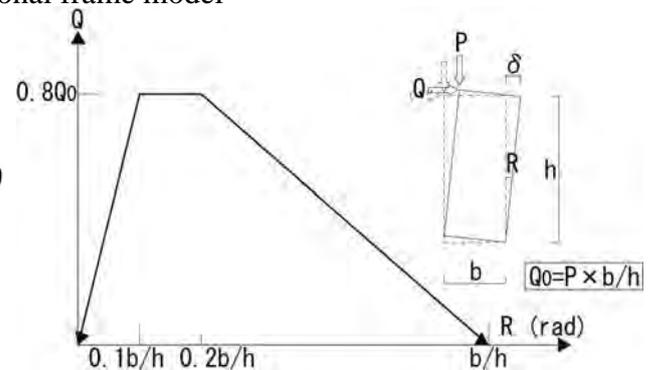
Fig.12 Model of column rocking resistance

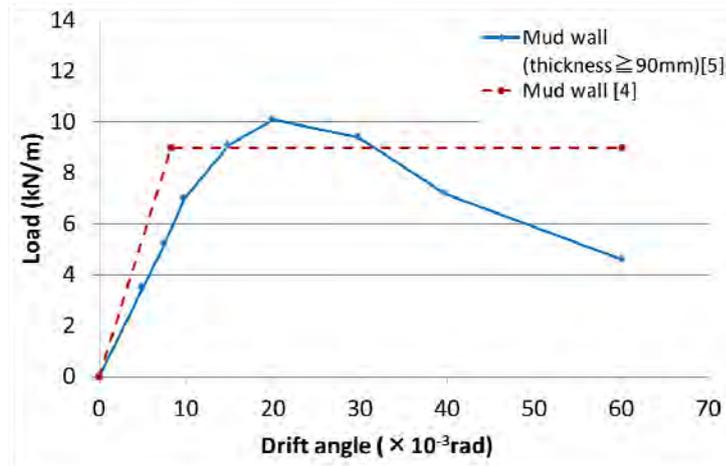
Fig.13 Load-story drift relation model of mud walls

On the basis of those studies, the shear modulus  $G$  of the mud walls of the present analysis model was estimated to be  $0.01\text{kN/mm}^2$ . Eigenvalue analysis was conducted to evaluate the natural frequencies and modes, as natural frequencies and modes were evaluated from the microtremore measurements, presented in Section 3. Hence, it should be considered that the joint would not behave, during microtremore, as semi-rigid shown in Fig.11, but would behave as rigid joint at the joint between a penetration beam and a column, because strain level might be too small to develop rotation at the joint. At the same time, it was considered that the mechanical condition of the joints of the roof frame structure, rigid or semi-rigid, were unknown. Taking into account these considerations, eigenvalue analysis was conducted for three models by paying attention to the joint of a penetrating beam and a column as ;A) rigid model, B)semi-rigid joint model with partially rigid joints , and C) semi-rigid joint model with partially hinge joints. Hence, “partially rigid joints” and “partially semi-rigid joints” were corresponding to the assumed joint mechanical condition of the roof frame structure. Fig.14 shows how to model the bracket complex. Rotation was produced at the base of a brock by embedding effect as shown in Fig.11. As a result of the eigenvalue analysis, Table 1 compares the measured natural frequencies with analysis models. Compared in Table 1, the analysis model of the rigid joint “Model A” showed better agreement with the measurements. Furthermore, it would not affect the natural frequency whether the mechanical condition of the joints of the roof structure was rigid (Model B) or semi-rigid (Model C). This comparison indicates that no rotation would be caused between a penetrating beam and a column during microtremore, therefore, would behave because a rigid joint, as the strain level would be so small. Fig. 15 shows the vibration modes of which natural frequencies are listed in Table 1.

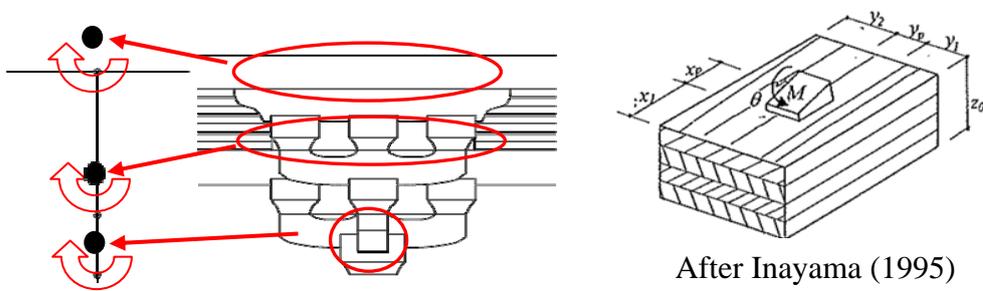
Fig.14 Model of bracket complex by using rotational spring

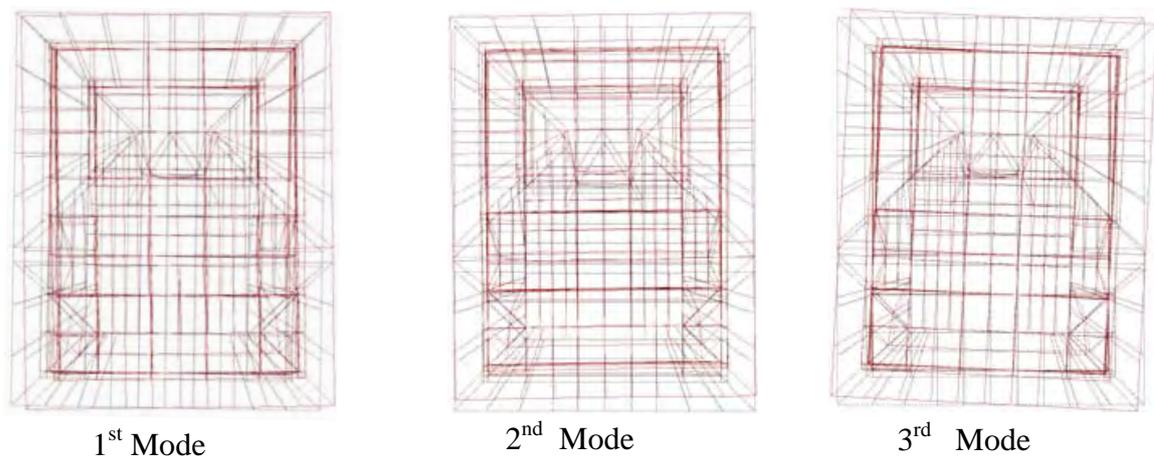
Fig.15 Vibration modes (Model A)

1 <sup>st</sup> mode	2 <sup>nd</sup> mode	3 <sup>rd</sup> mode
Microtremore measurement		1.51(Hz)	1.73(Hz)	2.10(Hz)
		EW-direction translational	NS-direction translational	Torsional
Analysis model	Model A	1.71(Hz)	1.93(Hz)	2.02(Hz)
		EW-direction translational	NS-direction translational	torsional
Analysis model	Model B	1.02(Hz)	1.16(Hz)	1.24(Hz)
		EW-direction translational	NS-direction translational	torsional
Analysis model	Model C	1.01(Hz)	1.15(Hz)	1.24(Hz)
		EW-direction translational	NS-direction translational	torsional

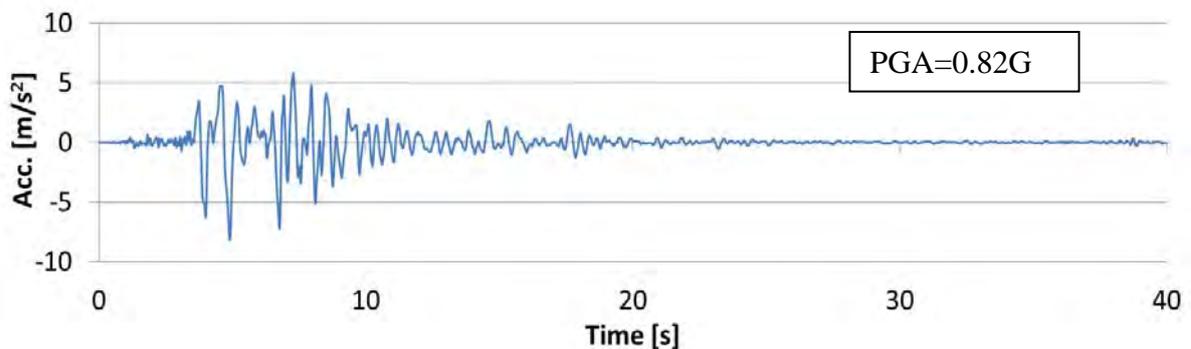
Fig.16 Wave form of input ground motion (JMA Kobe NS,

Non-linear earthquake response analysis of the 3-dimensional frame model was conducted. The present paper describes the analysis results for the input ground motions as ; 1) the simulated ground motion of which response spectrum agreed with that designated on the engineering bedrock in Japan Building Code. 2), and 2) the acceleration data recorded during Kobe earthquake of 1995 (NS component recorded at JMA Kobe. Time histories and response spectra of those input motions are shown in Figs 16 and 17. PGA of the input ground motions for the former and the latter ones are 0.34G and 0.82G, respectively. Those ground motions were input to the analysis model in NS direction, and in EW direction, respectively.

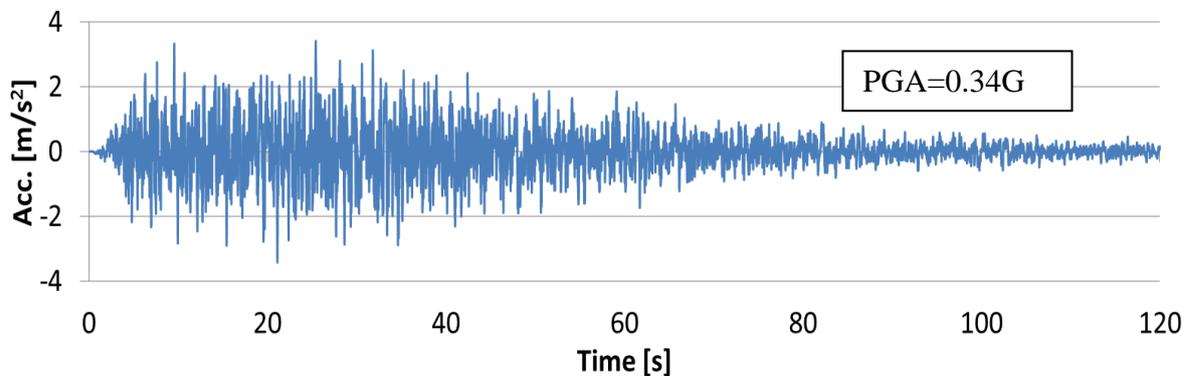
Fig.17 Wave form of input ground motion (Simulated ground motion of which response spectra is compatible with that of Japan Building Code)

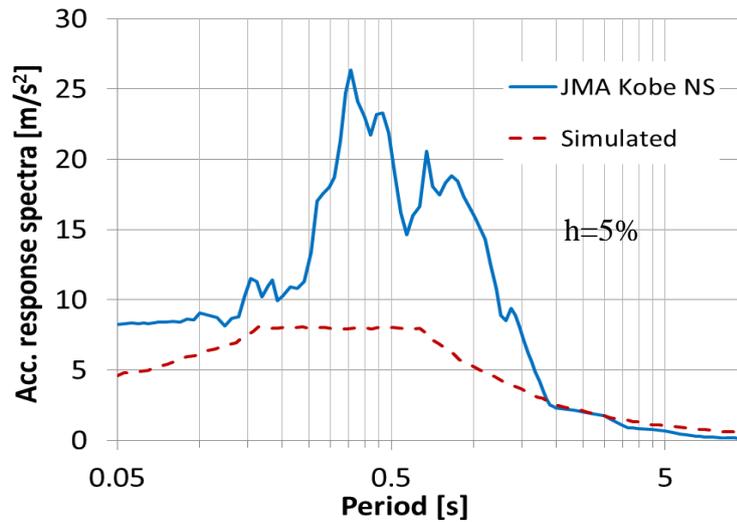
Fig.18 Acceleration response spectra of input ground motions
