HISTORIC MILITARY ARCHITECTURES IN THE PROVINCE OF MANTUA: THE EFFECTS OF THE 2012 EARTHQUAKES

Antonella Saisi¹ and Stefania Terenzoni²

Keywords: Earthquake, Masonry, Military Architecture, Towers.

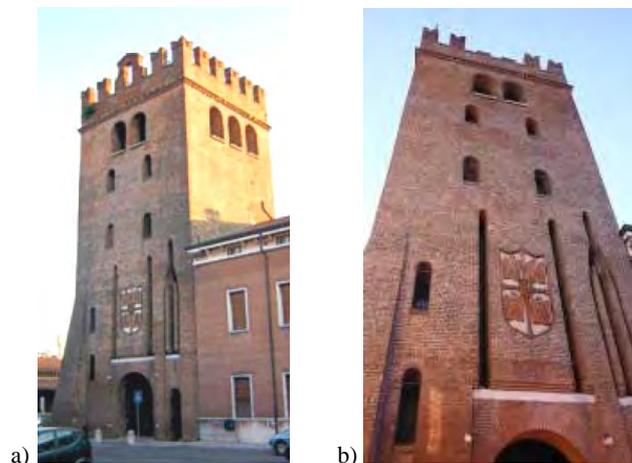
Figure 3: Civic Tower of Sermide before (a) and after the earthquake (b). The reported damages included the partial collapse or damage to the battlements.

Although the examined defensive architectures were near the epicentres of the earthquakes, ruinous collapse, as in the case of the fortresses of Emilia [3], did not occurred despite showing significant damage and cracks. The reported damage to towers are often concentrated in the upper part, with the partial collapse or damage to the battlements and of any superposed structure, usually belfry, as happens to bell-towers subjected to seismic actions (Fig. 3). The collapse of the lantern of the Church of Santa Barbara, the chapel of the Palazzo Ducale in Mantua, as an example, was probably the most evident damage in Mantua; it is a clearly recognizable gap in the urban skyline near the Castle of San Giorgio, when accessing to the city from the bridge with the same name.

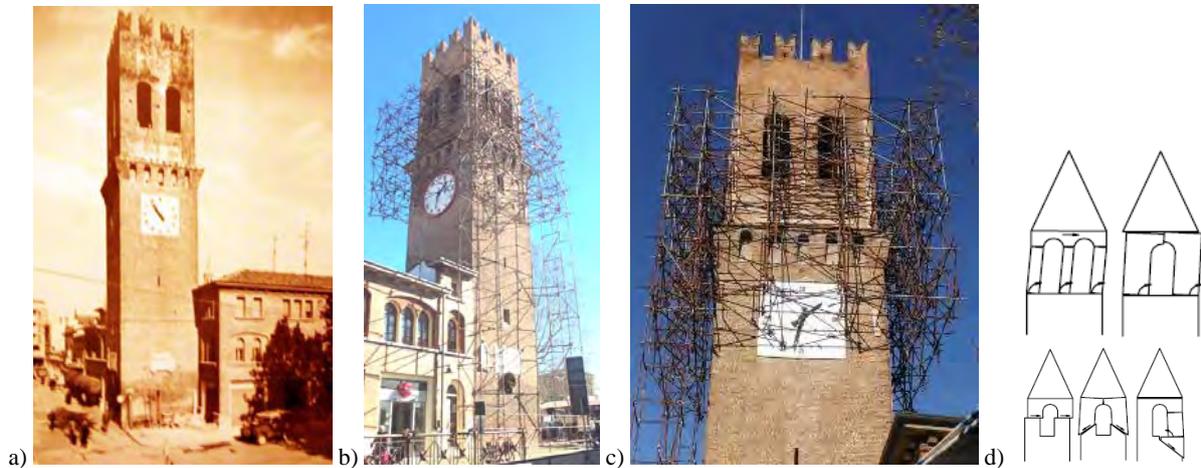
Figure 4: Civic Tower of Suzzara (a). The damage mechanism seems caused by the rotation of the corner pillars and by the following corner expulsion (b-d)

Damage to the belfry is also present in the Civic Tower of Suzzara, the only remain of the castle, dating back to the thirteenth century; the damage mechanism seems caused by the rotation of the corner pillars and by the following corner expulsion; this damage is easy readable through the crack observation on the front north and west (Fig. 4).

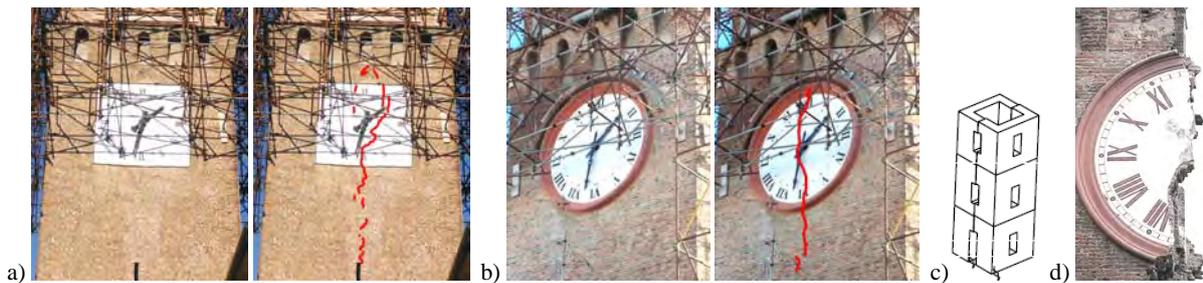
Figure 5: Civic Tower of Suzzara: the tower has vertical cracks in the central part respectively of the fronts south (a) and north (b). The damage is present in the forms of the Civil Protection for bell-towers (c) and is very similar to the one of the collapsed Clock Tower of Finale Emilia (d), symbol of the Emilia earthquake.

In the analyzed architectures, being now mainly isolated buildings or not well connected to other existing buildings, the documented damage are frequently caused by bending effects with the formation of vertical cracks or sub-horizontal cracks with the following discretization of the walls and outward rotation of the corner elements. The collapse of one of the symbolic

buildings of the 2012 earthquake, the Clock Tower of Finale Emilia, was determined by the progression of this damage mechanism. The cracks visible on both the north front, both on the south front of the Civic Tower of Suzzara at the clock level, in a position very similar to that of the Tower of Finale Emilia, document a similar structural behaviour, as well (Fig. 5).

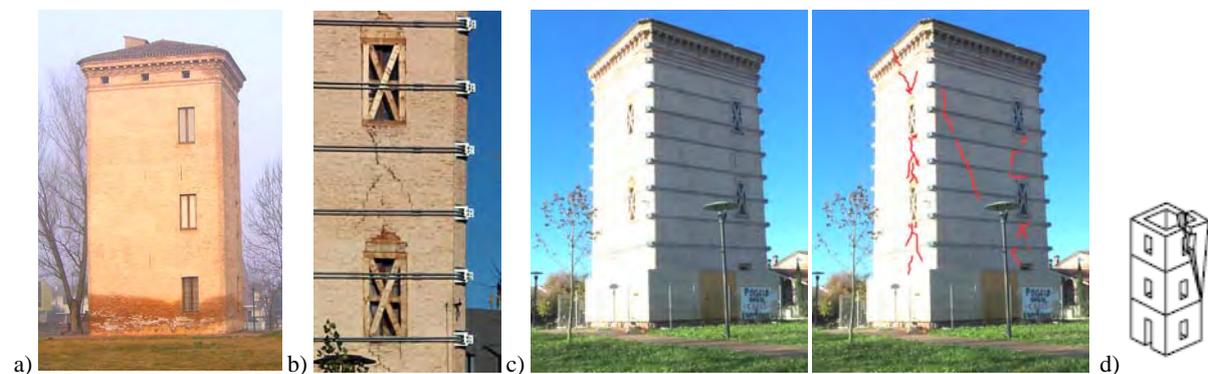
Figure 6: Torre Falconiera at Poggio Rusco before the earthquake (a); details of the shear cracks under the openings (b). The damaged platbands required a reinforcement of the openings with a wooden structure. The crack pattern (c) shows a shear behaviour of the walls that triggers a corner movement (d).

A frequent intervention to defence buildings was the opening enlargement to fit new needs and requirements, being originally of small size. The alignment of the openings, especially if placed close to the corner, as in the Tower Falconiera at Poggio Rusco (Fig. 6), and the shear behaviour of the walls and the typical St. Andrew-cross cracks below the windows (Fig. 6b), have triggered subsequent kinematic rotation of the corner (Fig. 6c,d).

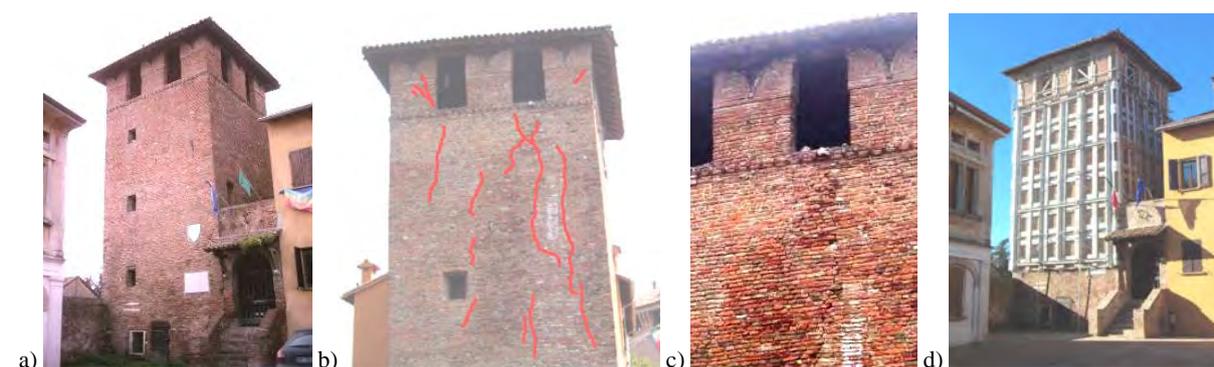
Figure 7: Tower of Prisons at Gonzaga before the earthquake (a); the formation of deep vertical cracks (b) in the south side was caused by the overturning mechanism of the south-west corner (c), and highlighted by an apparent out of plumb which justified the massive emergency intervention for the safety of the tower itself (d).

Similar damage affects in a more accentuated way the Tower of Prisons at Gonzaga (Fig. 7), where the formation of a deep vertical crack on the south side caused the overturning mechanism of the south-west corner (Fig. 7b,c); the clear out-of-plumb justifies the massive prompt intervention for the safety of the tower (Fig. 7d).

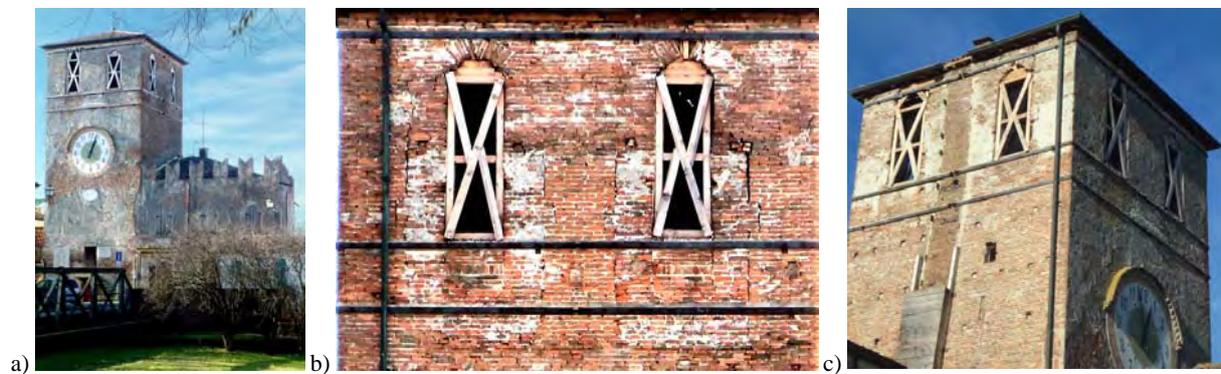
Figure 9: Torre Matildica a Bagnolo San Vito (a). The presence of several discontinuities in the upper area (b) of all the fronts was due to the constructive phases not effectively linked is evident from the cracks at the interface, and reinforced by both local supporting wooden frames both tie-rods elements to tie the top of the tower (c).

The closing and opening of new holes in the wall is usually carried out by simple addition to the masonry of new frames without connections. Opening infillings (windows, doors, chimneys, fireplaces, niches, etc.), or wide discontinuities due to the historic construction phases, effectively link or not, during the earthquake tend to behave independently or even to

detach, not collaborating effectively with the adjoining side panels (Fig. 9). Furthermore, at the interfaces cracks progressively spread, as well wall portions could start the overturning. In the case of buildings evolved and transformed over time, damage and cracks could be caused by the several structural discontinuity even not linked due to the use both of different materials, both the different construction techniques. This is the case of the Palazzo Ducale in Rovere; a former fortification was modified on the base of a plan by Luca Fancelli. Apparently it was little damaged on the external fronts, apart from the collapse of one of the heavy Venetians chimneys (Fig. 10), and some cracks on the north front where an intervention is already in progress. Nevertheless, it shows widespread damage indoor due to the heterogeneity of the walls because of the several construction phases, often not effectively linked between them.

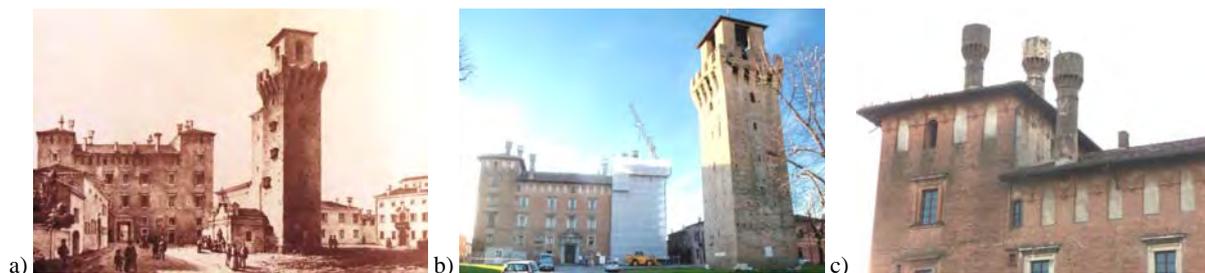
Figure 10: Palazzo Ducale of Revere before the intervention of 19th century (a). Apparently it was little damaged on the external fronts, apart from the collapse of one of the heavy Venetians chimneys (b,c), and some cracks on the north front.

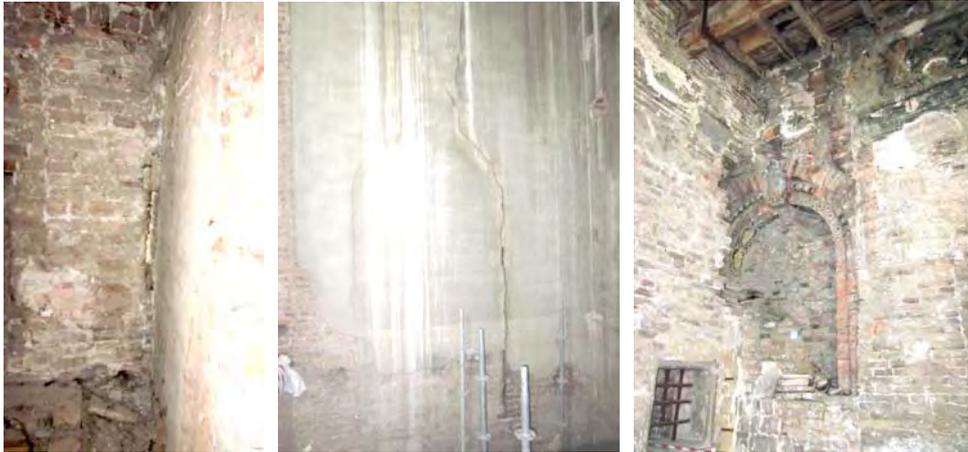
Figure 12: Palazzo del Podestà in Mantua. Examples of damage related to the lack of effective connection between the historic building phases.

In a minor way, also in the Palazzo del Podestà, in the Palazzo Ducale in Mantua and especially in the Castle of San Giorgio, the earthquake caused slight damage related to the lack of effective connection between the historic building phases or to former damage. Despite this damage did not cause evident structural problems, the seismic actions and the movement of the existing cracks damaged important decorative elements, also creating serious concerns for the frescoes by Mantegna in the Camera Picta, located in the Castle of San Giorgio and still not fully accessible.

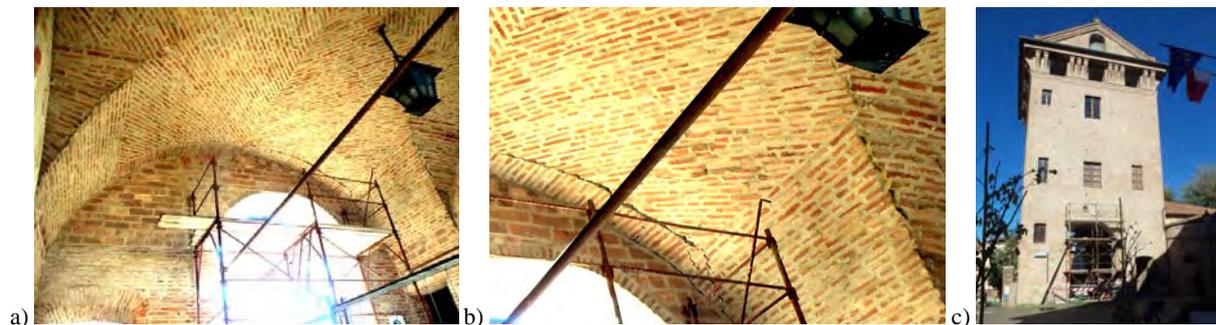
Figure 12: Civic Tower of Gonzaga. Details of the vault damage (a,b). Deformations or movements of the walls, even if limited, can damage arches or separate vaults from the perimeter walls, as happened in the vault at the base of the Civic Tower of Gonzaga apparently not damaged in the outside walls (c).

Deformations or movements of the walls, even if limited, can damage arches or separate vaults, as happened in the vault at the base of the Civic Tower of Gonzaga apparently not damaged in the outside walls (Fig. 12).

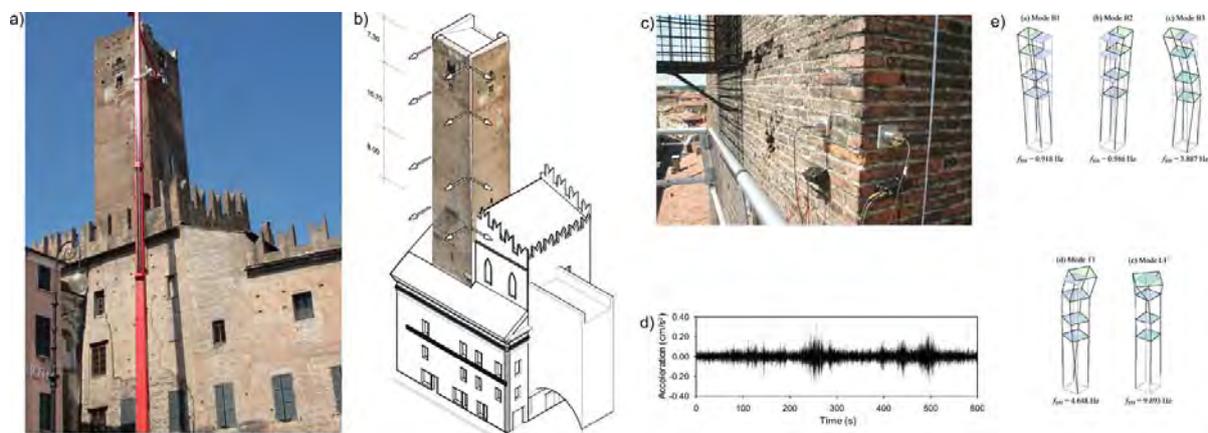
Figure 11: Gabbia Tower in Mantua. An extensive investigation was carried out since the end of July 2012 including dynamic testing and a permanent dynamic monitoring of the structure, still active [17].

For example, on the Gabbia Tower, an extensive investigation was carried out since the end of July 2012 including a permanent dynamic monitoring of the structure still active (Saisi 2014). The assessment of the structural integrity and of the load-bearing capacity of the building required firstly careful inspection and on-site investigation and the following modelling and numerical analysis; this information was articulated within a synergistic process where information and methodologies flow from several disciplines and related to the reconstruction of the building evolution, the materials and construction techniques and the possible state of decay.
