## ARCHITECTONIC AND STRUCTURAL STUDY OF FORT SAN DIEGO AT ACAPULCO

**Abstract.** *With reference to historical data the actual conditions of Fort San Diego at Acapulco are analyzed. This study encompasses the architectural features, the geometry details and the structural behavior. Results of field works are presented and discussed, mainly on topographical survey, architectural features, materials characterization, and hardness measurements of the main materials and survey of damages. Architectural aspects are related to classical treatise and antique books on military engineering. The recommendations for the preservation of the architectural values are made based on these. Geometrical characteristics are pointed out, and it is demonstrated that the plan follows three concentric circles almost perfectly. The circles have radii of 70 varas (58.45 m), 50 varas (41.75 m) and 40 varas (33.40 m) respectively. It is also noted that the outer picks form a quasi-perfect pentagon. With the data of field studies a probable construction sequence is proposed consisting of eight major steps that take several decades to be completed. The probable structural behavior was investigated mainly for

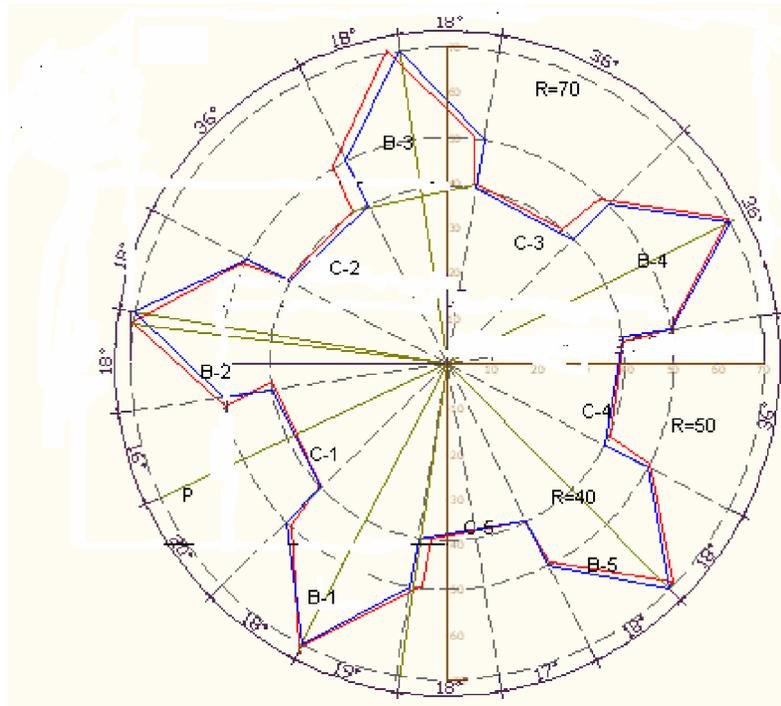
Figure 2. Geometrical characteristics of San Diego Fort at Acapulco

The analysis of Figure 2 shows that the geometry follows, in a very direct and simple way, the rules according to the defensive criteria for the fortifications at that time. Considering the limitations of measure apparatus at that time (cords, chains and primitive levels or corobates) and the technical difficulties in a very irregular land, is amazing the level of accuracy attained, the deviation of the angles defining the picks of the five bastions is not more than 2 degrees

(2.3%), that is, the real plan is very accurate respect the theoretical project of a regular pentagon, this fact is represented in Figure 2 which shows the theoretical and actual traces, the last based in measurements taken in April 2007.

The geometry of the actual fort in plan is a rectangular pentagon inscribed in an exterior circle with 140 *varas* (116.9 m) diameter, other concentric circle with diameter of 100 *varas* (83.5 m) defines the lateral folds of the five bastions. Other smaller concentric circle with diameter of 80 *varas* (66.8 m) define the point were the ends of the bastions intersect with the beginning of the curtains. It is assumed that the unit of measure of that time was the *vara castellana* equivalent to 835 mm. The angle of the vertices between two consecutive bastions is 70 degrees with small variations. The main geometrical characteristics of the fort are presented in Figure 2. It was demonstrated that Ramón Panón, the author of the regular pentagon, based his design on the rules established by Christoval de Rojas, as well as some influence of classical treaties of Vitruvius and Le Pestre.

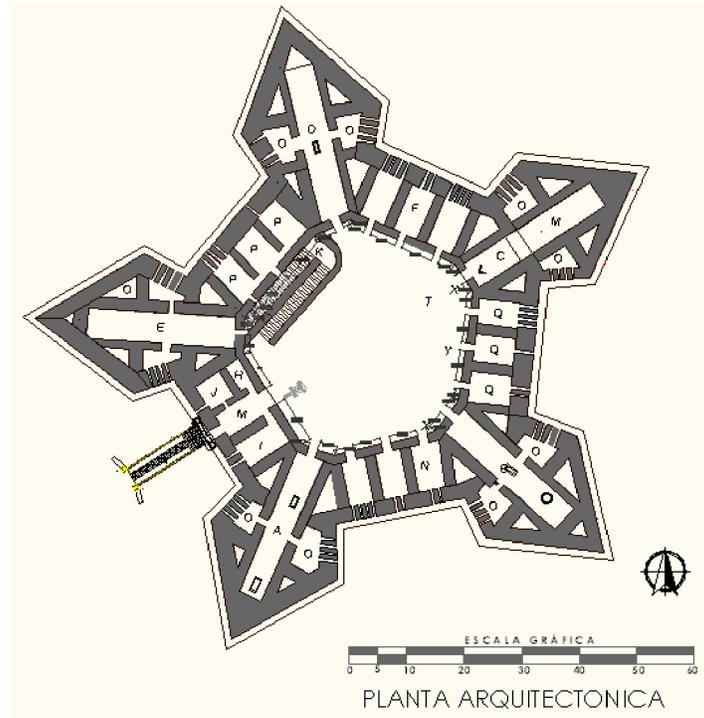
Figure 3. Inner distribution of San Diego Fort at Acapulco

Figure 3 shows the distribution of rooms in the inner part of the fort and Figure 4 show the correspondent theoretical design proposed by Rojas in his treaty of 1598, so the military engineer Panón for sure based his design, trace and construction on that book. The pentagon shape according with Rojas was very useful in places with a face directed to the sea and the other directed to land, because permitted strategic movements for attack and defense strategies, as well for counteroffensive, vigilance and internal security. Before construction it was recommended to the builders to perform a paper scale drawing on a wood platform of “generous dimension” in order to verify dimensions and angles as well as geometric forms by means of architects square and compass. With this exercise the definitive trace on the land was facilitated using ropes and poles, as an extension of the experience on paper.

In general the architectonic program utilized in the construction of the fort included: five bastions with the names of La Concepción, Santa Bárbara, San Luis, San Antonio and San José; a chapel, bridge, the plaza or mall, habitation rooms, storage, defensive ditch and covered access.
