REMAINS OF URBAN HERITAGE DEFENCE STRUCTURES – CONSERVATION, MONITORING AND USE

BEDNARZ Łukasz¹, BAJNO Dariusz²

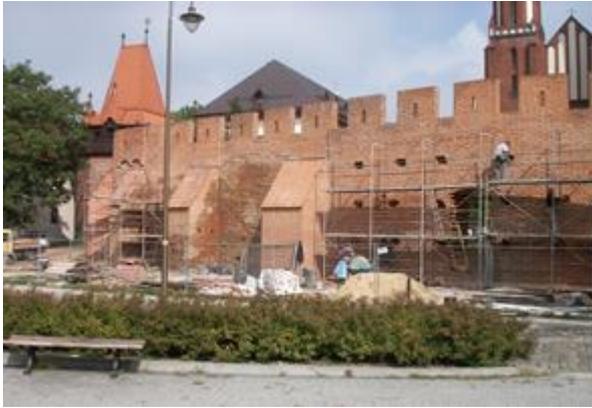
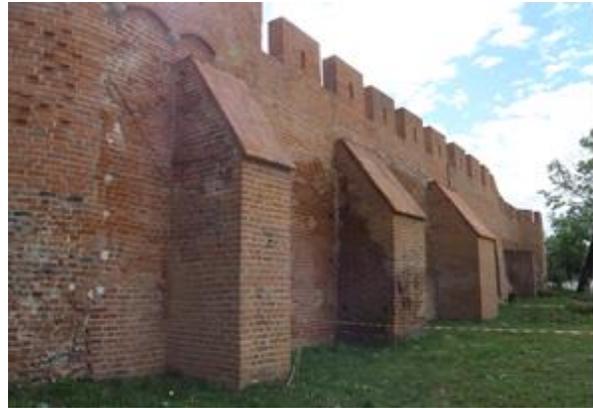
Figure 1: Western side Opole defence walls – the north- Figure 2: Western side Opole defence walls – the south-
ern fragment next to a tower. ern fragment.

The Opole fortifications (fig. 1, 2) were rebuilt and modernised several times in the period between the 13th and 18th centuries and represent an interesting example of the development of the practice of fortress construction in Poland. Walls were built of gothic ceramic bricks in a double-strecher bond (13th century) and single-strecher bond (14th century) with strongly fired tie-bricks. The external wall face consists of full ceramic bricks with lime mortar. The inside of the wall is filled with split lime stone, bound with lime mortar. The wall is $1.90 \div 2.25$ m thick. Originally, the wall had a cladding of bricks in Polish (gothic) bond and Slavic/ Slavonic bond in places. It was originally 6 to 9 m high.

In Opole, a large fragment of the western part and a small part of the eastern part (near the upper castle) of the defence walls have been preserved to the present day. Heritage masonry defence structures, which have survived to the present day, are typically used for purposes other than those originally envisaged by their builders. This is especially so in the case of the various elements of defensive walls, which have been adapted for use for residential, public service or storage purposes. Long periods of such use impacts the durability of these structures. Durability is closely related to improper maintenance of a building, changes in the type and value of external loading (including dynamic loading coming from, e.g., intensive street traffic), repair and “modernisation” work based on materials with mechanical, thermal and moisture parameters significantly different from the materials originally used. The massive appearance of the walls can be misleading, as not all were built as monolithic structures of ceramic bricks, which at the

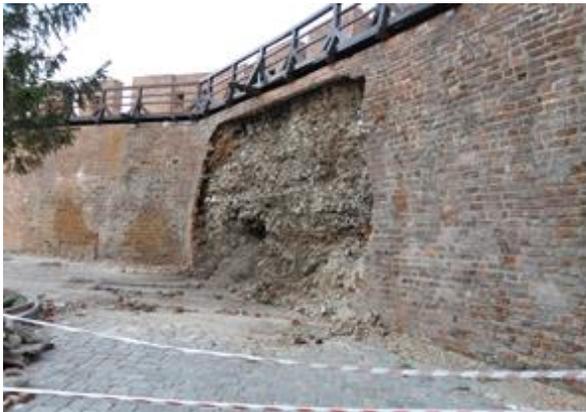
Figure 3: Eastern part of the wall and its damaged 8 m long section.

The multi-layer wall structure is presented in fig. 3, 4. Despite a number of efforts to investigate the interior of the structure with non-destructive methods, a more detailed analysis was possible only after an eastern part of the wall face collapsed in March 2012. A heterogeneous wall with a minimal bonding can be observed. The assumption is that the external wall face was made of bricks, serving as retaining structures for securing loose lime stones from spilling out of the wall. The wall has a significant number of cracks and fissures with damp along its whole length. The cause is changing atmospheric conditions which impact the wall surface and penetrate into the interior of the structure in different ways at different times of the year, leading also to problems with foundations. Even tiny leaks which appear in places where pointing is missing or in brick fissures can cause significant cracks and structural damage resulting from biological corrosion of the external materials and wall filling, as well as from water freezing inside the cracks.

Today, the wall is not a monolithic structure. It consists of three separate vertical parts, i.e. two external leaves and an in-filled (rubble) core. Wall surfaces are made of ceramic bricks with lime mortar, with new brick fragments (resulting from more recent repair work) laid with contemporary modified mortars. The core of the wall is made of lime stone bound with lime mortar. The mortar has lost its binding properties across much of the core surface, with the result that the core material acts as a typical filler, just as in the case of containers filled with loose material which generate not insignificant horizontal pressure on vertical wall surfaces, which are $\frac{1}{2}$ a brick in thickness. An important factor which determines wall stability and safety is its fragility and the vertical loading value, which in a situation where there is no bonding of rigid building elements exceeds all limitations of wall building standards, including prevailing standards [3]. Moreover, not one of the external leaves has kept its vertical form. Concave wall deformations range between 4÷22 cm along the height of the structure.

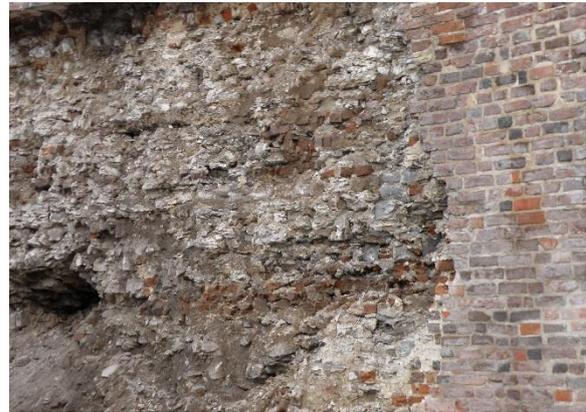
Figure 4: Detail of damaged defence wall.

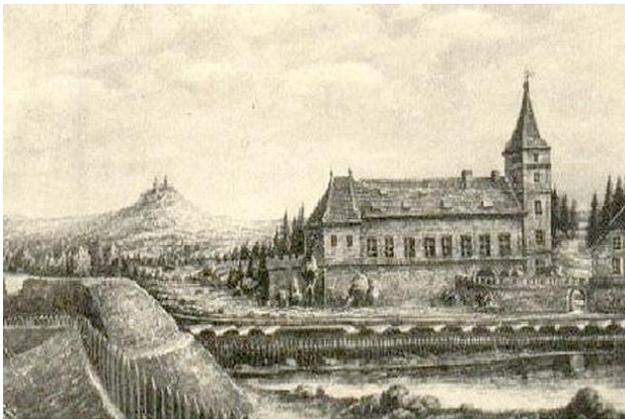
Figure 5: Kędzierzyn-Koźle castle – a 19th century drawing. [4].

The fortifications of the castle in Koźle (fig. 5), which were analysed, differ from the example described above in that they were constructed as a whole with bricks with lime mortar and stone foundations (fig. 6). Their technical condition is also very bad for reasons similar to those of the Opole case. The oldest fragments of the Opole Piasts' castle in Koźle date back to the first half of the 14th century. The castle was located on the left bank of the Oder river, on a man-made embankment which reached a height of 4 m in places. The stronghold was built on

a quadrangle plan with three corners cut to give an impression of slightly rounded walls. A square tower protruding from the wall line was built in the fourth (south-east) corner. The walls were surrounded by a moat. The gate to the castle was located in the eastern wall next to the tower. A tower comprising residential quarters was placed in the middle of the main bailey. The castle had also an outer bailey. In the 16th century the castle was rebuilt. A new residential building was added and a tall bastille in the south-western corner. The outer bailey was rebuilt in the subsequent century and a whole southern wing was added to the castle. A new gate leading to the courtyard through the southern wing was built in the 19th century. After 1743, the Prussians established a big fortress comprising the castle and the town in Koźle. In 1915 more architectural changes were introduced. The castle was destroyed during the World War Two. Only fragments of the perimeter walls, tower foundations and the remains of two castle wings have survived to the present day.

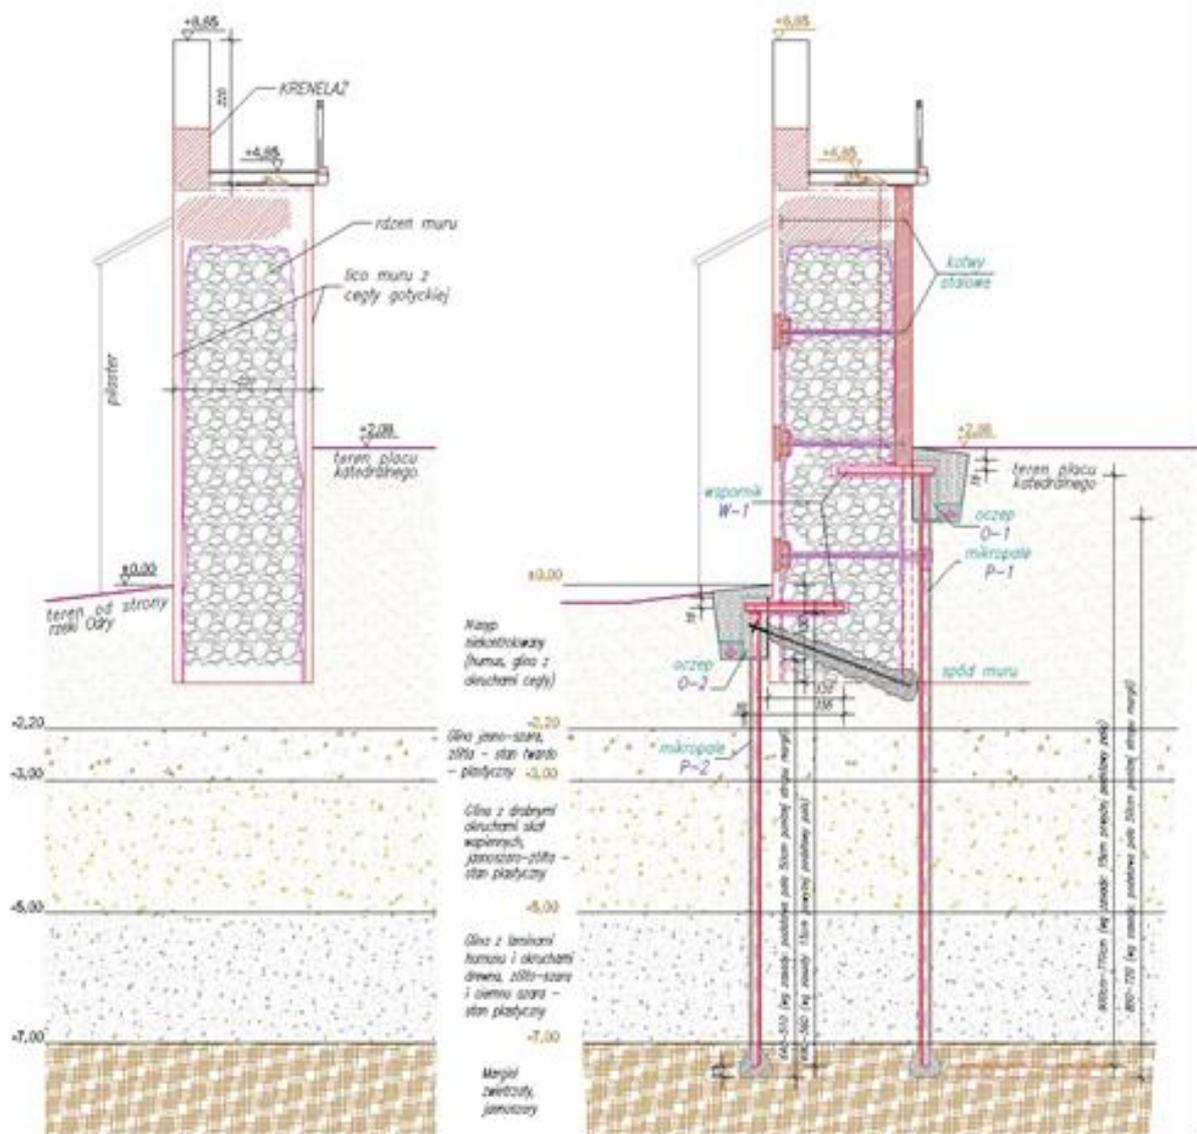
Figure 7: Wall cross-section before and after strengthening.

In the case of the defence walls investigated, it was concluded that repair of damaged fragments would not solve the problems with load-bearing capacity and stability of the structure as a whole. Consequently, a much wider scope of repair and strengthening work was recommended. The work conducted will not change the appearance of the walls or decreasing their historical and heritage value and attractiveness for tourists. Additional investigation of foundation sub-soil indicated that the walls had not been built on load-bearing sub-soil. The building structures were deemed to require full structural strengthening both at the level of their foundations and along their whole height and thickness. In the case of the Opole defence walls, an additional strengthening proposal was to introduce a palisade topped with a pile cap and cantilevers for supporting the whole wall structure in the bottom part (figs.7 - 11). Two leaves on the external wall face were joined together with transverse steel anchors, each one ending with ceramic supports made from original bricks (fig. 12, 13).

The wall fragment which had collapsed has been rebuilt. But instead of applying the original external half-brick thick leaf, a massive wall one brick thick was constructed and strengthened internally with pilasters. Internal steel anchors (made of stainless steel) have support elements at each end made from original bricks taken from the wall. The supports have been strengthened with Ruredil X MESH C10/M25 composite mesh glued with mineral mortar (fig. 9). An ending made of stainless steel to be linked directly to the bricks and in supporting joints was made of stainless steel (fig. 9). The strengthening system described above represents only one stage in protecting the damaged building structure from further degradation. Such structures have to be secured from atmospheric conditions, engineering appropriate inclination of flat surfaces to enable total extraction of water from precipitation and full hydrophobisation of surfaces penetrated by external moisture.

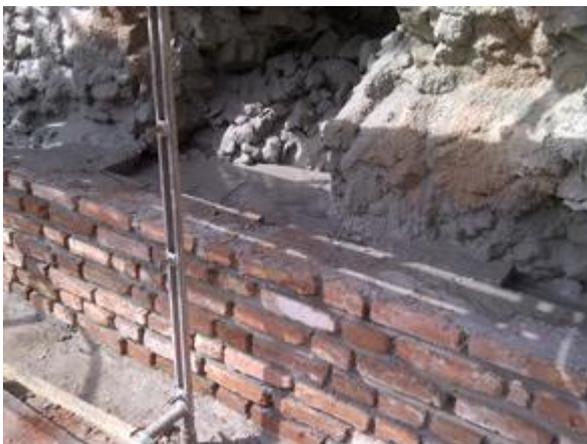
Figure 8: Infilling masonry in collapsed wall.

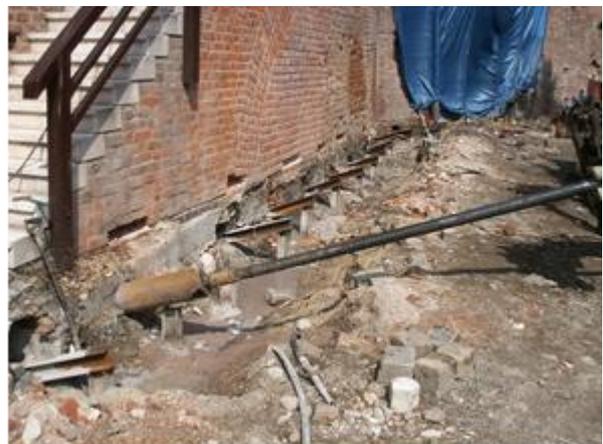
Figure 9: Drilling of holes and installing pile cantilevers.

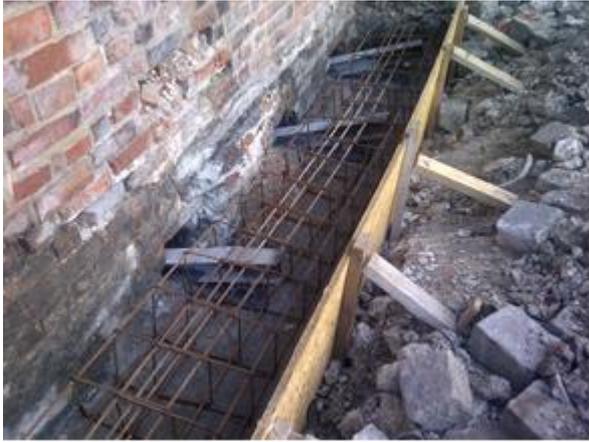
Figure 10: Pile cap reinforcement.

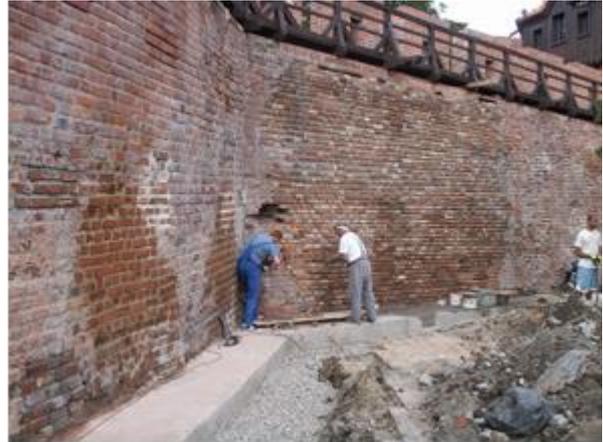
Figure 11: Completed pile cap reinforcement with a drainage system protective layer.

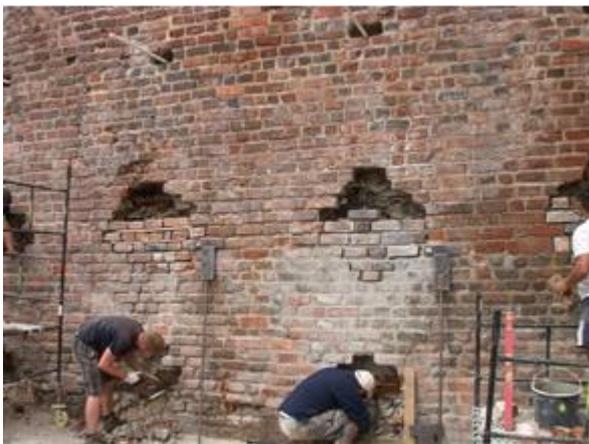
Figure 12: Elements joining together external leaves – anchor arrangement.

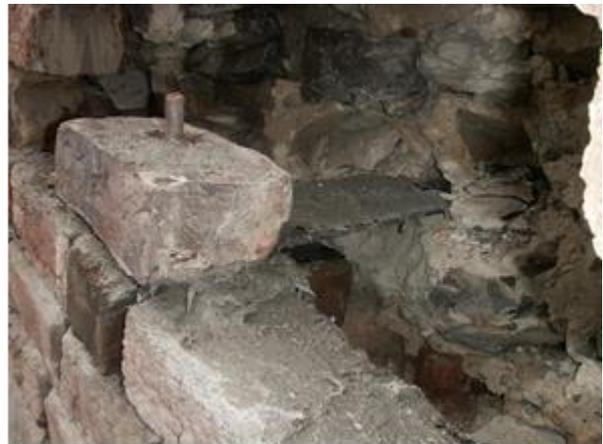
Figure 13: Elements joining together external leaves – an anchor.
