DIFFERENT ANALYSIS STRATEGIES IN THE STRUCTURAL ASSESSMENT OF THE ST. ANNE OF PIETRA PERDUCA ORATORY

Matteo D'Andrea¹, Daniela Besana², Andrea Penna²

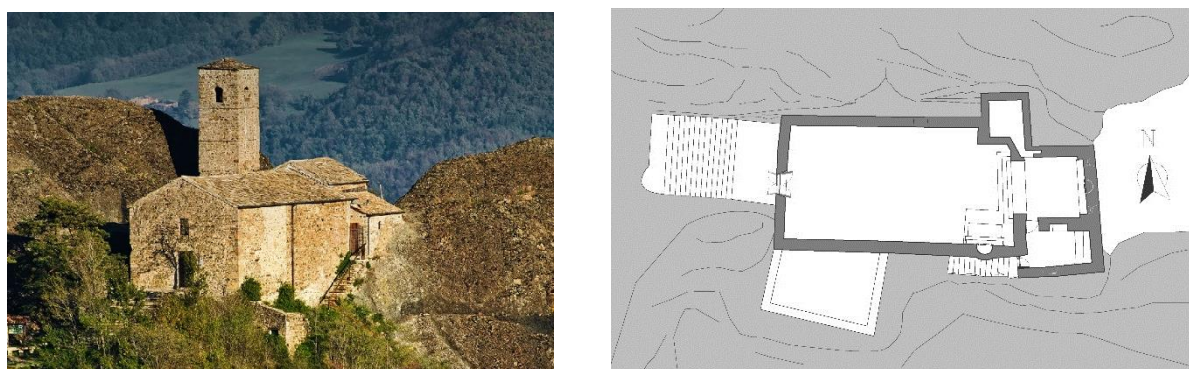
Figure 1. Picture (left) and plan view (right) of the Oratory of St. Anne of Pietra Perduca

The cognitive method described above was applied to the conservation project of the Oratory of St. Anne of Pietra Perduca (Figure 1). This oratory is a little religious building of the 13th century made of stone masonry founded on high ophiolite in the Trebbia valley. As first instrument of knowledge, a geometrical and morphological survey campaign was conducted on the building.

The building has a rectangular single nave, which leads to the square-plan presbytery, which has a flat apse defined by a small niche in the wall. Near the presbytery there is the vestry, recently rebuilt in 2010 because of its high state of decay. The direct survey also gave information on the texture of walls: all the walls are made of the same kind of limestone and have a thickness ranging from 50 to 70 cm. The study of archival sources led to the determination of the construction phases of the whole oratory, starting from its foundation in the 13th century, through several expansions over the centuries, to the current conformation, with the presbytery, the sacristy and the bell tower [2].

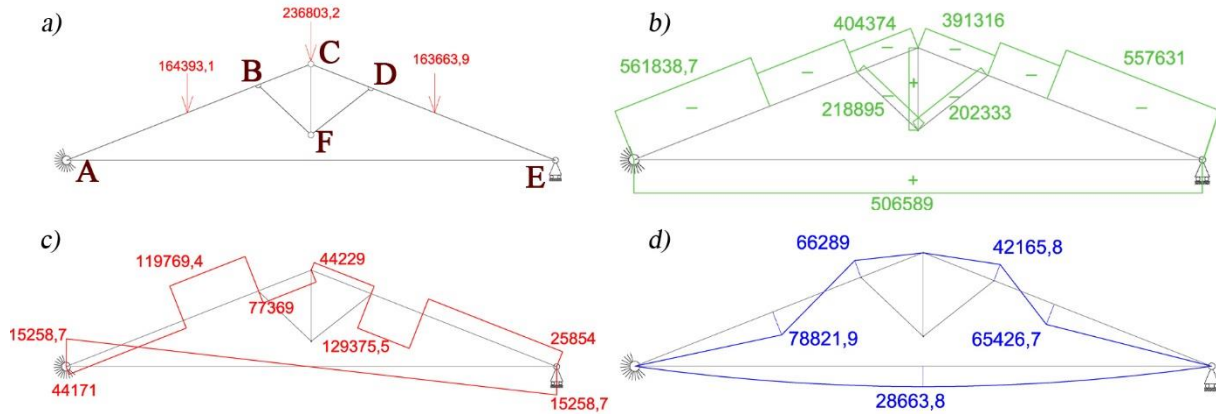
Figure 3: The roof truss. Static scheme a); diagrams of axial force b), shear force c) and bending moment d).

The structure of the roof includes three timber trusses with similar arrangement. The loads are applied to the trusses through the support points of the purlins on the principal rafter. The

central truss is considered because it is most loaded. It covers a 7 m span and is made of elements of variable section (22 x 23, 23 x 24, 18 x 21 and 13 x 13 cm² for the principal rafters, the chain, the monk and the diagonal posts, respectively). The results of linear analysis are reported in Figure 3.

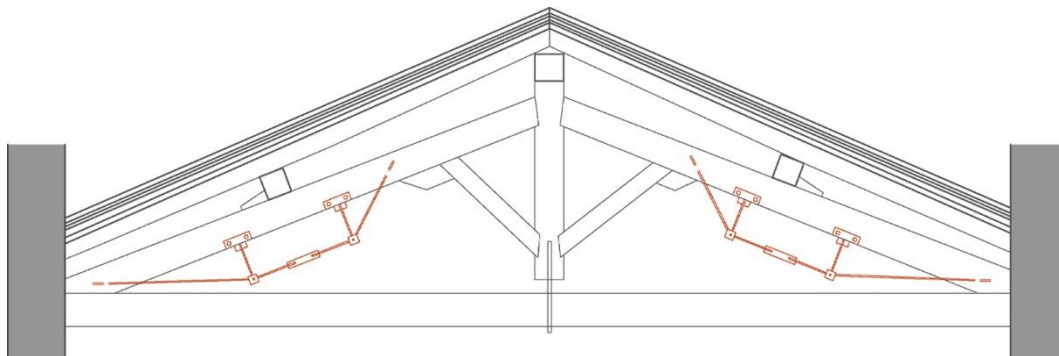
Figure 6: The post-tensioning intervention on the roof truss.

In order to improve the flexural strength and stiffness of the principal rafters, the application of a post-tensioning intervention is suggested (Figure 6). Steel posts connected to the intrados of the rafters allow exploiting the deformation reduction effect of eccentrically tensioned steel cables [9].

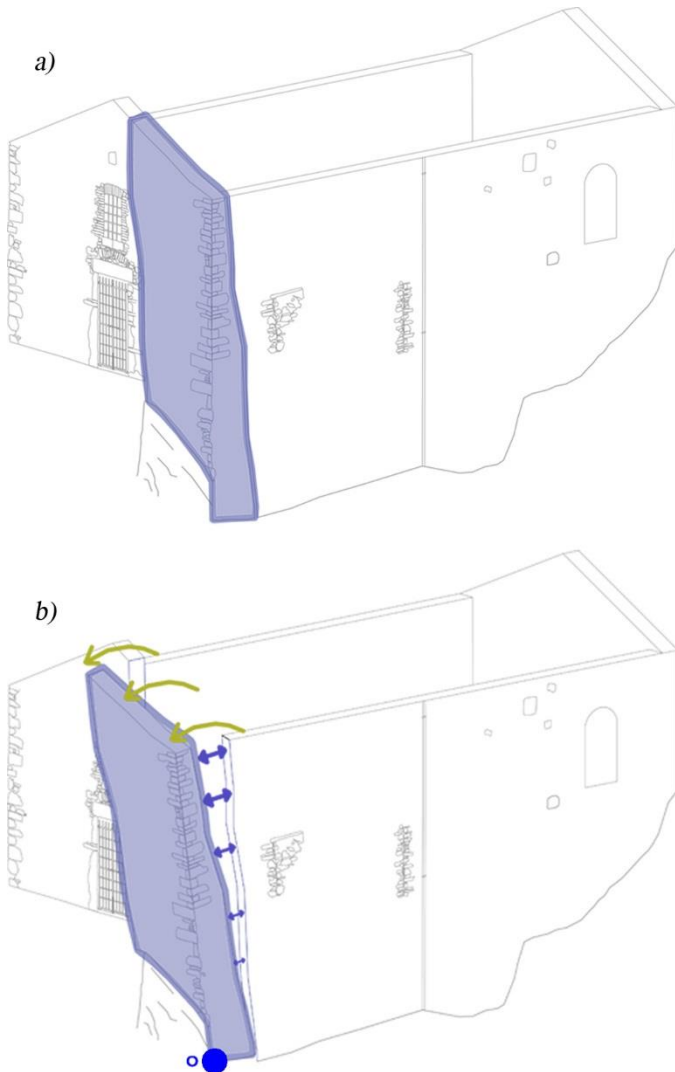
Figure 7: Front wall: kinematic chain *a)*; kinematic activation *b)*.

A significant vertical crack covers the wall corner portion. This crack pattern suggests that the cohesion loss between the mortar and blocks is due to horizontal forces perpendicular to the western front, which also suffered some out-of-plane overturning. The wall corner portion vulnerable to out-of-plane overturning is reported in Figure 7. Figure 8 shows the activation scheme of the kinematic system which causes the overturning of the wall around the rotation point O at the ground level.

The weight P of the portion considered is 268130 N and the lengths b_1 and b_p are respectively 0.26 m and 3.95 m.

The equilibrium is satisfied for $\alpha = 0.065$, calculated by equating the two expressions MR and MS. To improve this low value of the load multiplier, the proposed intervention includes the repair of the vertical crack and the insertion of a steel tie-rod in the top part of the wall (parallel to the overturning direction). On the outer surface of the western wall, the tie rod is constrained with a plate anchor.

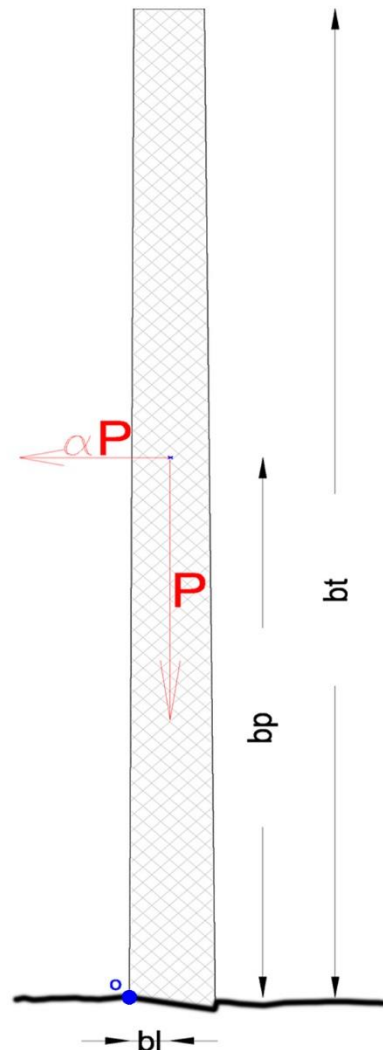
Figure 8: Wall section static scheme.

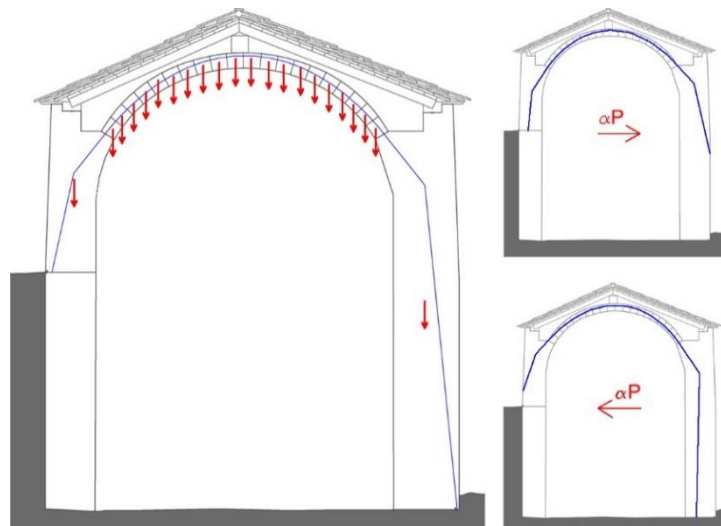
Figure 9: Thrust line in static Mery's method (left) and in Heyman's criterion, which was applied also including lateral loadings (right).

The weight of each masonry ashlar is 1299.4 N, which already accounts for the mortar weight, by means of a 20% increase. The volumic mass of generic filling is assumed equal to 1800 kg/m³, which corresponds to a weight of 193.8 N. With the aid of the graphical method of Mery, assuming the tangent of the curve at the vault keystone, we derived the ideal thrust line which is always contained in the safety core of each ashlar. In this way we can define the vault thrust on the abutments. The vault system is safe, because there is no implication of tipping (Figure 9a) [13].

system by applying horizontal forces whose magnitude is equal to the vertical forces value increased by the factor α . The vault is not in a static equilibrium when the magnitude of the horizontal forces induces the curve of pressures to touch or exceed the thickness of the vault itself. This comes from the Heyman's safety criterion [14], which, differently to the Mery's method, states that the vault is safe if the line pressure is all contained in its thickness (Figure 9 b,c). In the cases studied, the α limit value is 0,12. The displacement of an element also involves other effects, which change with the displacement. In order to consider these effects, we modelled the vault using the TREMURI program by assimilating ashlars to prismatic 2-node macro-elements (2D analysis).

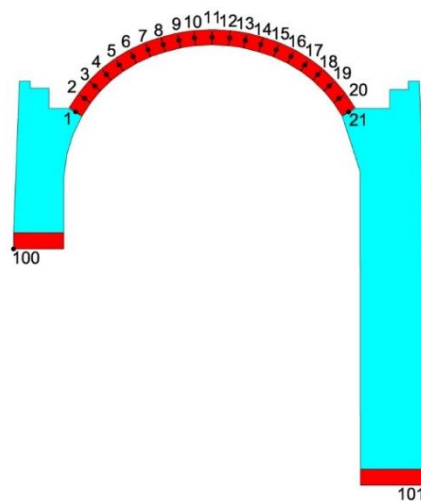
Figure 10: 2-dimensional vault TREMURI model.

Nodes 1 and 21 were modeled as polygonal, recreating the actual shape of the abutments. Below these nodes, two macro-elements serve as interface elements between the nodes 1 and 100 and between 21 and 101. Nodes 100 and 101 are fully restrained as they correspond to the points where the structure is connected to the rock. Vertical loads proportional to the considered masses are applied on the nodes (Figure 10).

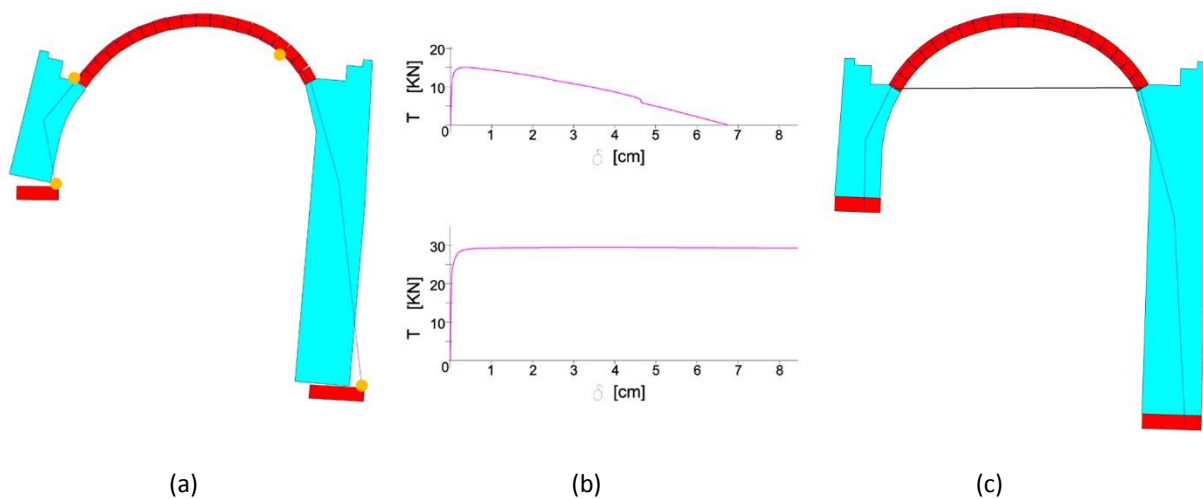
Figure 11: (a) Reponse of the as-built vault system with indication of the hinges of the failure mechanism; (b) Force-displacement diagrams before (top) and after (bottom) the intervention; (c) vault model with tie-rod.

As it can be noticed from the diagram reported in Figure 11b (top), the evolution of the total horizontal thrust T for increasing lateral displacement δ shows a curve peak that corresponds to a critical multiplicative factor α , beyond which any further displacement tends to reduce the resistance due to second order effects. This curve defines the capacity of the structure and can be divided into:

- a first linear portion, which describes the elastic phase of the system, for which α is 0.105, similar to the value 0.12 determined by the graphical method;
- a increasing curved portion up to a peak and a curved downward, that describe the evolution with plastic deformation and effects of the second order, for which α is decreasing with maximum value of 0.18.

The effect of the introduction of a steel tie-rod (16 mm diameter) connecting the nodes at the vault haunches, was also evaluated by means of TREMURI (Figure 11c).

The associated diagram, in Figure 11b (bottom), shows that the introduction of the tie-rod provides a significant enhancement of the lateral capacity of the vault structural system.

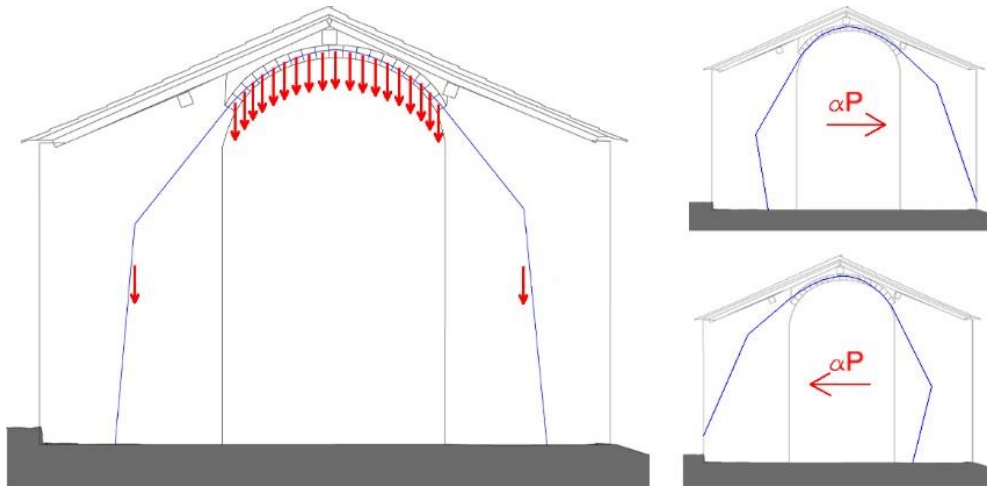
Figure 12: Thrust line in static Mery's method (left) and in Heyman's criterion, which was applied also including lateral loadings (right).

With the graphical method of Mery, we could draw the thrust line, which is always contained in the safety core of each ashlar. Then, we studied the arch response to lateral (seismic) loadings: we study graphically the limit conditions set in which the structural safety is guaranteed. In Figure 12 two different thrust lines are reported condiering both positive and negative loading directions. In the first case (top) α is equal to 0.34, while in the second (bottom) α is 0.25.

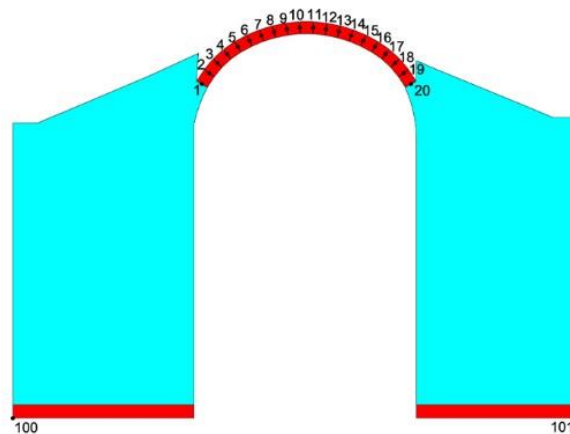
Figure 13: TREMURI arch model.

In order to evaluate the effects of the second order on this model and establish the critical value of α , the in-plane behavior of the whole system was modeled by means of the TREMURI program (Figure 13).

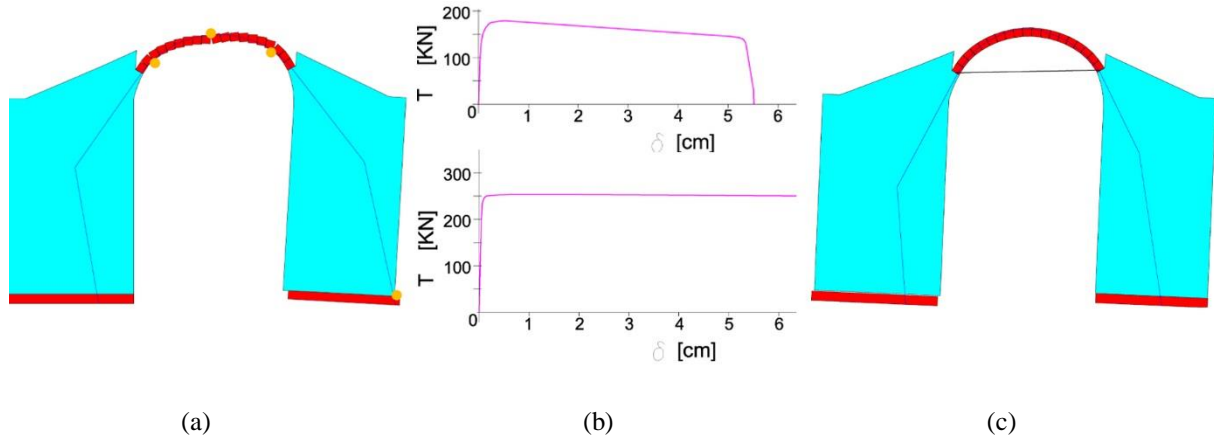
Figure 14: (a) Reponse of the as-built arch system with indication of the hinges of the failure mechanism; (b) Force-displacement diagrams before (top) and after (bottom) the intervention; (c) arch model with tie-ro

The results of non-linear analysis showed that, after a specific value of the horizontal displacement, some hinges appear to the extrados and the intrados of the arch (Figure 14a). The analysis showed that once the mechanism was activated second order effects reduced the lateral force for increasing lateral displacements. From the force-displacement diagram reported in Figure 14b (top), it can be noticed that the limit of the first linear-elastic phase corresponds to $\alpha = 0.19$ which is then followed by a cracked phase with a peak value of α equal to 0.34.

Also in this case, the effects of the introduction of a steel tie-rod, which connects the nodes to the arch haunches (Figure 14c), was evaluated numerically. The force-displacement diagram reported in Figure 14b (bottom) shows the improvement in the lateral response due to the considered strengthening intervention.
