## THE GELMEL CASTLE IN HOOGSTRATEN (BELGIUM): TOWARDS VISUAL PERFECTION OF THE BRICKWORK FACADES

**Keywords:** brickwork, tuck pointing, pointing lines, brickwork imitations

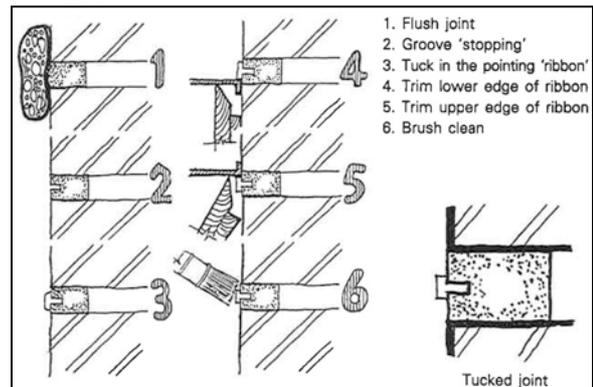
Figure 5: © LYNCH, G., Volume 2, 1994, p. 152

Tuck pointing is a particular pointing style to simulate conscientious executed brickwork. The name refers to the eighteenth century ‘tuck and pat’ work:

*‘The pat was the small knob of lime putty lifted off the feather-edge and used for pointing. The joint finish was an illusion created to disguise the irregularities of stick brick and bonding. By colouring the joints the same as the bricks, and then forming a thin lime putty joint, it was possible to convince the observer that he was looking at accurate gauged brickwork. Tuck pointing, like gauged brickwork, was developed during the seventeenth century and remained a popular pointing style into the twentieth century.’ [6]*

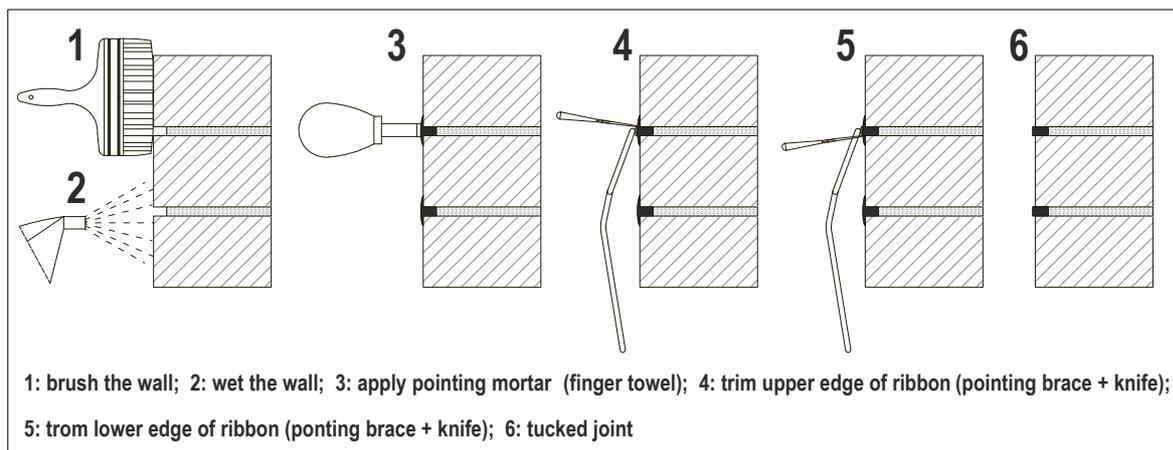
The development of nineteenth century Portland cements, combined with the desire for brickwork in sharp, straight lines made it possible to point the joints with cement mortars of different aesthetic aspects. Next to this aesthetic advantage, pointing provides a barrier to the infiltration of moisture and as such, it increases the lifetime of the masonry. Adam Hammond (1875) [7] documents the traditional tuck pointing application and Gerard Lynch (1994) [8] explains the modern procedure for tuck pointing (figure 5). But the Flemish tuck pointing version, developed in the nineteenth century, is at variance with this British technique. (figure 6) No stopping mortar was used and the ribbon is therefore an integral part of the pointing. After cleaning and moistening the wall, the pointing mortar is applied on the bed joints using a finger towel. Subsequently the mortar waste is trimmed along both sides of a 60 cm long jointer brace with a knife. (figure 9) The same procedure is repeated for the perpendicular joints by means of a smaller jointer brace.

Figure 6: Flemish tuck-pointing procedure (© A. Verdonck)

Finally the bricks edges are often coloured to disguise irregularities of the bricks and bonding and to achieve sharp, straight lines. This kind of tuck pointing can differ in appearance; rectangular (*‘joint a ruban’* or *‘joint à l’Anglais’* in French and *‘rechthoekige knipvoeg’* in Dutch), triangular (*‘joint en diamant’* or *‘joint triangulaire’* in French and *‘driehoekige knipvoeg’* in Dutch) or round (*‘joint en moulure’* in French and *‘baguettevoegen’* in Dutch).

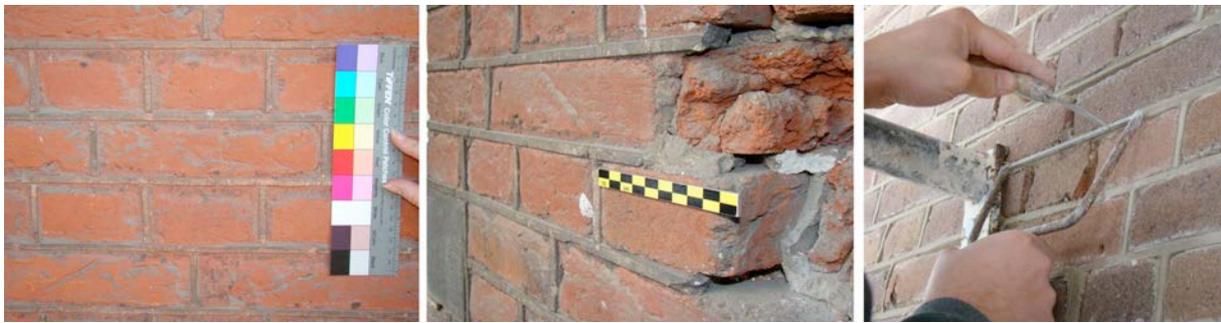
In the castle and farm complex only the rectangular aspect was found on the Victor Besme phase of 1880. Red bricks of 18/18,5 x 5,5 x 8,5/9 cm were used in cross bond. The ribbon of approximately 0,6 to 0,7 cm is beige and the bricks edges were coloured with red lime paint. (figure 7) In the cross section small lime granules and a few hydraulic remnants were found. The binder is therefore identified as light hydraulic lime. The medium coarse sand is a blend of microcrystalline quartz sand, poly and microcrystalline quartz granules and some feldspar granules. No added pigments were found in the beige mortar, which has a heavily polluted surface.

The damage of the tuck pointed facades in the castle is rather limited and in general due to mechanical issues. (figure 8) The brickwork is polluted and therefore a low pressure (max. 2 bar) steam cleaning is required. In the damaged zones the missing or broken joints have to be removed carefully using a hammer and small needle chisel guided by a feather edge to avoid brick damage. After reparation of the brickwork, the tuck pointing procedure can be applied using the historic mortar composition and technique. The red lime paint on the bricks edges is washed out, but this degradation does not affect the readability of the whole.

Figure 7 (left): Flemish tuck pointing of the Victor Besme phase (1880) on the facades of the inner court of the castle (© Verdonck Ann) - Figure 8 (middle): Damaged tuck pointing zone (© A. Verdonck) - Figure 9 (right): Reparation of the tuck pointing: trimming the upper edge of the ribbon with a pointing brace and knife (© A. Verdonck)

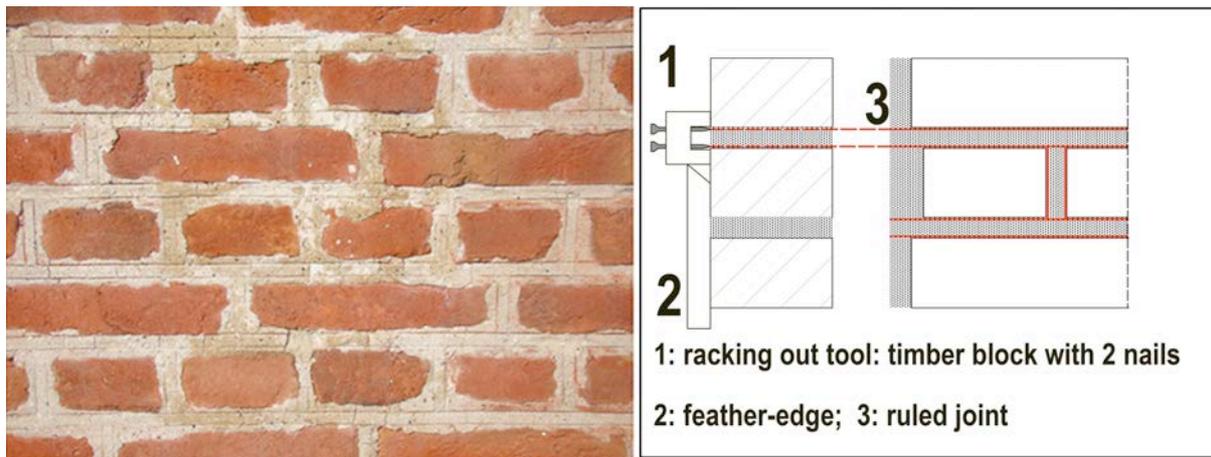
this irregular appearance, the bricks edges were painted with red-pigmented lime wash. Before colouring the bricks, the joints were double grooved. Joint lines of approximately 1 to 2 mm deep and wide were drawn into the wet mortar and the bricks were painted leaving the joints between the lines untouched, simulating accurate gauged brickwork. Usually lines were applied on the bed joints only but in the castle chapel facades also the perpend joints were grooved. The used raking out method is certainly not executed by means of a penny neither by dinging. (figure 10) It is more likely that nails (nail jointer or thin-bladed iron jointer) were used guided by a feather-edge. (figure 11) [10]

The double grooving is well conserved but the paint on the brickwork is almost completely disappeared over time. Restoration test strips will be necessary to determine the right paint and colour for the reconstruction of the red brick finish.

Figure 10 (left): Flat jointed brickwork with double grooved joints on the chapel facades (© A. Verdonck) - Figure 11 (right): Racking procedure (© A. Verdonck)

The former weapons room is transformed and reconstructed in 1811 by architect-urban planner Frans Stoop as castle chapel. In 1845-1850 the chapel was transformed into a Gothic Revival ensemble. The rendering was removed and the brickwork was exposed and completed with stone imitation rendering on the corona, mouldings and lancets. At that time the brickwork (red bricks of approximately 19,5/20 cm x 7 cm x 4 cm in cross bond) was flat jointed. The face of the bedding lime mortar was finished as work proceeds and the surplus material, which has been squeezed out of the joints, left a rough finish on the bricks. To camouflage

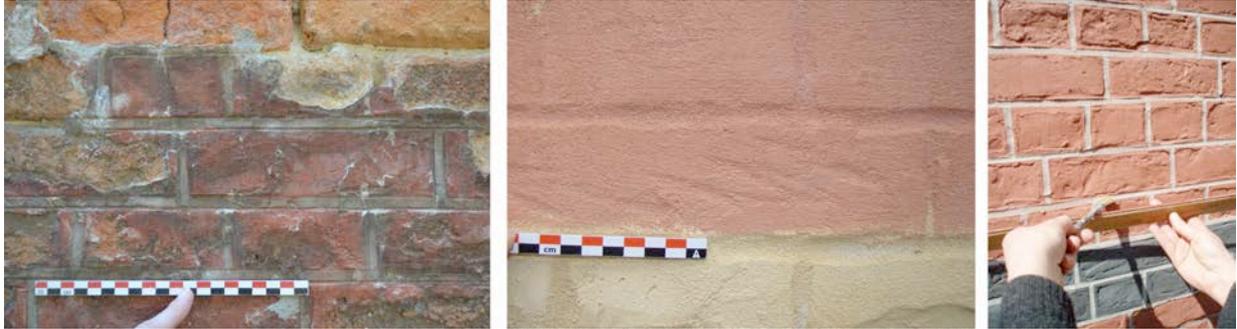
The farm complex was heavily transformed between 1875-1882 (V. Besme). After transformation some brickwork facades of the farm complex and the vaults of the castle gallery were finished with a brickwork imitating finish. A lime mortar of approximately 0,4/0,5 cm was applied on the brickwork facade. This lime finish was afterwards treaded with sculpture spatulas to imitate the brickwork aspect; joints were drawn into the wet mortar and the brick surface was sculpted to simulate real brickwork. (figure 12) After drying, the walls were col-

our washed with red lime paint. The used pigments were red ochre and carbon black. [12] Finally the joints were painted beige using a brush guided by a feather-edge. (figure 14)

This particular finish is heavily damaged and has to be reconstructed. For this purpose, some restoration test strips were made to establish the rendering layer, the joints and surface treatment. (figure 13) We decided to use a mass coloured lime mortar to start with. The tests show the sculptured joints and brick surface. After hardening, the red colour wash and joint paintings can be applied. (figure 14)

Figure 12 (left): Brickwork-imitating finish on the north façade of the farm complex: heavily polluted but well preserved zone (© A. Verdonck) - Figure 13 (middle): Restoration test strip of the base layer with sculpted joints and brick surface to simulate real brickwork (© A. Verdonck) - Figure 14 (right): Application of the red colour wash and joint painting using a brush guided by a feather-edge (© A. Verdonck)
