SEISMIC SAFETY EVALUATION OF HOKKEDO HALL IN TODAIJI- TEMPLE, WORLD HERITAGE – PART 1: SHAKING TABLE TEST OF FULL-SCALE MODEL OF STATUE OF BUDDHA

Keywords: Buddhist statue, Seismic performance, Shaking table test.

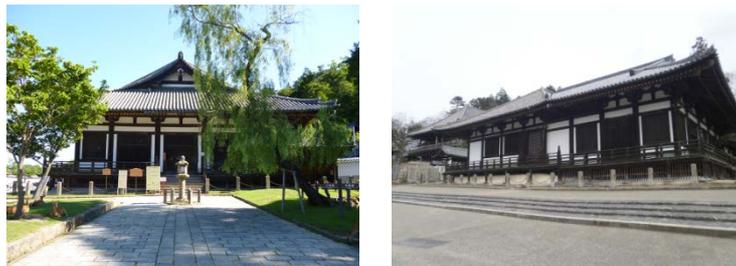
Figure 1: Building’s appearance (Hokkedo Hall in Todaiji Temple, right: south facade, left: east facade).

Hokkedo Hall (Figure 1) is one of the buildings of Todaiji Temple, the head temple of the Kegon sect, and it is located to the east of Nara City and was designated as a national treasure in 1951. Hokkedo Hall is the oldest of the buildings in Todaiji Temple and is said to be the remains of Konshuji Temple which supposedly existed before the foundation of Todaiji Temple according to the temple's history. There are many explanations about the foundation of the hall and no definitive answer has been given yet. However, the most widely held explanation is that the hall was founded around 749 because the "Kensakudo Hall" recorded in "Todaiji Temple Shiizu" almost corresponds to the location of the existing Hokkedo Hall, according to one explanation. The Hokkedo Hall underwent several repairs up to the present. It is said that the hall was originally a Yosemite-zukuri (hipped roof) style structure where the Shodo hall (the inner shrine) and the Raido (worship hall) were built in a row but the Raido was reconstructed to a hip-and-gable roof structure and the two buildings were joined with Nakanoma room and the roof truss during a repair carried out in 1264 [3]. The reconstruction provided

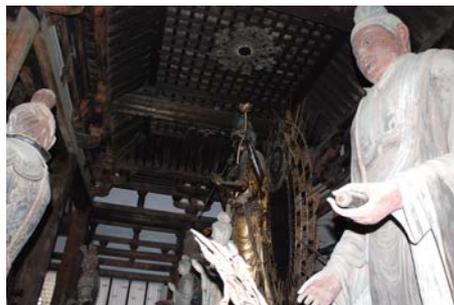
Figure 3: Group of Buddhist statues in Hokkedo Hall.

The dual octagonal Shumidan (Buddhist altars) is placed at the center of the architectural Shumidan in the Shodo hall Najin (inner sanctuary) of the Hokkedo Hall, and sixteen Buddhist statues are enshrined around Fukukensaku Kannon, which is the principle image, on the octagonal Shumidan and architectural Shumidan (Figure 3). Of the Buddhist statues enshrined in the Hokkedo Hall, 12 statues are designated as national treasures and the remaining four statues as important cultural properties. Of the 16 Buddhist statues, nine statues of relatively high height were made with the dry lacquer technique in which a wooden frame supports the outer hull made with linen clothes pasted by Japanese lacquer [4]. Five of them are clay and two are wooden. The two wooden statues were supposedly made in the Kamakura Period while the other 14 statues in the Tenpyo Period. Due to the repair work that started in May 2010, the group of Buddhist statues was relocated from the Shumidan and restoration work was performed on some of the statues. At the opening of the Todaiji Temple museum in May 2011, clay statues were relocated to the museum. The other Buddhist statues were returned to the Shumidan after its repair work was finished in 2013.

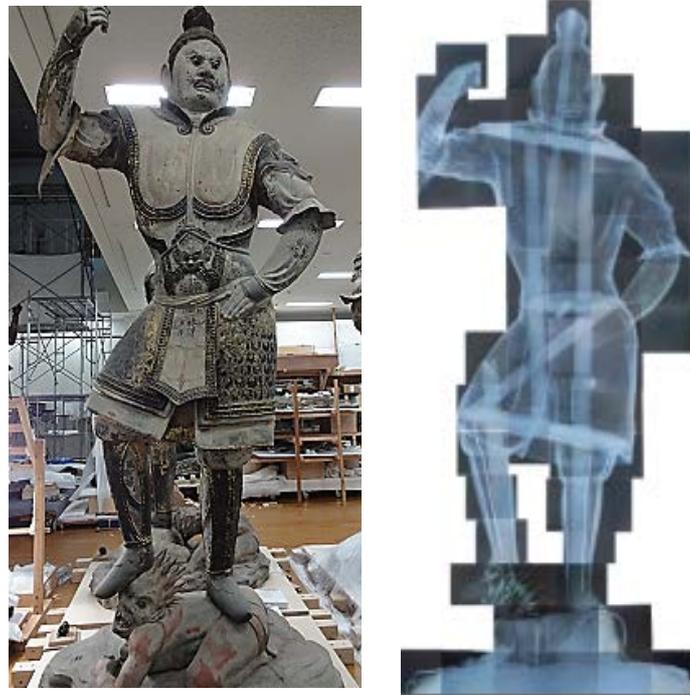
Figure 4: Dry lacquered standing statue of Jikokuten (left: appearance, right: x-ray image).

In a miniature model test, it was desirable to verify the scale effect by using the objective Agyo statue of Kongo-rikishi made with the dry lacquer technique. However, it was not easy to examine the specifications such as mass, employed materials and structure because the Buddhist statues are designated as national treasures. Thus, testing was conducted on a dry lacquered standing statue of Jikokuten (Figure 4) because information on the statue of Jikokuten was available to some extent and there existed many statues of the same type and whose size and structure were similar to those of the statue of Kongo-rikishi. Made with the dry lacquer technique, the standing statue of Jikokuten has a height of 350.4 cm, a total weight of 231.5 kg, and a dry lacquer thickness of approximately 5.0 to 6.0 mm.

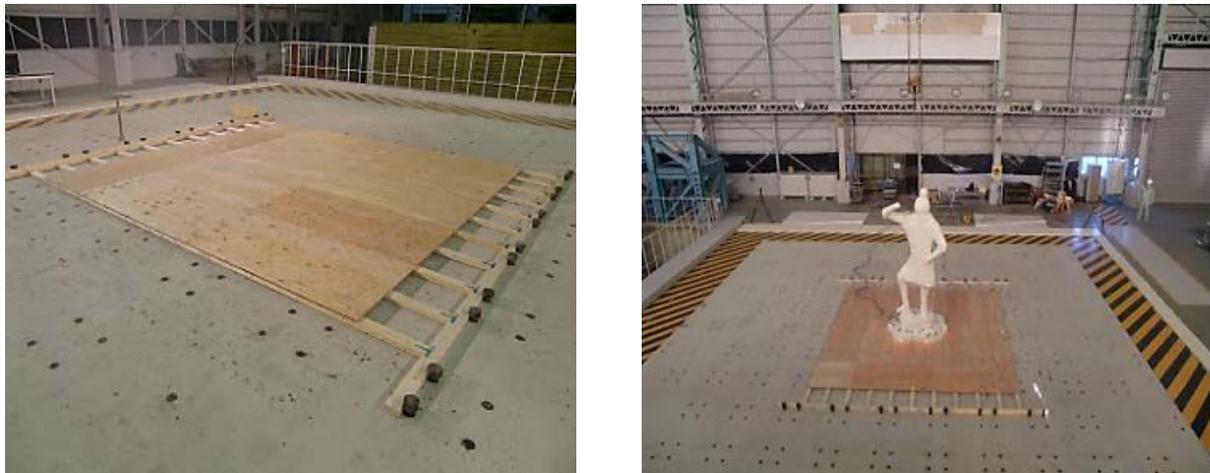
Figure 7: Floor installed on the vibrating table.

Because the past study showed that vertical vibration causes little effect on rollover, vibration was performed using the vibration table excited horizontal direction, which was developed by the National Research Institute for Earth Science and Disaster. Because it had been confirmed that the friction between the test piece and the installation surface was a major factor of falling conditions, a simplified floor was made with plywood on the vibrating table as shown in Figure 7 and vibration test was conducted on the floor. The friction coefficient of plywood used in the floor was about 0.5 to 0.6. It was recognized that the friction coefficient had no correlation to the weight and installation area of the object. However, as in the case of plywood, which had irregularities on its surface, friction was apt to increase as the weight of an object subjected to friction increases due to the effect of the object penetrating the plywood. Thus, it was estimated that the friction coefficient was larger than the measured value. Because the test piece might be damaged in case of a rollover during excitation, the head of the test piece was tied with a wire rope provided with allowance so that the behavior during vibration would not be affected by using the adjustable ceiling crane mounted on the top of the vibrating table. A list of input waves is shown in Table 2. It was easy to perform verification using a harmonic sine wave as with the miniature model test. However, only the seismic wave was the excitation exceeding the falling limit acceleration because the performance of the vibrating table gave rise to concerns about potential impacts on the peripheral facilities
