## HISTORICAL URBAN CENTER AND RENOVATION PROJECT IN CASE OF EARTHQUAKE: İSTANBUL TARLABAŞI NEIGHBOURHOOD CASE

**Abstract.** *The study discusses the renovation project of Tarlabası neighbourhood which is located in the historical centre, Beyoğlu district in Istanbul due to the earthquake risk mitigation policy of the government. Tarlabası neighbourhood is located in the northern part of Beyoğlu district which it is the historical, cultural and commercial centre of European side of Istanbul Turkey. The big part of the building stock is brick masonry structure most of which was built in 19th century. Most of the buildings located in the neighbourhood need to be repaired. Tarlabası neighbourhood has been counted as an urban renovation area depending on the law (2005, Law No. 5366) which came into force in 2006. According to the renovation project, three quarter (sub-neighbourhoods) named as Bülbül, Çukur and Şehit Muhtar in Tarlabası neighbourhood were selected as project implementation areas. This project targeted renovation of 278 buildings including 210 registered historical buildings. In addition, nine blocks of building area in the selected region was redesigned and re-function

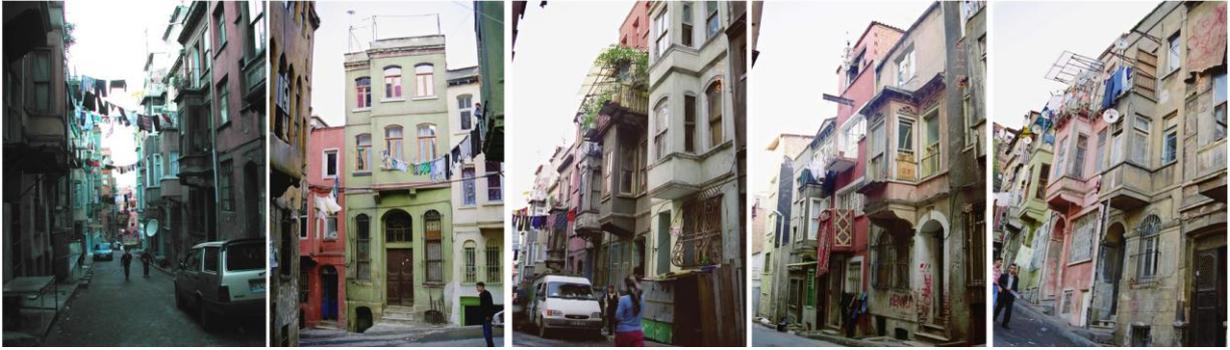
Figure 2: Case study area site view (Photo by Gül Yücel, 2003).

Pursuant to JICA Report in a potential earthquake structure damage failure and building vulnerability have been studied on quarter scale and with various levels of damage ratios, it has been detected that 44 quarters (98%) have vulnerable to an earthquake. In Beyoğlu district the number of districts of which narrow road ratio is above 80% on quarter scale corresponds to 20. On quarter scale, the number of quarters of which primary emergency evacuation fields such as park and open spaces is below 25% corresponds to 31 (69%) [2]. In a majority of quarters there are no safe evacuation fields in cases of emergency. In the same report there are earthquake-risk analyses and strategic urban transformation measures offered in parallel. In the location assessment including specialized measures to protect historical urban sites Beyoğlu is listed with its 29 quarters next to Fatih and Eminönü (Currently Fatih and Eminönü are under one roof as Fatih Municipality). As indicated by the research data of the report and subsequent rehabilitation project covering three quarters in Tarlabası region the region is rich in terms of the finest samples of civil architecture (Figure 2).

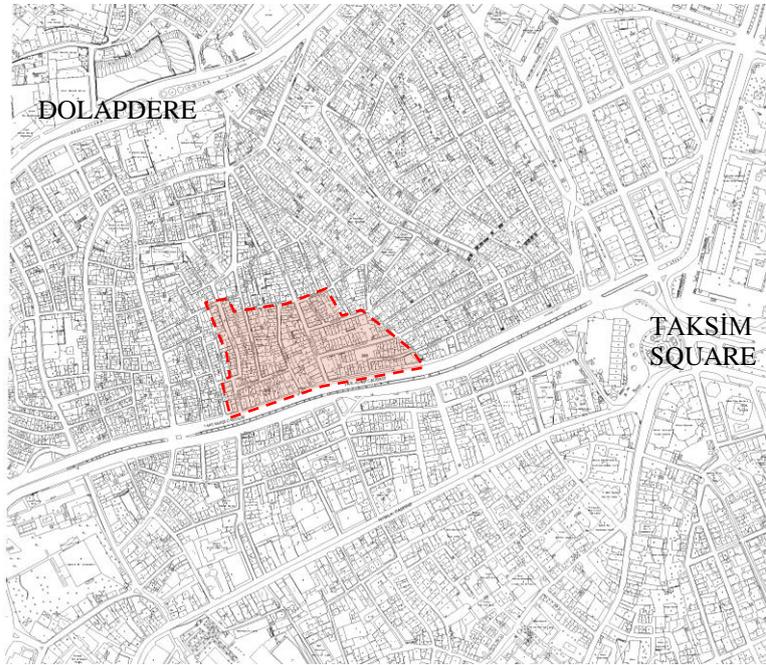
Figure 3: Tarlabası 1st Leg Renovation Project Area

Tarlabası 1st Leg Renovation Project is implemented in Istanbul Beyoğlu district Tarlabası region, which is a historic settlement adjacent to Taksim Square (Figure 3).

Project site is composed of Bülbül, Çukur and Şehit Muhtar quarters in Tarlabası. Nine city blocks are located in circa 20 thousand square meter area (Figure 3) [8, 9]. Ongoing construction space in this Project is 72.104 m<sup>2</sup> (Excluding the structures to keep untouched in Renovation site, total construction are of the licensed buildings (approximate fixed size) 62.804 m<sup>2</sup>

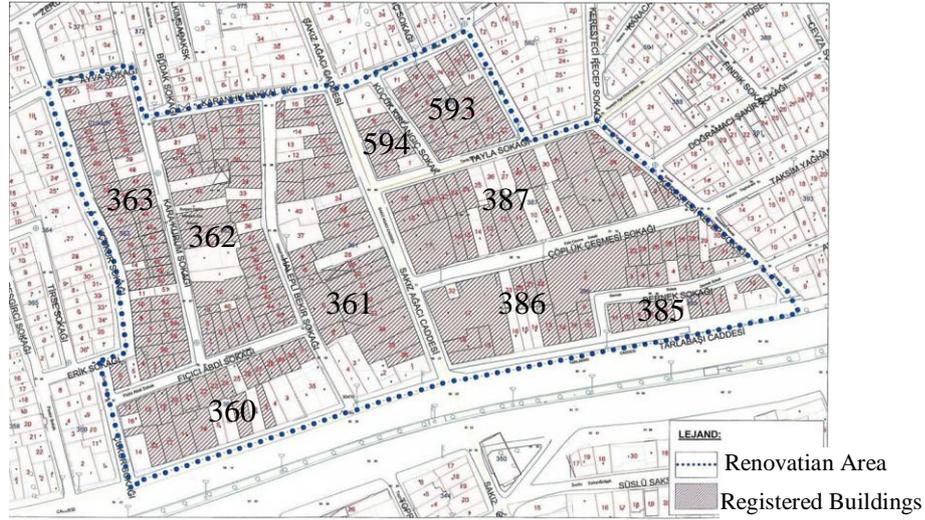
Figure 4: Tarlabası 1st Leg Renovation Project area with registered buildings [8]

Of the 278 buildings 210 are registered civil architecture samples and the area also encompass buildings and intermediate streets and substructure. The area corresponds to 3% of Tarlabası [8, 9]. Renovation contract of the area was co-signed with Beyoğlu Municipality in 2007 and the construction is still in-progress. Partial demolishment has been continuing on the city block (Figure 5).

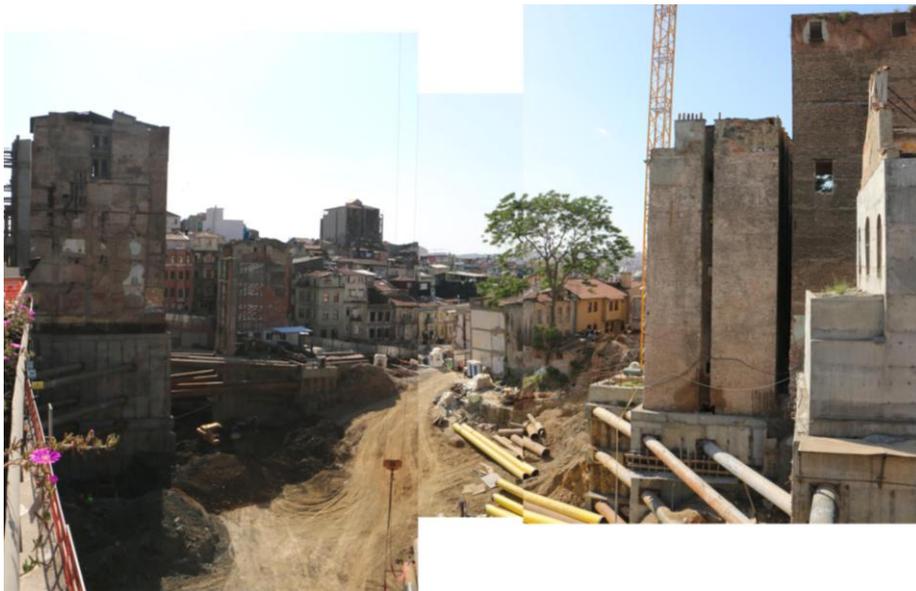
Figure 5: Case study area site view (Block 360 area) (Photo by Gül Yücel, 2014).

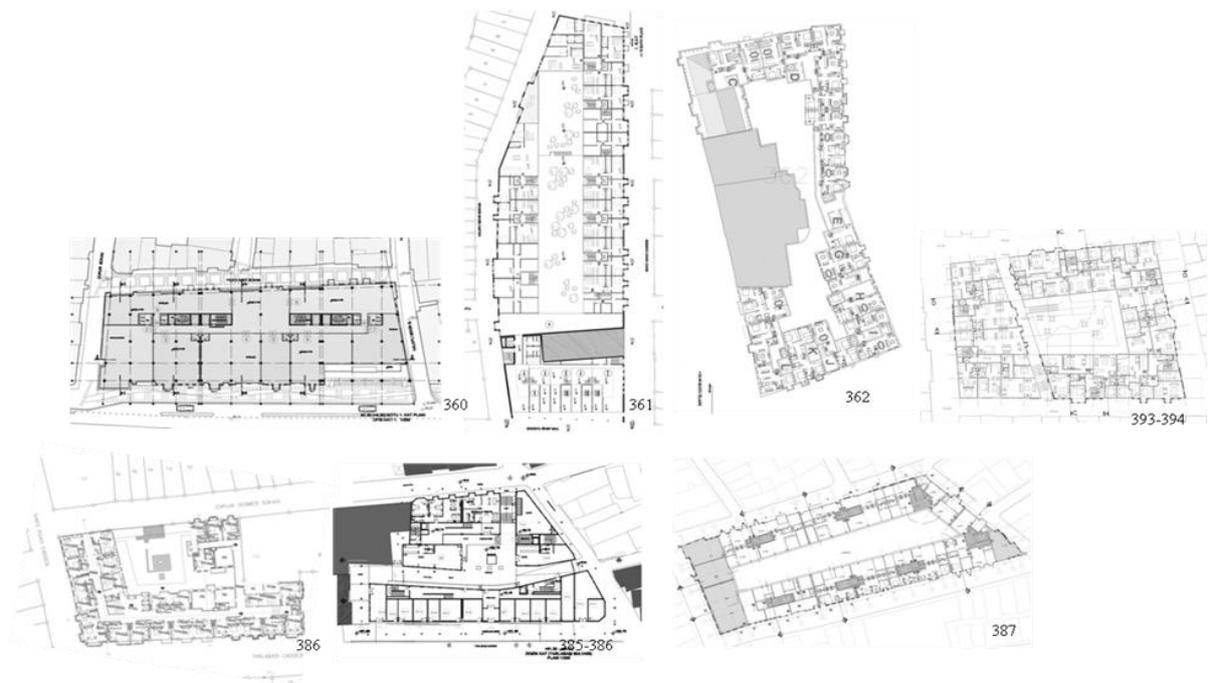
Figure 6: Case study area block plans [8].

In this Renovation Project there is no safe open area alternative to select as emergency excavation site. By altering the authentic structure in blocks a middle patio has been formed (Figure 6). However active usability of this area is not clear due to the structure height on the block it is situated on. The change of sectional structure adopted in Tarlabası Renovation Project into monolithic structure body on city-block scale triggers an impact on structure-

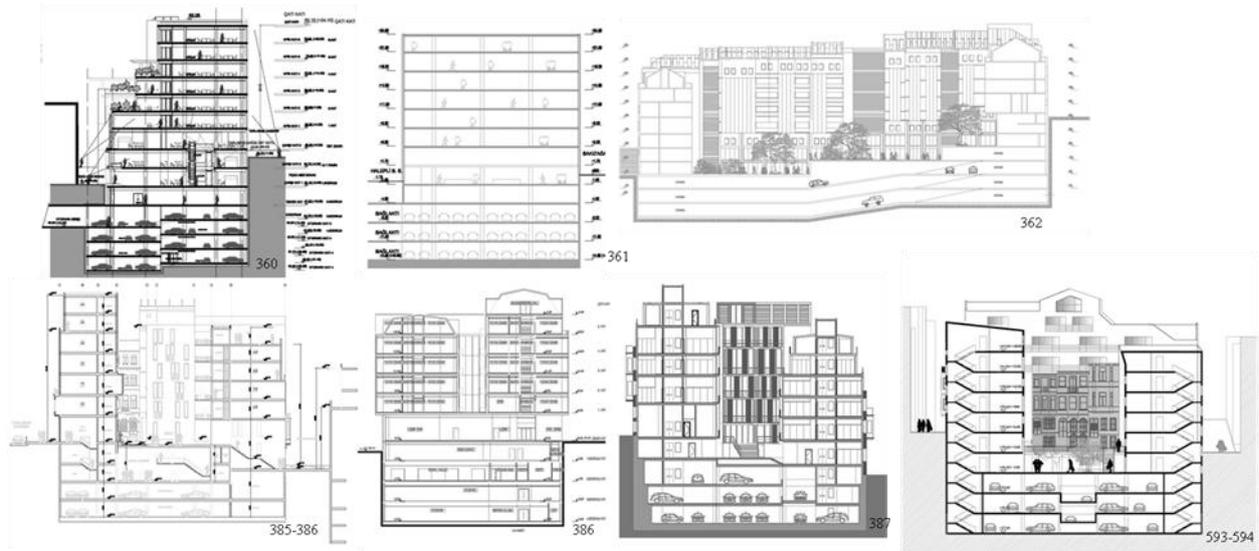
Figure 7: Case study area block sections [8]

The use is subject to change according to structure blocks. No. 360 block adjacent to Tarlabası Boulevard has been planned as an office. No. 361 construction block on the other hand has been designed as office for the part facing Tarlabası Boulevard and the remaining part as residence. In No. 362 construction block, except the church inside, the whole structure has been saved for housing. Similar to the other block there is an underground car park below this block. 385-386 no city blocks are designed as house and hotel. Again the registered building within the block has been separated from new structure division. 387 No. city block has been designed as a house covering the whole city block and a car park with three storey. By uniting 593 and 594 no. city blocks existing street has been designed as a passage inside the building. Car park extends towards four basements (Figure 7).

The street to which 360 no. city block faces hosted a building alongside five storey under the basement. It is still unclear whether the structures on the city block facing the street that widens on the base floors shall be adversely affected during the process. The future of the other streets which have entrance-exit relation with the car park on the basement of single structure below the city block is also unclear. Car park exits have been pointed outside city block inside the road.

street relation on sloped topographic pattern. The new construction body which is formed with extra storey as well cannot maintain its authentic identity with the road staying on the same scale. Unified city-blocks or using underground section of the road increases the affectability of the problematic transportation network of the region in the face of disasters. In the current structure stock, the rise in the number of basement floors not higher than one increases the amount of excavation on natural ground. Building of basement floors projected for city-block scale poses risks for registered structures to remain untouched. The excavation works to be conducted for basement floors which were absent on city-block scale before put existing historical tissue under threat.
