SEISMIC VULNERABILITY ASSESSMENT OF ISRAELI HISTORICAL CENTRES

Keywords: Seismic Vulnerability Assessment, Urban Scale, Typologies Vulnerability

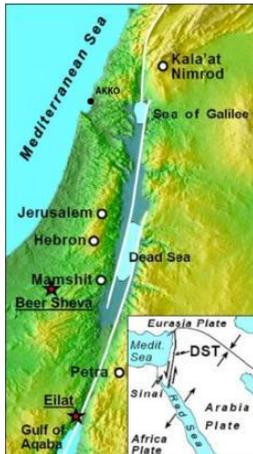
Galilee region belongs to the Dead Sea Transform (DST) fault system, also referred to as the Dead Sea Rift (Figure 7). It is composed by series of faults that define the boundary between the African Plate (west Israel) and the Arabian Plate (east Israel). The zone is characterized by left lateral displacement, because of the relative movements of the two plates [6]. Because of this, the Israeli territory is characterized by a significant seismic hazard (Figure 8). It is situated on the Dead Sea fault and suffered earthquakes of different intensities, sometimes characterised by severe damage (Figure 9).

Figure 7: Dead Sea transform fault system
Source: <http://www.gii.co.il>

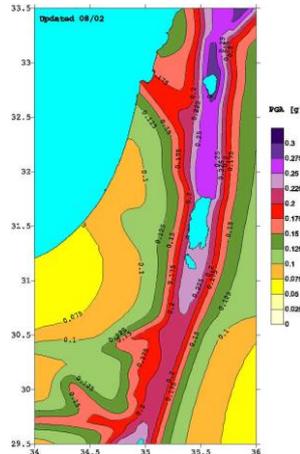
Figure 8: PGA map of the Israeli seismic code SI 413 (1995, 2004 amendment).
Source: <http://www.gii.co.il>

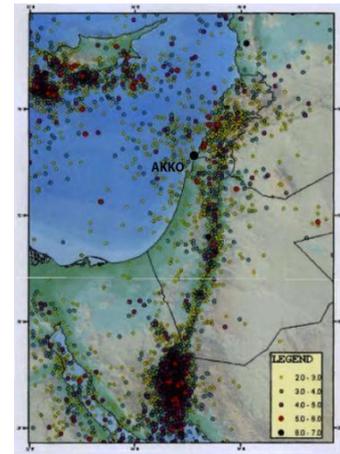
Figure 9: Regional seismicity during 1900-2007
Source: A. Shapira, R. Hofstetter, Geophysical Institute of Israel, Earthquake hazard assessment for building codes. Final report, 2007

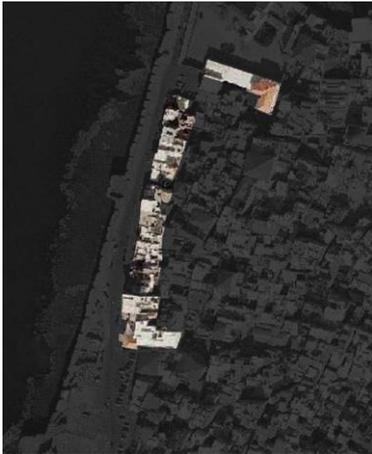
Figure 10: Localization of the buildings in Old Acre

The analysed aggregate buildings are consequence of different architectural sequences, use of materials and customers intervention occurred during centuries of unplanned transformations. As a consequence their structure does not allow studying them as simple buildings [8]. The study is focused on the analysis of clustered buildings whose architectural, structural and typological features are representative of the historic urban fabric. For the town of Acre (Figure 10) they are located in Quarter n.10; for the town of Safed (Figure 11) in the Sa-faradim quarter.

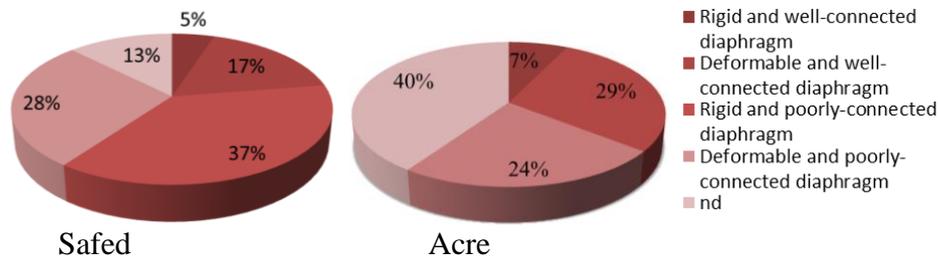
In Figure 12 is reported an example of the statistical analysis performed, in which connection between horizontal and vertical diaphragms are evaluated. The evaluation of buildings seismic vulnerability through the use of expeditious methods disregards the complete structural survey of each building since it is not coherent with the proposed approach. In this term statistical results allow to complete and integrate lack of information.

Figure 12: Horizontal structures connections

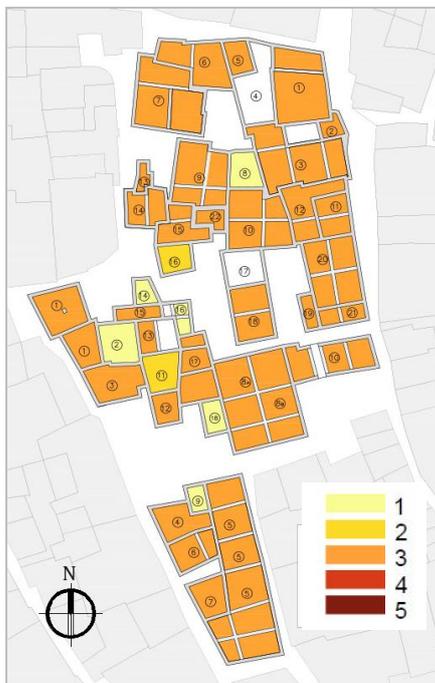
For the aggregate buildings of Safed thirty-eight structural units are analyzed. Considering I1 and I2, one index doesn't exceed the other and their distribution is diversified. A vulnerability assessment for each structural unit and for the totality of them is evaluated considering different values of PGA/g and the obtained linguistic vulnerability assessments are graphically represented in Figure 13 and Figure 14. Considering the group, it is “medium” for PGA/g=0,23, while for the other critical acceleration levels it is “very small”. These assessments are confirmed by the results obtained through fragility curves. Indeed the $E[Vg]$ values show that for PGA/g between PGA/g=0,07 and PGA/g=0,05 there is a low expectation of severe damage equal to 1,6% with the range of expectation variability between 0% and 5%. For values of PGA/g higher than PGA/g=0,23 the expectation of severe damage increases to 40% with the range between 15,5% and 58,2%.

Figure 13: Graphic representation of the linguistic vulnerability assessment provided by Vulnus for $PGA/g = 0.23$ (1: very small; 2: small; 3: medium; 4: severe; 5: very severe)

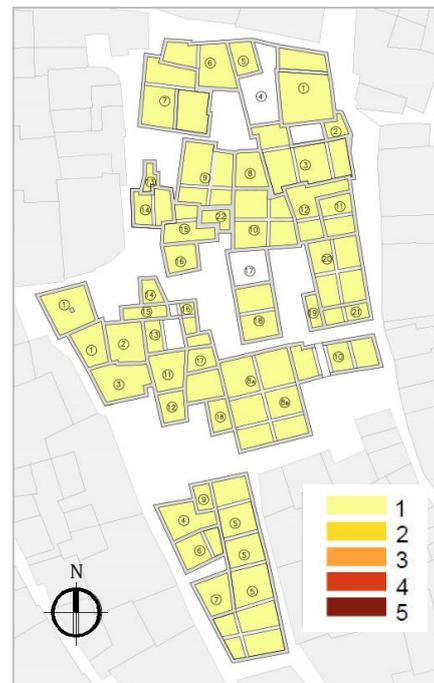
Figure 14: Graphic representation of the linguistic vulnerability assessment provided by Vulnus for $PGA/g = 0.07$, $PGA/g = 0.06$ and $PGA/g = 0.05$ (1: very small; 2: small; 3: medium; 4: severe; 5: very severe)

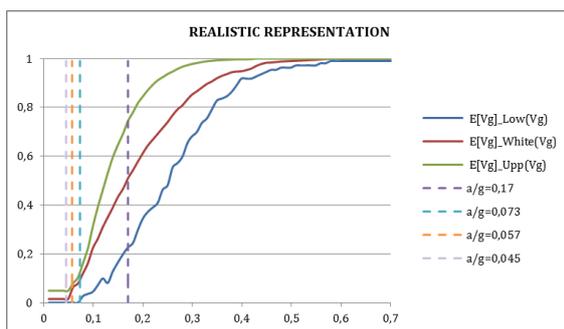
Considering expected values of severe damage, the obtained fragility curves are compared (Figure 15 and Figure 16). They show the same trend even if $E(Vg)$ Low is lower for modular structures: the range of most probable values of severe damage expected frequency is grown, showing lower expected values of severe damage for the level of acceleration stated by the Israeli code. Therefore, considering the curves trend, existing buildings are represented quite realistically by the module schematization.

Figure 15: Fragility curves - realistic representation

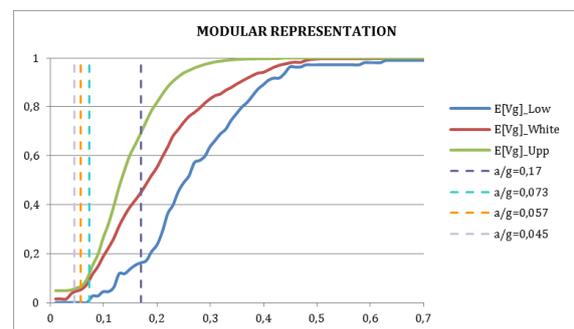
Figure 16: Fragility curves - modular representation.

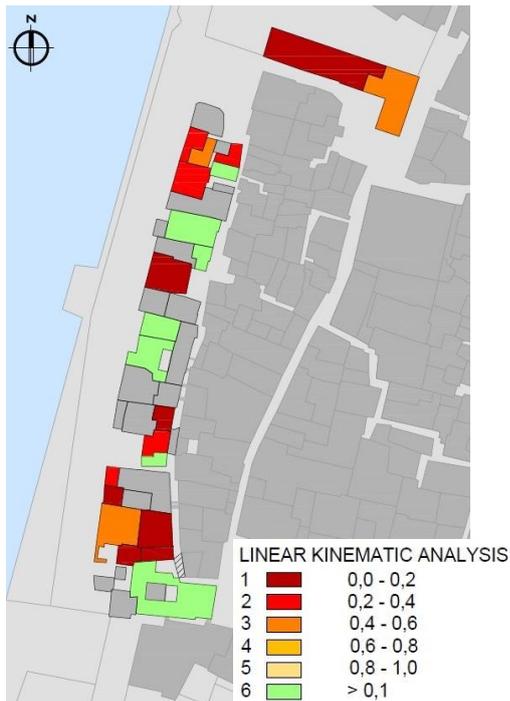
Results of each local mechanism of collapse are represented through safety coefficients for each building. They are arranged by means of a qualitative color scale in order to highlight most vulnerable walls. In Figure 17 and Figure 18, safety coefficients of walls overturning essentially resting on the ground (worst configuration) are reported both for linear and nonlinear kinematic analyses. Nonlinear safety coefficient, determined by the ratio between ultimate displacement capacity and required displacement, is generally higher than linear one.

Figure 17: Representation of linear analysis results through the safety coefficient

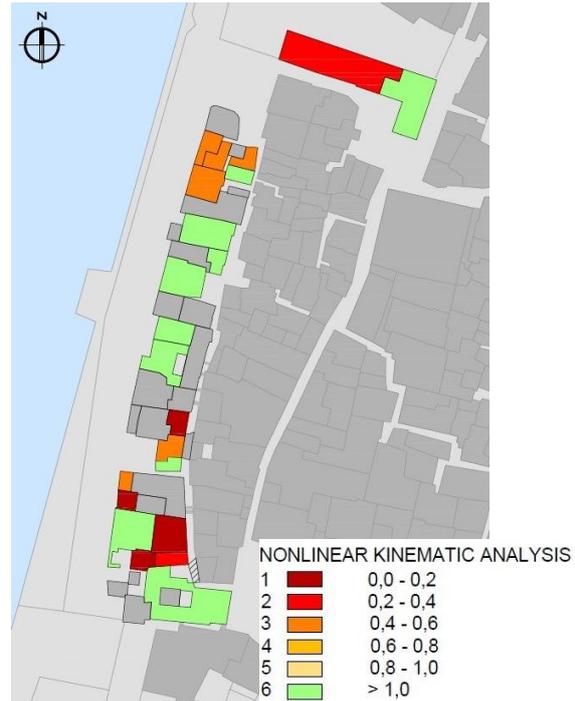
Figure 18: Representation of nonlinear analysis results through the safety coefficient
