Vulnerability Evaluation of the Old Building Stock in Historical Areas: The Case of the Old City Centre in Coimbra in Portugal

Romeu S. Vicente and Humberto Varum
University of Aveiro, Department of Civil Engineering, Aveiro, Portugal

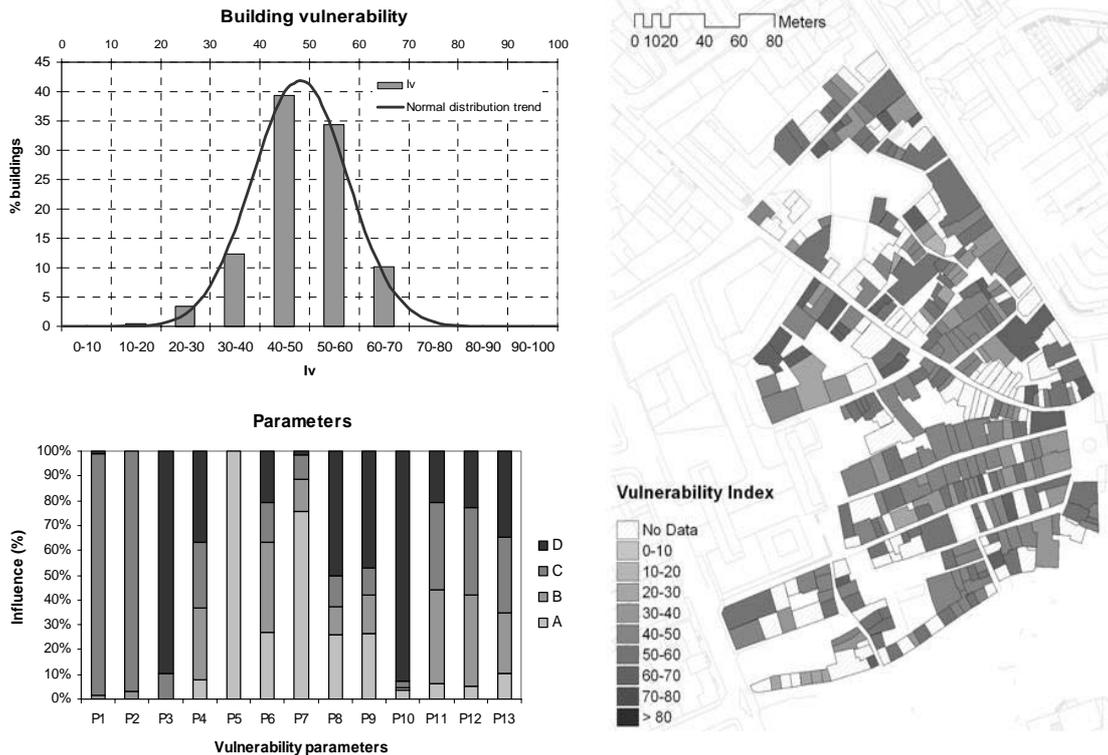
Figure 5 : Vulnerability results

From the vulnerability analysis the carried evidence a average vulnerability index of 48.09 (see Fig. 5). Around 83% of the building stock has a vulnerability index over 40 and 44% over 50 (see figure 4b). This first level evaluation, even though limited is fundamental not only for the 13 parameter evaluation (masonry quality, state of conservation, structural irregularities, building interaction, etc.) but also for the identification of more critical and vulnerable buildings and that are picked out for a more detailed analysis in terms of seismic behaviour. Only 15% of the buildings have an I_v below 40, which figures as the lower limit for vulnerability allowed.

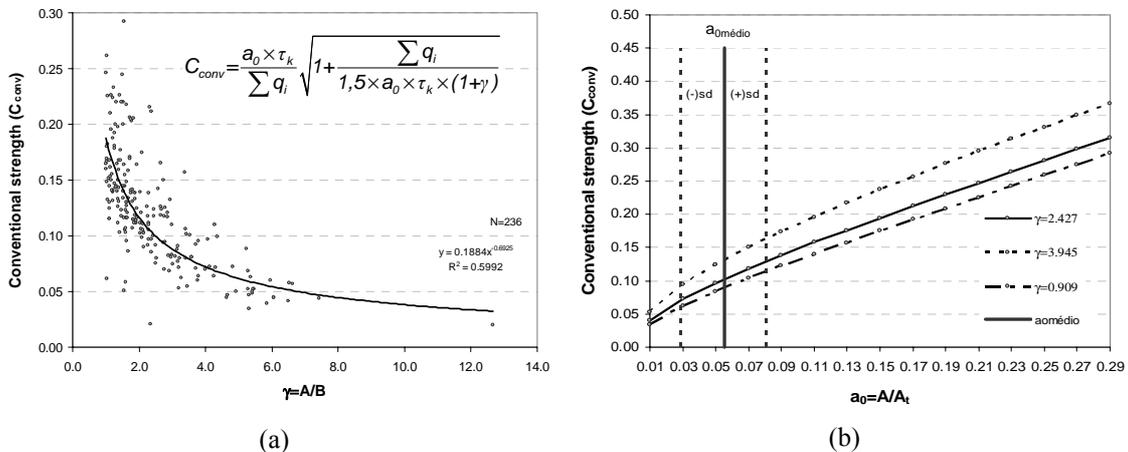
Figure 6 : Conventional strength relationships

Fig. 6a, shows the relationship between the conventional strength of the vertical load bearing structure, which is a measure of the masonry shear strength and the ratio of maximum/minimum walls area. It is verified that the conventional strength grows when the ratio A_{max}/A_{min} revealing better behaviour and consequently lower vulnerability index for buildings with similar resistance in both directions. In Fig. 6b, can be seen the conventional strength growth with the mean values of parameters γ and a_0 for the masonry buildings of the old city centre analysed. For the masonry shear strength, τ_k, and vertical loading, q_i, characteristic values of 40 kPa and 50 kN/m^2

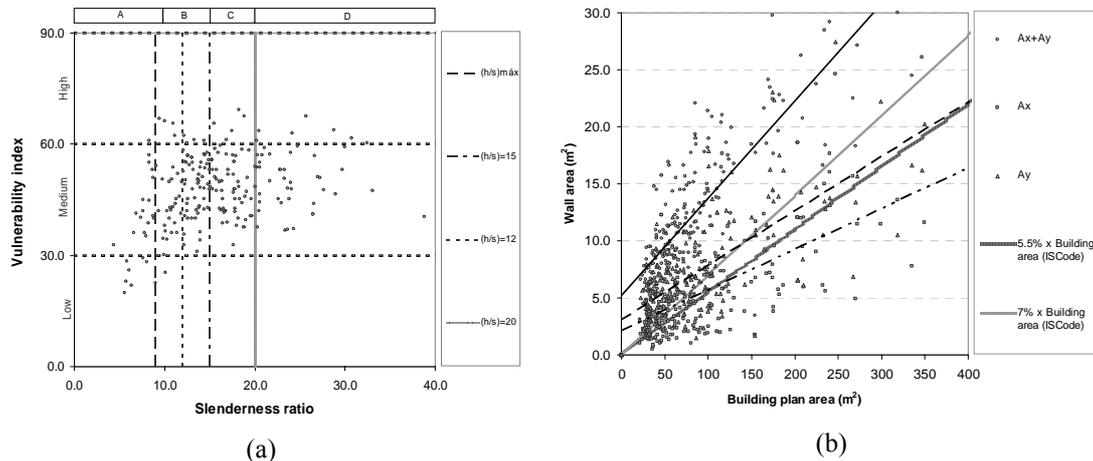
Figure 7 : Slenderness and resisting wall area results

The analyses of the wall façade slenderness of the building stock shows that the overturning mechanism (total or partial) of the majority of unrestrained walls is associated to high

vulnerability levels (see Fig 7a). It is also observed that the EC8 (EC8, 2003) recommended slenderness ratio for shear walls of 9 and 15, respectively for unreinforced stone masonry units and other masonries in low seismicity zones is clearly exceeded. Fig. 7b, has revealed that the wall area in both directions is under the values indicated, for example, in the Italian seismic code (Italian Seismic Code, 1996) (5.5% of building area) for a project seismic action, by means of a peak ground acceleration of about 0.20g.

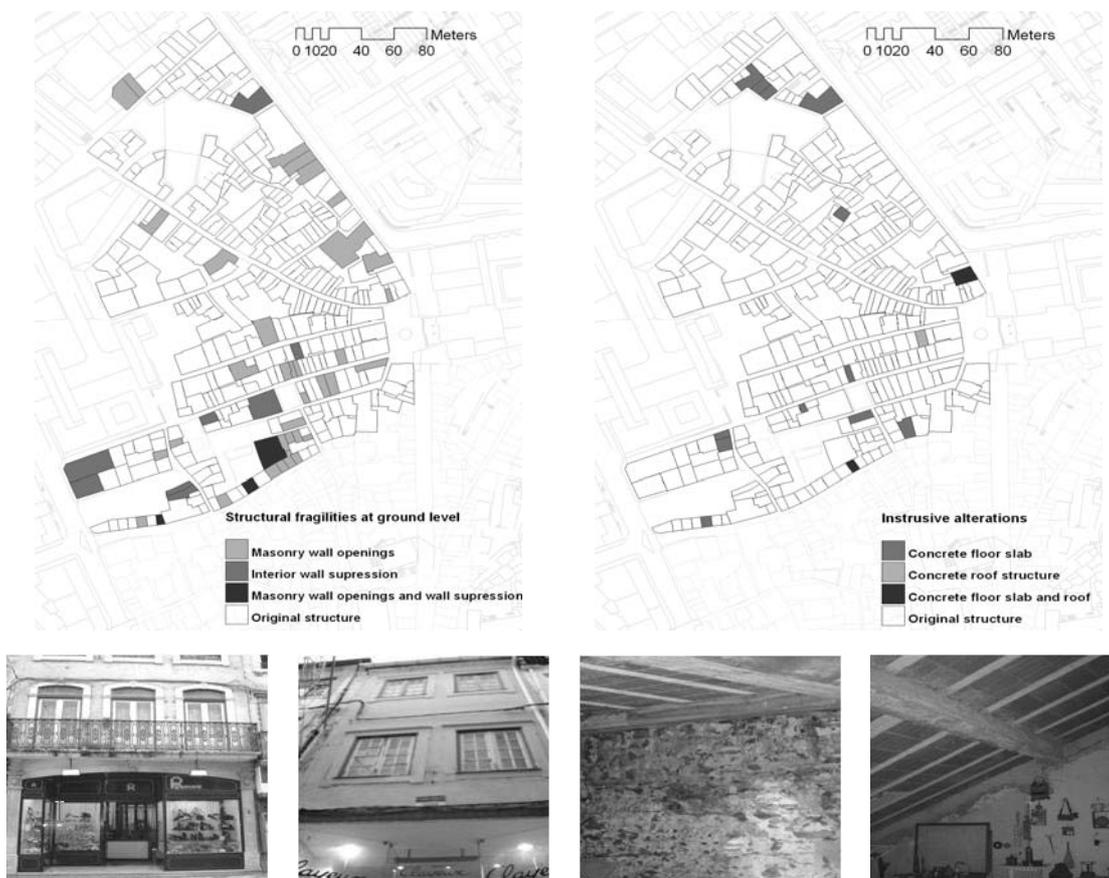
Figure 8 : Structural fragilities and intrusive techniques

The old building stock, over the years, has suffered many structural alterations required by functional adaptability of these building to new functions (see Fig. 8). The use of concrete increases its global mass, without contributing to the increase the global stiffness. Other actions,

such as the cutting of masonry walls and demolition of interior partition walls also reduce global stiffness and weaken the seismic response of these building typologies.
