ASSESSMENT OF STRUCTURAL DAMAGE IN HISTORICAL CONSTRUCTIONS USING NUMERICAL MODELS: THE CASE OF THE CHURCH OF THE POBLET MONASTERY

Savvas Saloustros, Luca Pelà, Pere Roca, and Jorge Portal

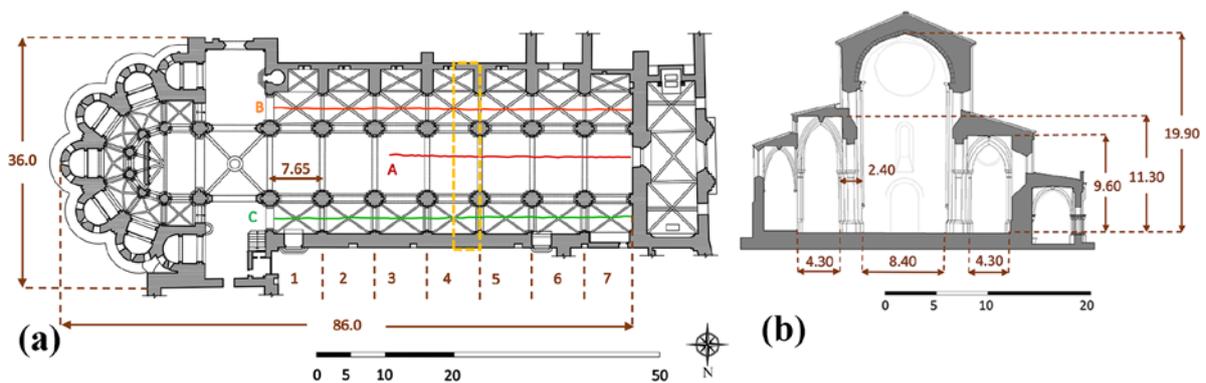
Figure 1: The church of the Poblet Monastery: (a) plan at the roof level, with the numeration of the bays and indication of the main cracks, and (b) cross-section of a typical bay.

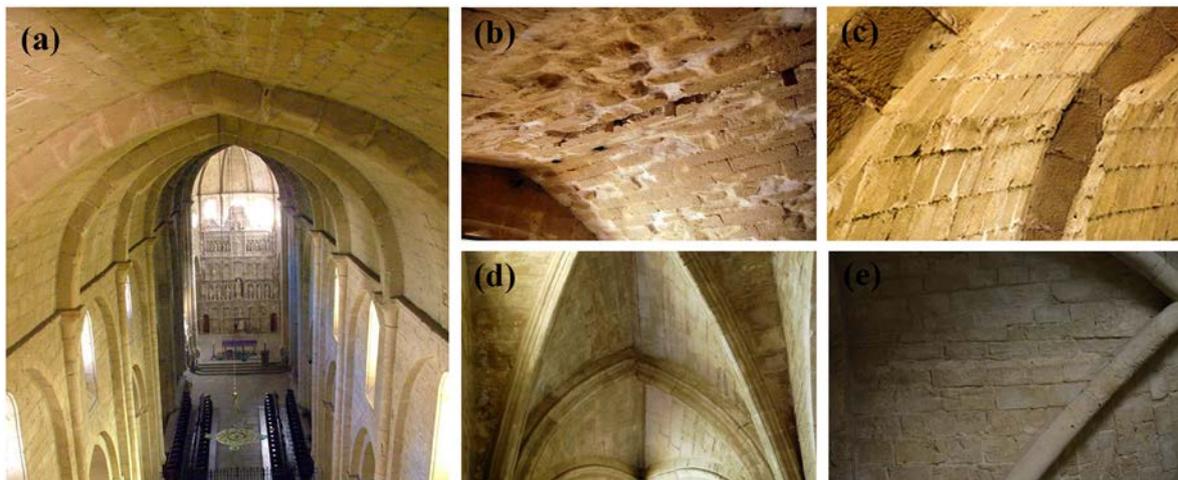
Today, the church presents damage mainly in the western part including the main nave and the lateral aisles. The bays affected by past fires present stone deterioration with significant loss of material. Additionally, the corrosion of the large amount of metal elements inserted in joints and open cracks during interventions after year 1940 accelerates the stone degradation. Apart from this material deterioration, the structure presents significant deformation and structural damage. The clerestory walls exhibit an outwards rotation, which reaches values of 14 cm in the southern one and 10 cm in the northern one. This deformation is possibly due to the inadequate equilibrium condition caused by the low height of the lateral aisles, as can be seen in Figure 1b. The barrel vault has a significant deflection progressing from the 1st and 7th to the 4th bay (see Figure 1a for the numeration of bays) and reaching values of 50 cm (Figure 2a). In addition to this deformation, the barrel vault presents a wide crack near its key (crack A in Figure 1a), which continues longitudinally across almost all the bays of the church (Figure 2b). Cracking of the stone is also evident near the key of the vaults of the lateral aisles (cracks B and C in Figure 1a), which is accompanied by relative vertical displacements of 5 ÷ 7 cm (Figure 2d-e). Finally, local stone crushing is visible at the middle height of the arches in the main nave (Figure 2c).

Figure 2: Deformation and damage in the main and lateral aisles of the church: (a) deformation in the arches and barrel vault of the main nave, (b) cracking in the barrel vault, (c) crushing in the arches of the main nave, (d) cracking in the vault of the southern aisle, and (e) repaired cracking in the vault of the northern aisle.

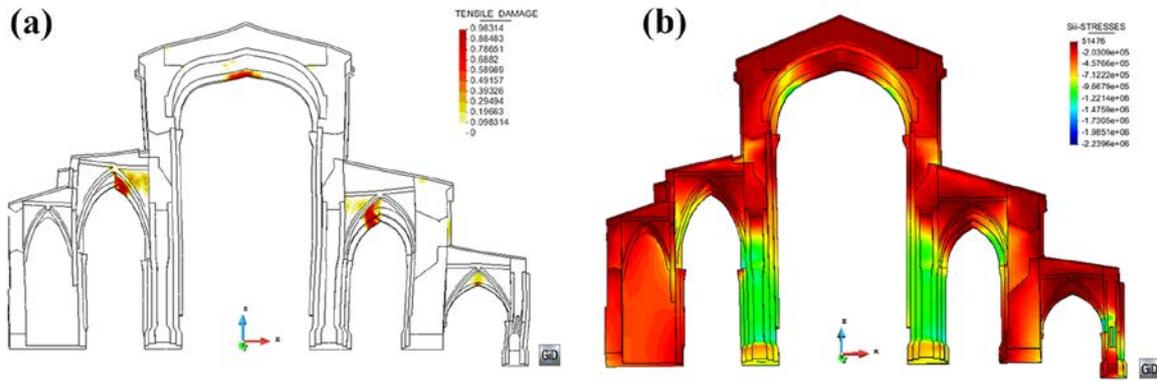
Concerning the stress-state of the bay, tensile damage, and thus cracking of the material, is clearly visible in the intrados of the arch in the main nave and the intrados of the arches and vaults in the lateral aisles (Figure 3). This result is in very good agreement with the damage observed in the real building, which suggests that the cause of this damage is actually related to the design of the structure and particularly to the low position of the lateral vaults with respect to the height of the central nave.

Finally, the numerical analysis does not predict any crushing of the stone in compression for the assumed value of the compressive strength. Among the highest compressed areas— with decreasing magnitude—are the northern springing of the vault in the southern aisle (left aisle in Figure 3), the intrados of the arch in the northern aisle (right aisle in Figure 3), the base of the piers, and finally the intrados of the arches in the barrel vault. Consequently, self-weight alone does not seem to produce the crushing of stone in the arches of the main nave and therefore other possible causes for this damage are investigated in the following sections.

Figure 3: Numerical analysis results for the action of the self-weight: (a) tensile damage and (b) compressive stresses.

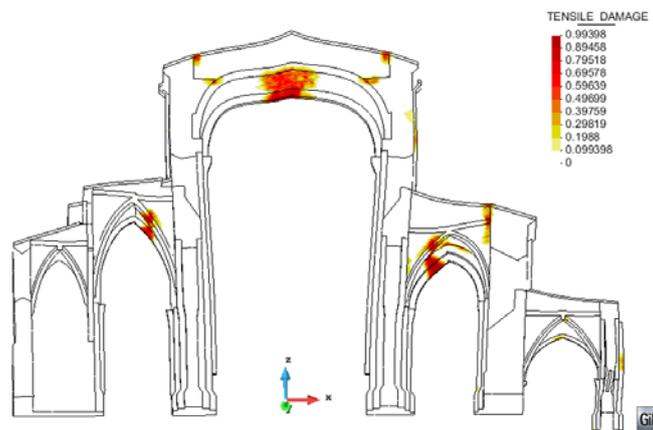
This analysis shows that an infill with low structural capacity would result to significant tensile damage in the barrel vault of the church (Figure 4). The predicted level of damage is inconsistent with the damage actually existing in the structure, suggesting that the infill above the lateral vaults is probably composed of a structurally more competent material. However, future in-situ inspection is necessary to identify and characterize the type of existing infill material and allow new analyses with a consistently updated model.

Figure 4: Tensile damage for the model with non-structural infill over the lateral vaults.

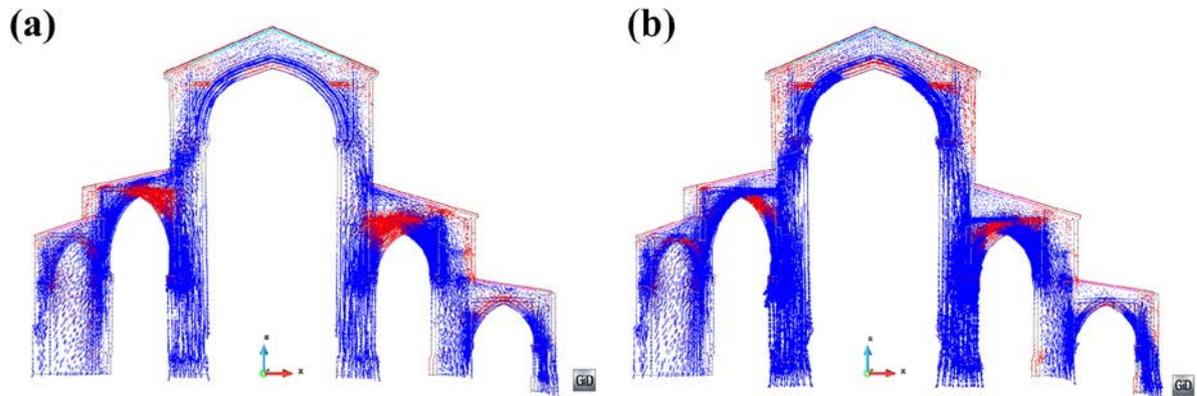
The reason for the higher damage, in case of a poor infill over the lateral vaults, is found in the lowering of the counteracting thrust of the lateral aisles. When a structural infill (material A) is assumed above the lateral vaults (reference model, Figure 5a) the thrust of the lateral aisles counteracts the one coming from the main nave at a higher position compared to the case with non-structural infill (material B) (Figure 5b). This difference leads to higher eccentricity of the thrust line within the width of the clerestory walls and thus to higher wall rotation and damage in the main nave.

Figure 5: Vectors of principal stresses (tensile in red, compressive in blue) for: (a) reference model with structural infill (material A) over the lateral vaults, and (b) model with non-structural infill (material B) over the lateral vaults.

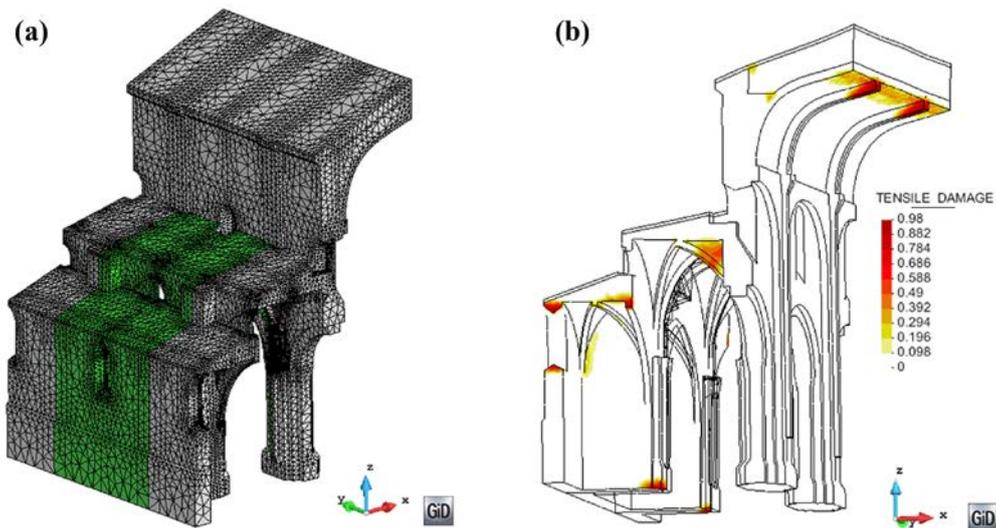
Figure 6: Simulation of the demolition of the southern aisle: (a) FE model (in green the demolished part), and (b) tensile damage contour.

The analysis provides valuable information on the possible influence of such demolition on the present damage and deformation of the church. In particular, the demolition of the lateral aisle causes a higher rotation of the southern clerestory wall and a higher deflection in the barrel vault with an increase of 430% and 30% respectively comparing to the initial state. This

deformation is an immediate consequence of the deprival of the counteracting thrust from the lateral aisle. In fact, in the present condition the structure shows a larger rotation in the southern clerestory wall than in the northern one. The deflection of the central barrel vault may have also increased due to this demolition. This deformation entails greater tensile damage near the key of the barrel vault as Figure 6b illustrates. In this case, tensile damage is clearly visible in the barrel vault, which reveals that the present cracking in this area was probably initiated or extended during this demolition.

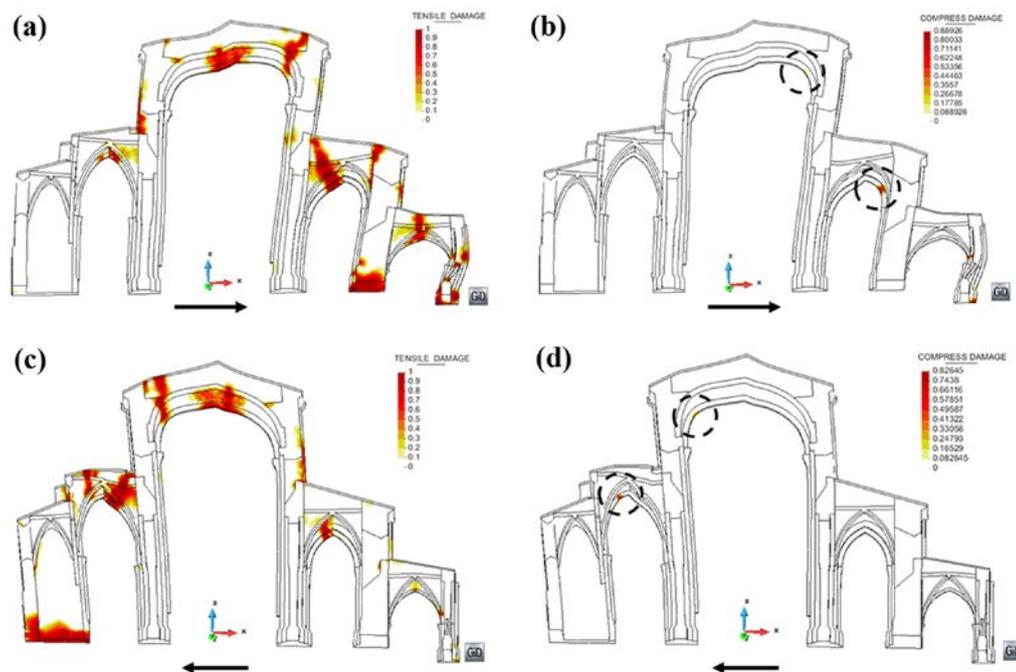
The distribution of the damage suggests two potential collapse mechanisms: (1) the local collapse of the barrel vault in the main nave, and (2) a global collapse including the main nave and one lateral aisle. The final state of the tensile and compressive damage distribution, according to performed the pushover analysis (Figure 7), shows that the second collapse mechanism is the more likely one.

Interestingly, the cracking and stone crushing in the intrados of the main and lateral naves predicted by the analysis is in good agreement with actually existing damage in the bays of the church. In particular, the numerical analysis indicates that an earthquake event could have initiated or extended the wide cracking near the key of the barrel vault (Figures 7a,c), producing at the same time crushing of the stone in the arches of the main and lateral aisles (Figures 7b,d).

Figure 7: (a) Tensile damage and (b) compressive damage contours for seismic forces towards north; (c) tensile damage and (d) compressive damage contours for seismic forces towards south.

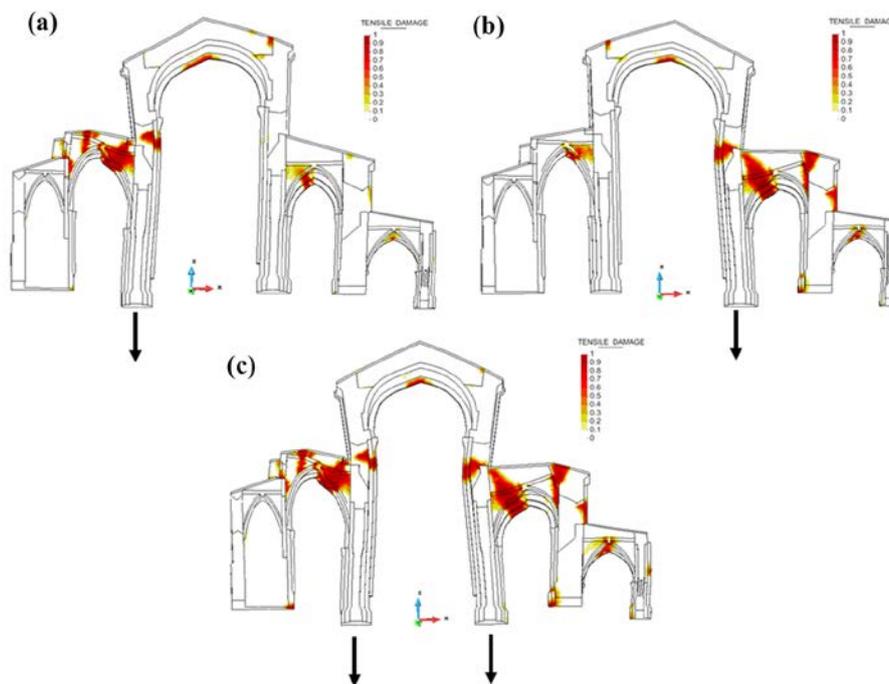
The results regarding tensile damage (Figure 8a) show that a moderate settlement (20mm) of one or both piers of the main nave will affect mostly the lower parts of the church. Specifically, the cracking near the key of the vaults in the lateral aisles is the first to propagate, accompanied with cracking in the nave walls. The latter damage, or possible related repair interventions, are not visible today, suggesting that soil settlements should not have occurred in significant values.

Figure 8: Tensile damage for: (a) settlement of the southern pier (35 mm), (b) settlement of the northern pier (24 mm) , and (c) settlement of both piers of the main nave (25 mm).

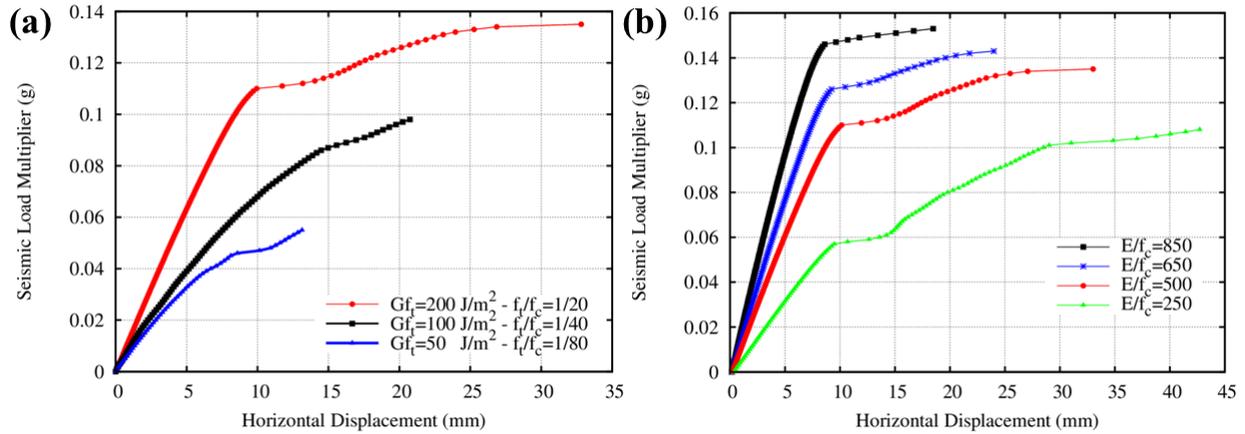
Figure 9: Capacity curves obtained for the variation of the: (a) tensile strength (f_t) and fracture energy (G_{ft}), (b) Young modulus (E). Control point at the key of the barrel vault.

The variation of the material parameters affects significantly the capacity of the structure against earthquake actions. In particular, the parametric analyses show a variation of the capacity between 0.058 g and 0.16 g (Figure 9). The lowest capacity is obtained for an almost null tensile strength ($f_t / f_c = 1/80 = 0.05$ MPa) and low fracture energy ($Gf_t = 50$ J/m^2). The low capacity obtained in this case, which suggests that excessive damage is possible even for low intensity earthquake events, advices a further investigation on the material properties of the existing masonry. For the rest combinations of the analyzed values, the structure shows a sufficient capacity for the earthquake demand of the area [12].

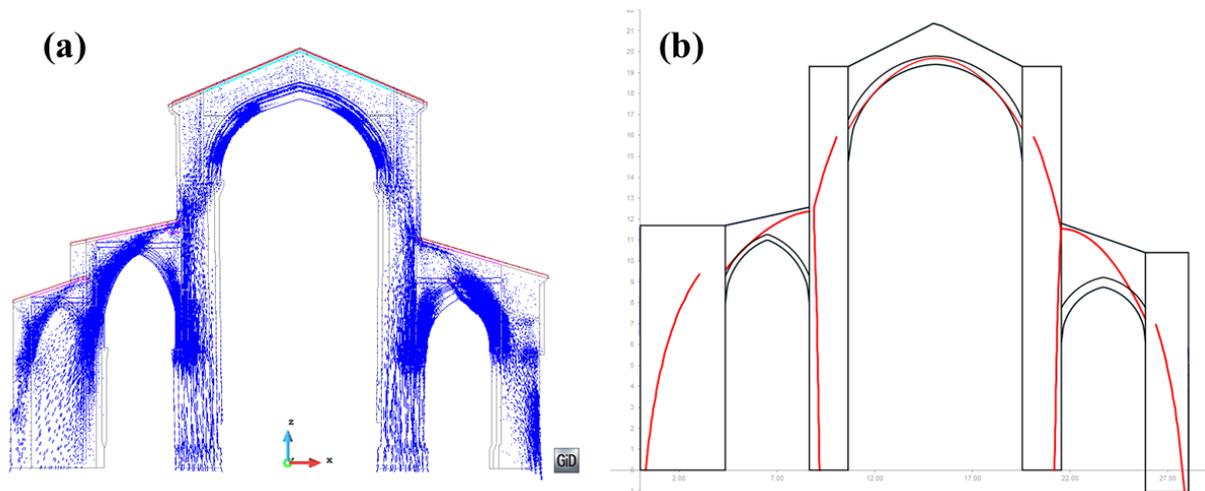
Figure 10: Comparison of the FE with the graphic statics: (a) vectors of minimum principal stresses from FEA and (b) equivalent thrust lines solution.

Figure 10a presents the results of such an analysis in terms of minimum principal stresses. These results can provide guidance for selecting the position and value of the thrust in various locations within the analyzed bay and consequently investigating if an equivalent graphic statics solution is possible. The graphic statics solution, derived with the use of an excel spreadsheet (Figure 10b) is in very good agreement with the numerical results and clearly shows the appearance of very eccentric thrust lines within the depth of the clerestory walls due to the limited height of the lateral vaults. As mentioned, this eccentricity can explain the outwards rotation of the clerestory walls and the cracking in the barrel vault. In turn, the high position and shape of the thrust lines in the lateral vaults explains the cracking experienced by them.
