IV-2. Some Early Reinforced Brickwork Masterpieces Revisited

D. Bernstein

ABSTRACT

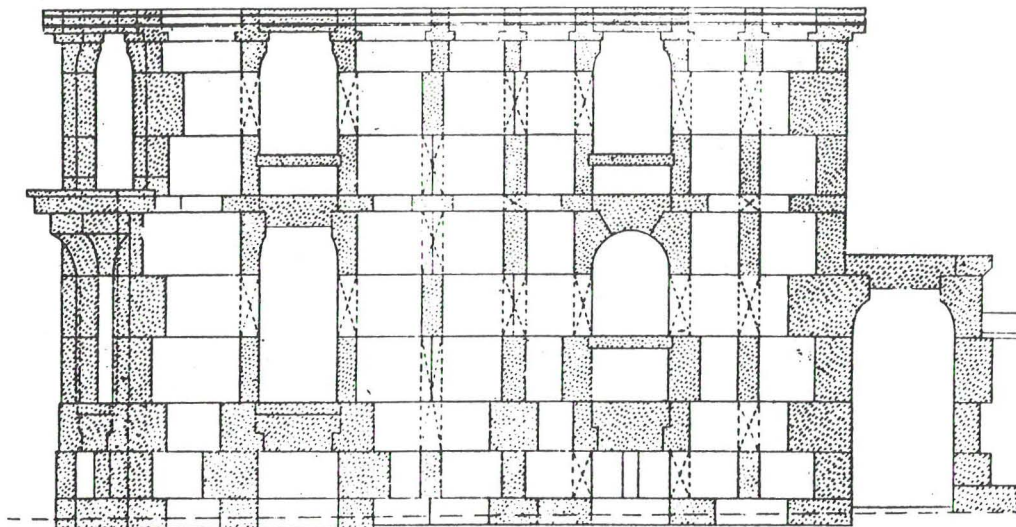
Figure 1.

It is most probably A. de Baudot himself who introduced into Cottancin's system the ribs (on the underside of the floor plates) and the reinforced brick walls and columns, producing thus, in his own words "monoliths, or at least structures of which the elements can be well connected."¹ One can imagine how dissatisfied he must have been with his own house (1892), in which reinforced mortar floors rest on an external unreinforced cavity wall: one leaf being in stone, the other in brick, the two connected through pilasters composed of headers in both materials (figure 1).

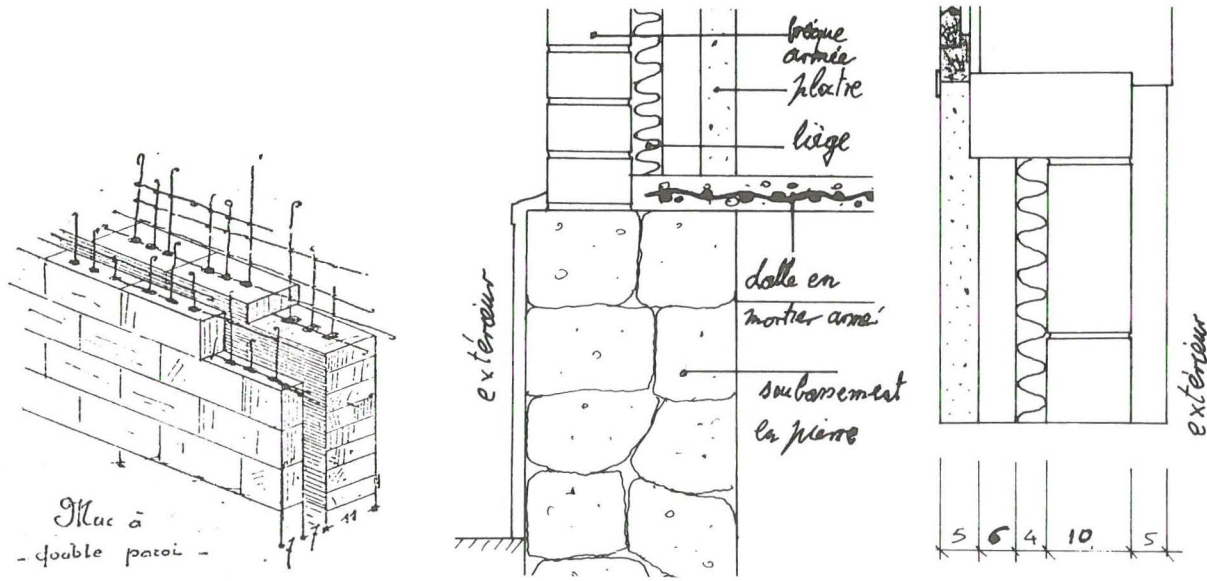
Figure 4.

The external leaf is reinforced brick the internal is in plaster (figure 4). The state of the two houses constructed according to the plan in figure 6 is excellent. The third, which is bigger and slightly more exposed, has suffered quite a lot of damage externally. The lack of maintenance in recent times has been the cause of an acceleration in the process.
