PERFORMANCE OF BRICK MASONRY VENEERS

A.A. Hamid

I.J. Becica

H.G. Harris

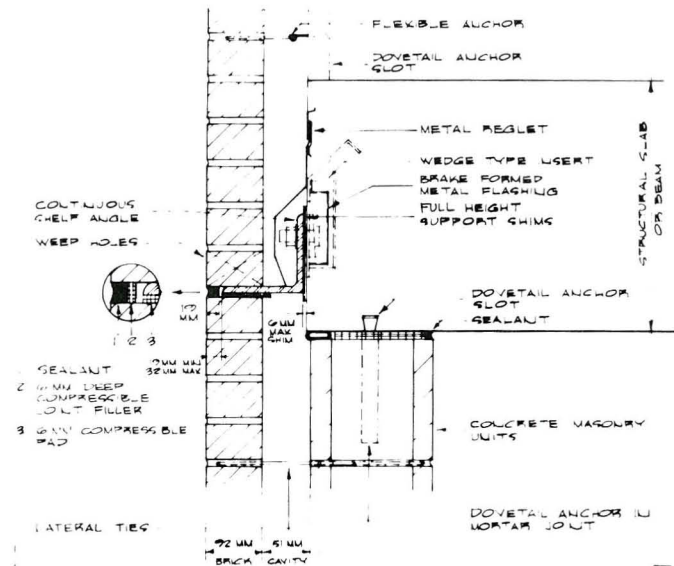
Fig. 1 Proper Shelf Angle Detail

Apart from the material properties discussed above, construction practice influences the behavior of masonry veneers. A typical brick masonry veneer detail for supporting panels from concrete structures is shown in Fig. 1. It should be noted that Fig. 1 is considered a proper detail in that vertical expansion of brick panels is provided for by a compressible joint located at the supporting angle. Also, sufficient adjustment is provided by the anchorage system such that masonry coursing can be maintained during construction. The introduction of a flashing membrane and weep holes at the base of each wall segment

Various deviations from the typical detail shown in Figure 1 have led to serious veneer distress. As a typical example, the compressible joint is either not detailed properly or not installed properly. The result is significant vertical loads being superimposed upon the veneer system. A continuous mortar joint at this location provides, in most cases, the necessary redundancy to allow the expansive strains, as outlined previously, to develop.

Secondly, failure of the drainage system consisting of flashing and thru-wall weep holes, can cause water to be entrapped between the rigid concrete structure and flexible masonry veneer. If freezing should occur, sufficient lateral pressures can be exerted on the masonry veneer to cause displacement laterally and potential collapse of wall panels.

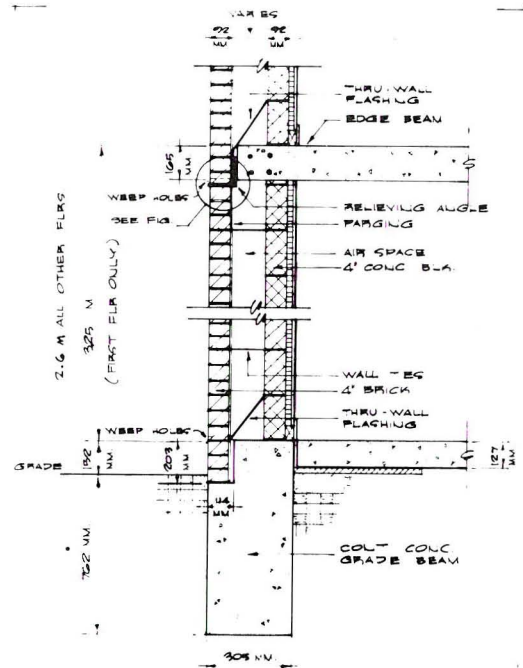
Fig. 2 Typical Wall Section

The building in question is a 6 story apartment structure consisting of flat plate and column construction. A typical column tributary area is 13 square meters. The exterior facade consists of a light colored brick protruding 102 mm from a darker colored recessed brick panel which alternates around the perimeter of the building. A vertical caulk joint seals the offset panels. Only the continuous vertical panel which spans from foundation to roof elevation uninterrupted by window openings showed any signs of distress. A typical wall section is shown in Fig. 2.

Distress in the structure consisted of bowing of the masonry veneer at the shelf angle locations and spalling of the first two courses either above and/or below the bearing location of the shelf angle. Ninety percent of the spalling failures noted and 100 percent of the bowing failures occurred on the southeast elevation of the building. In the northern hemisphere this fact coincides with the greatest wall panel temperature gain. Because of the apparent sporadic nature of the veneer failures, a detailed analysis was called for to determine the cause of distress.
