## **DIAGNOSTIC INVESTIGATION ON THE HISTORICAL MASONRY STRUCTURES OF A CASTLE BY THE COMPLEMENTARY USE OF NON DESTRUCTIVE TECHNIQUES.**

**L. Binda <sup>1</sup>, L. Cantini <sup>1</sup>, F. Fernandes<sup>2</sup>, A. Saisi <sup>1</sup>, C. Tedeschi <sup>1</sup>, L. Zanzi <sup>1</sup>**

An on-site investigation was carried out on the Pisece Castle in order to compare different non destructive tests and to check their complementarity in the detection of unknown masonry features. Some typical problems solved by the authors with the combination of different techniques such as boroscopy, radar and sonic tests, flat-jack and others together with laboratory tests on sampled materials are presented.

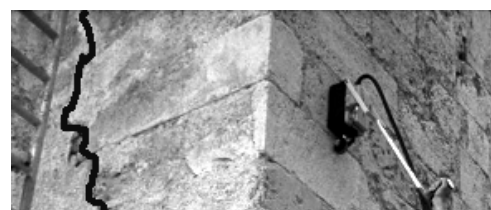
Finally, a radar vertical profile was executed on the external side of the tower starting at an eight of 190cm from the base and moving upward (Fig. 13). The profile is parallel to the corner at a distance from the corner of 70cm. The inspection was carried out in order to verify if radar was able to detect the presence and the depth of the wide cracks visible on the corner (Fig. 14).

Figure 13 Position of the vertical radar profile collected with a 1GHz antenna to map some important cracks.
