CRACKING OF THE APSE OF S. LORENZO IN CREMONA: STRUCTURAL INVESTIGATION AND MONITORING

A. ANZANI¹, L. BINDA², L. CANTINI³, G. CARDANI⁴, P. CONDOLEO⁵

¹Associate Professor, ²Full Professor, ³Research Assistant, ⁴Assistant Professor, ⁵PhD
D.I.S. Politecnico di Milano
Milano - Italy

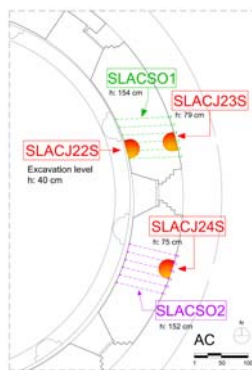
Figure 12. Position of sonic and flat-jack tests.

In Figures 12-15 the positions where sonic and flat-jack tests have been carried out on the apse are indicated. In both cases, sonic tests gave homogeneous results as shown; fairly high values of the sonic velocity were obtained, ranging between 1500 m/s and 2100 m/s. The lowest values of sonic velocities were detected in some parts of the pillars (PA2a, PA3b) due to the presence of local interventions weakening the masonry.

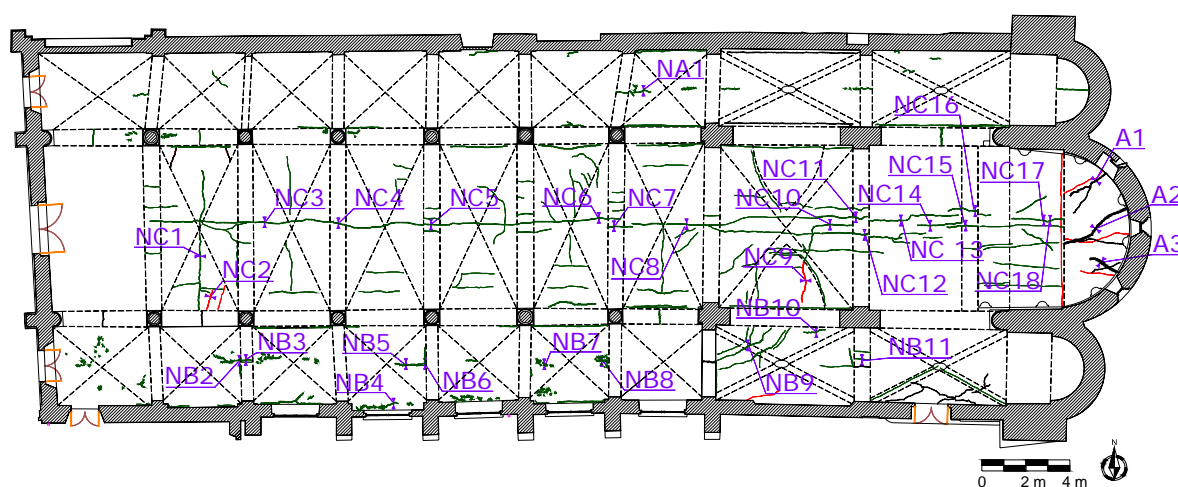
Figure 21. Monitored cracks along the central nave, plane (NC=central nave; NA and NB=lateral aisles; A=apse).

The evolution of the extensive crack pattern on many of the vaults has been studied continuously through the monitoring of 36 cracks. The cracks have been chosen considering their path, thickness and position relatively to the geometry of each vaults. The monitored cracks are shown in Figures 21-24.

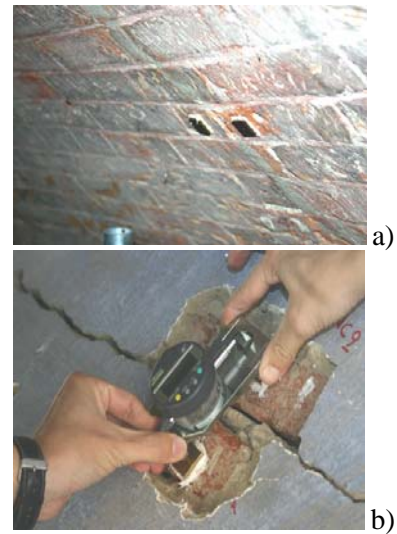
Figure 23. Crack monitoring: a) inox steel basis; b) millesimal dial gauge.

The monitoring has been carried out placing couples of inox steel basis with conical holes (Figure 23a) and reading their distance every month through a millesimal removal dial gauge (Figure 23b).
