## **REPAIR OF REINFORCED MASONRY WALLS WITH PREVIOUS SHEAR FAILURE**

### **SUMMARY**

A series of cyclic lateral load tests were performed to simulate earthquake behaviour on full scale masonry walls. One wall was made of clay bricks and confined by reinforced concrete elements, while the other one was made of fully grouted hollow concrete blocks with interior reinforcement. After the shear failure, they were repaired using welded mesh jacketing, covered with mortar.

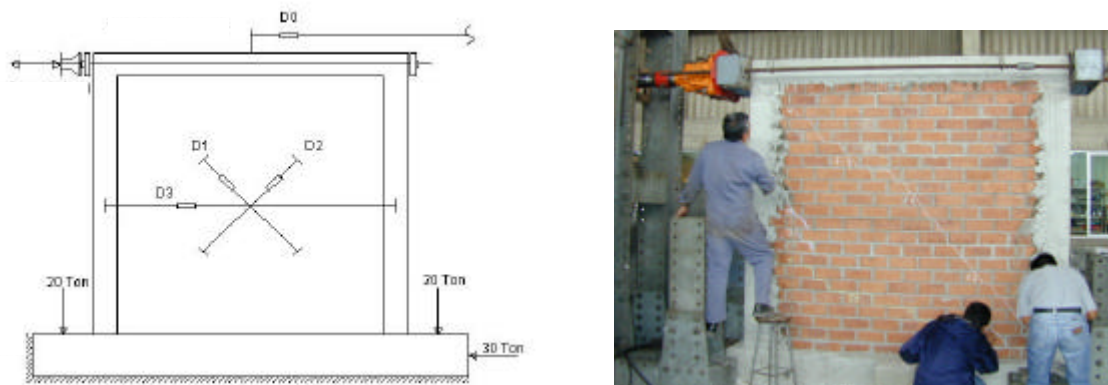
Figure 3. Lateral Load Test for Original Wall W1: Instrumentation and Overall View

The original walls W1 and W2 were subjected to a series of cyclic lateral load tests controlling the top displacement, as shown in Table 2, where each step consisted of 1, 2 or 3 cycles until the hysteretic loop stabilizes. In figures 3 and 4, the instrumentation and test

setting for both walls are shown. Figure 5 displays the walls at the end of the test. In both walls the shear failure was produced.

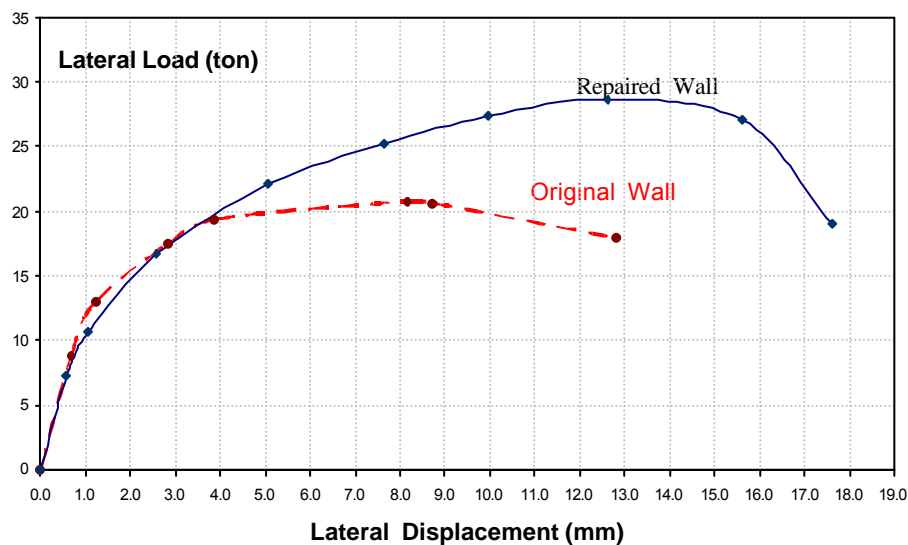
Figure 10. Envelopes of Lateral Loads in Confined Wall W1

Figure 10 displays the envelopes of lateral load of the original and repaired wall. An increase of 40% in lateral load resistance was achieved. Also, the load started to decrease in the original wall with 9-mm lateral displacement, due to the crushing of the bricks, while in the repaired wall, this effect started with 14-mm lateral displacement, due to the sliding failure observed. Therefore, it can be concluded that the reparation technique showed good results.

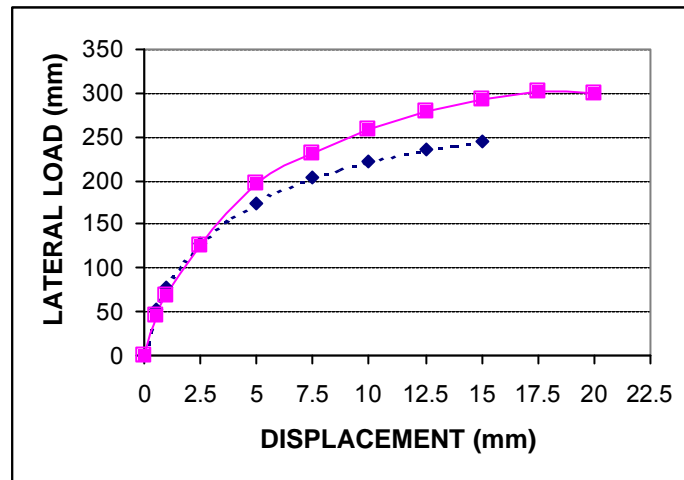
Figure 11. Envelopes of Lateral Loads in Wall W2

Figure 11 displays the envelopes of lateral load of the original and repaired wall, corresponding to the hysteretic loops shown in figure 12. An increase of 23 % in lateral load resistance was achieved.
