MASONRY INFLUENCE IN SEISMIC PERFORMANCE OF BUILDINGS - CASE STUDY IN PERU

DANIEL QUIUN

SUMMARY

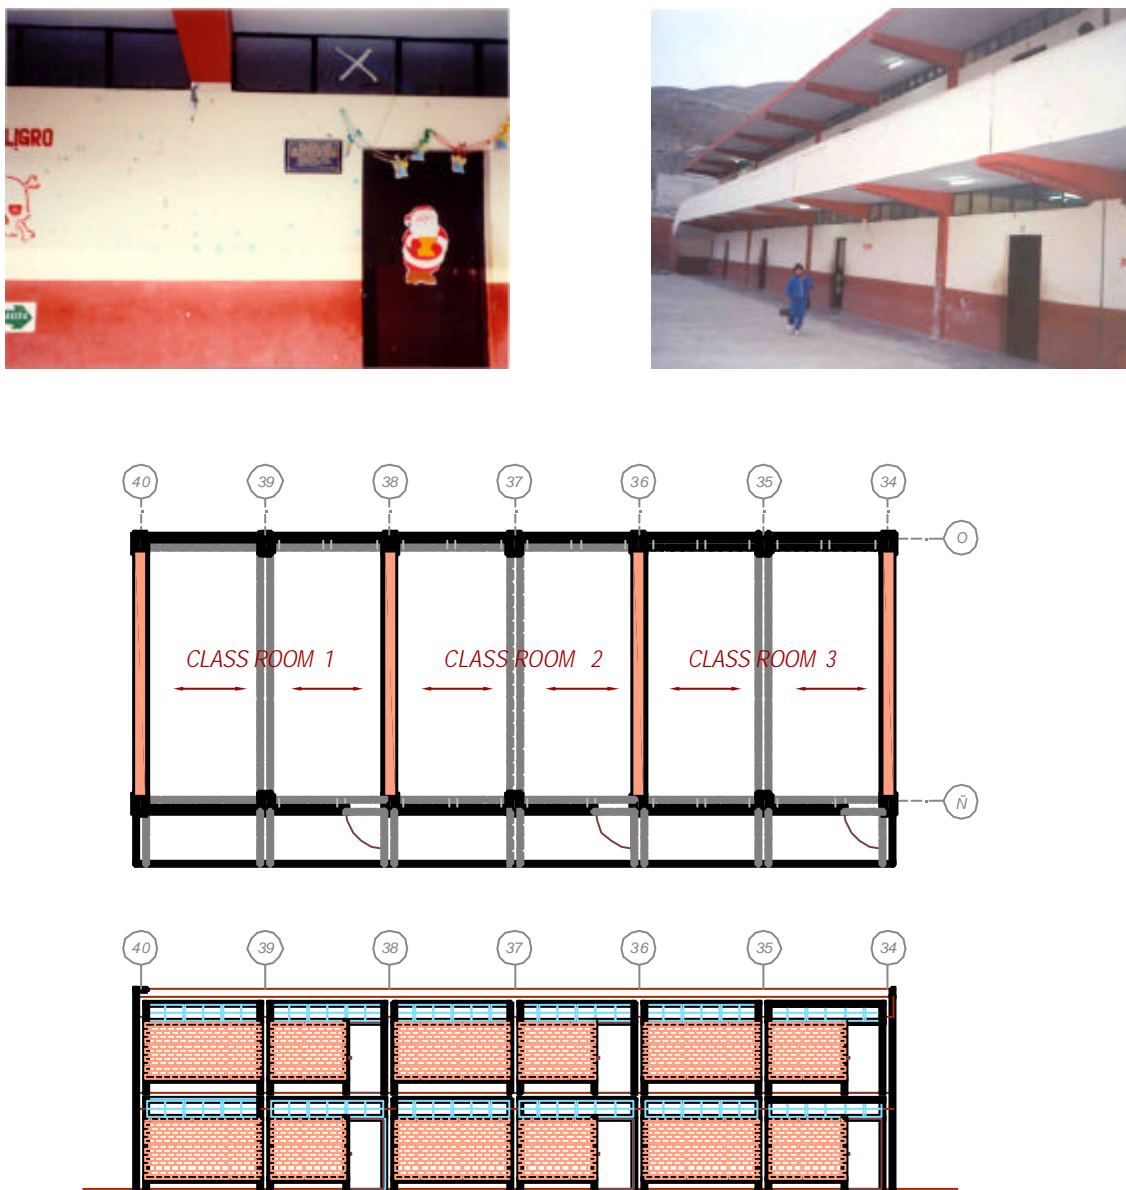
Figure 2. Typical old school building in Peru, has structural masonry walls in the transverse direction and nonstructural walls in longitudinal direction

The seismic resistant structure of typical Peruvian school buildings older than 1997, feature a weak longitudinal direction (flexible concrete frames) and a strong transversal direction (rigid masonry walls). Moreover, nonstructural masonry walls in the longitudinal direction usually are poorly isolated from the concrete frame, and can produce short-column effect even in moderate earthquakes. The 1996 Mw 7.5 Nasca earthquake (Quiun et. al. 1997) in central Peru coast, produced several damages to school buildings, mainly due to excessive lateral displacements in the longitudinal direction, that concluded in shear failure in short columns (figure 3). However, in the transverse direction, confined masonry walls were very effective to control lateral displacements and therefore no damage was observed.

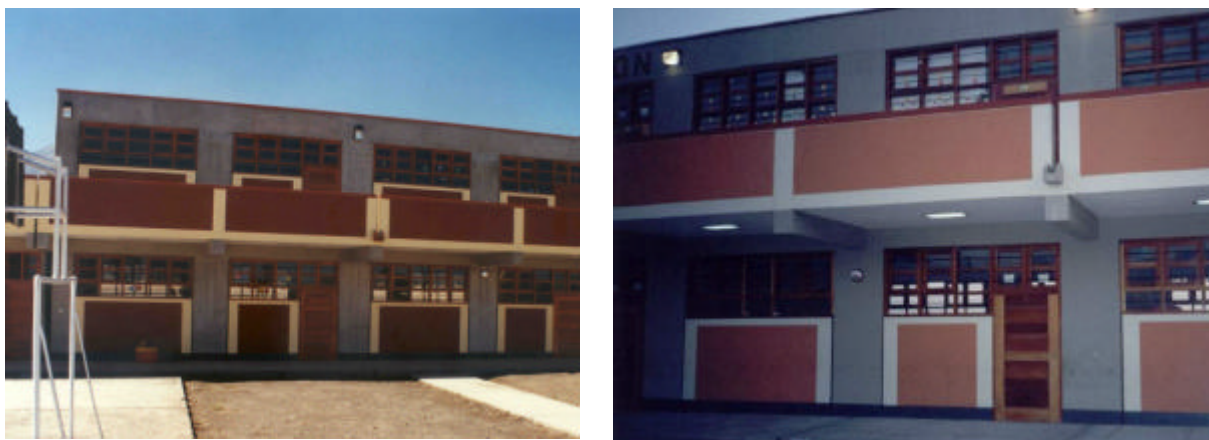
updated in 2003). The new schools are considered essential buildings and the maximum allowed drift for concrete buildings was lowered to 0.007. They feature strong reinforced concrete columns in the longitudinal direction and maintained the stiff masonry walls in the transverse direction, resulting in no damage. Also, the nonstructural masonry walls in the longitudinal direction were better detailed and properly isolated from the concrete frame; walls need RC columns and beams to withstand out-of-plane seismic loads (figure 6).

Figure 6. New school buildings without damage in Atico earthquake

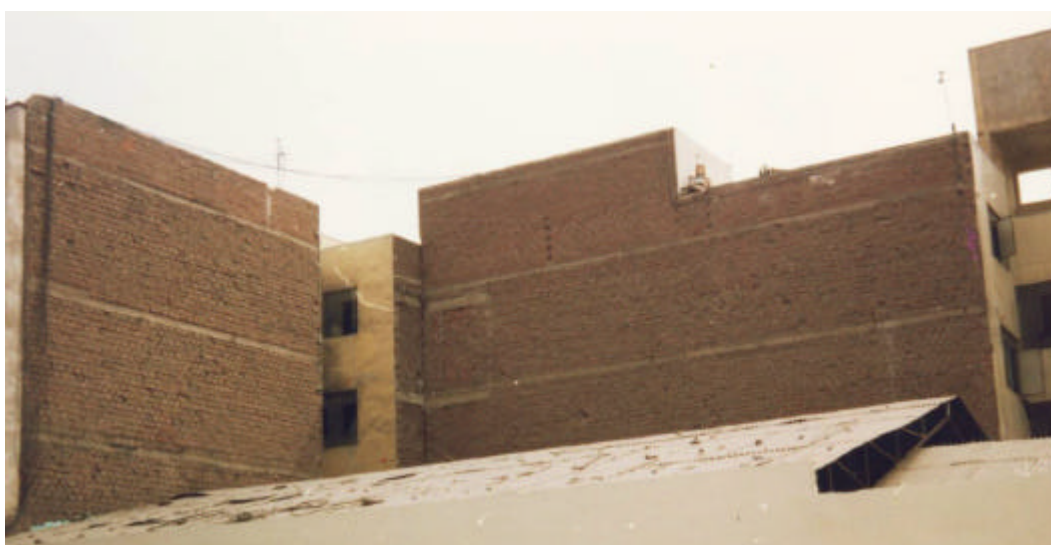
In the first half of the 20th century, many single houses (1 to 3 stories) and multistory residential buildings (3 to 5 stories) in Peru have used unreinforced masonry for bearing and non-bearing walls, mostly using clay bricks. In these older buildings, bearing walls usually have 0.25m width independently of the building height. The non-bearing inner walls usually have 0.15m width and were called bracing walls. These buildings (figure 7) have withstood several earthquakes without any damage, perhaps due to good soil conditions and a high wall density in the main structural directions, that maintained the structural walls in the elastic range (San Bartolome 1994). It must be mentioned that at that time, bricks for use in all walls were 100% solid.

Figure 7. Old unreinforced masonry buildings without damage in Lima
