ANALYSIS OF PATHOLOGICAL DEFECTS OF LOAD-BEARING MASONRY TECHNOLOGY IN LOW INCOME PROJECTS

C. RICHTER; C.T. FORMOSO; A. B. MASUERO

School of Engineering
Federal University of Rio Grande do Sul
Porto Alegre RS BRAZIL

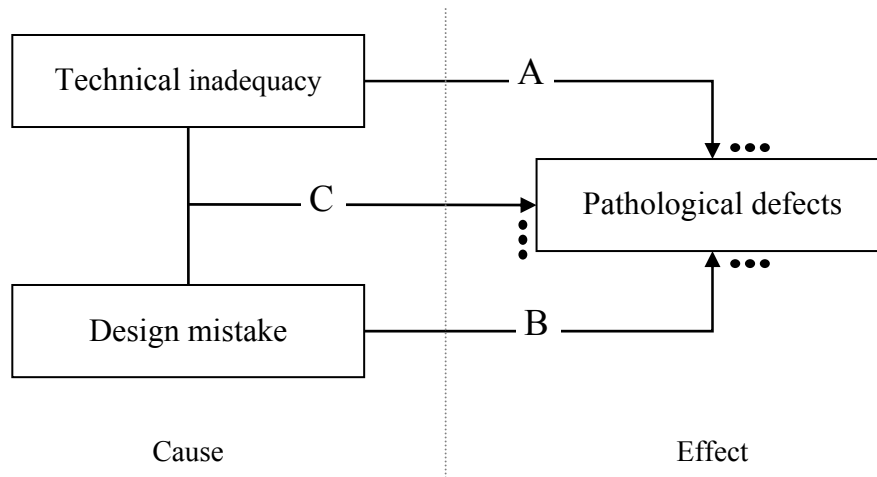
Figure 5: Relationship between cause and effect

To put it briefly, for now, the relationships between cause and effect are summarised on figure 5. In doing so, it was concluded that one pathological defect (effect) was caused by more than one technical inadequacy (A), design mistake (B) or a combination of both (C) (cause), and one of these causes alone could be responsible for more than one pathological defect.

The main design mistakes were: (a) inadequate support joint in the wall-slab interface of the last floor (necessary to release the shrinkage and temperatures stress); (b) insufficient control joints in the slabs and walls (necessary to reduce the movements of moisture and thermal variations), (c) insufficient top beams in the first and intermediate floors; (d) insufficient overlapping of both upper and lower window-beams; (e) insufficient grout points inside the vertical hollow bricks in the last floor (to strengthen specific wall junctions); and, (f) too many piping systems inside the slabs.
