## **THE DISASTERS OF SEPTEMBER 11, 2001**

DAVID T. BIGGS, P.E.

### **SUMMARY**

This paper presents some structural observations, findings, and recommendations regarding the masonry performance of the buildings affected by the September 11 attacks in New York City and Washington D.C.

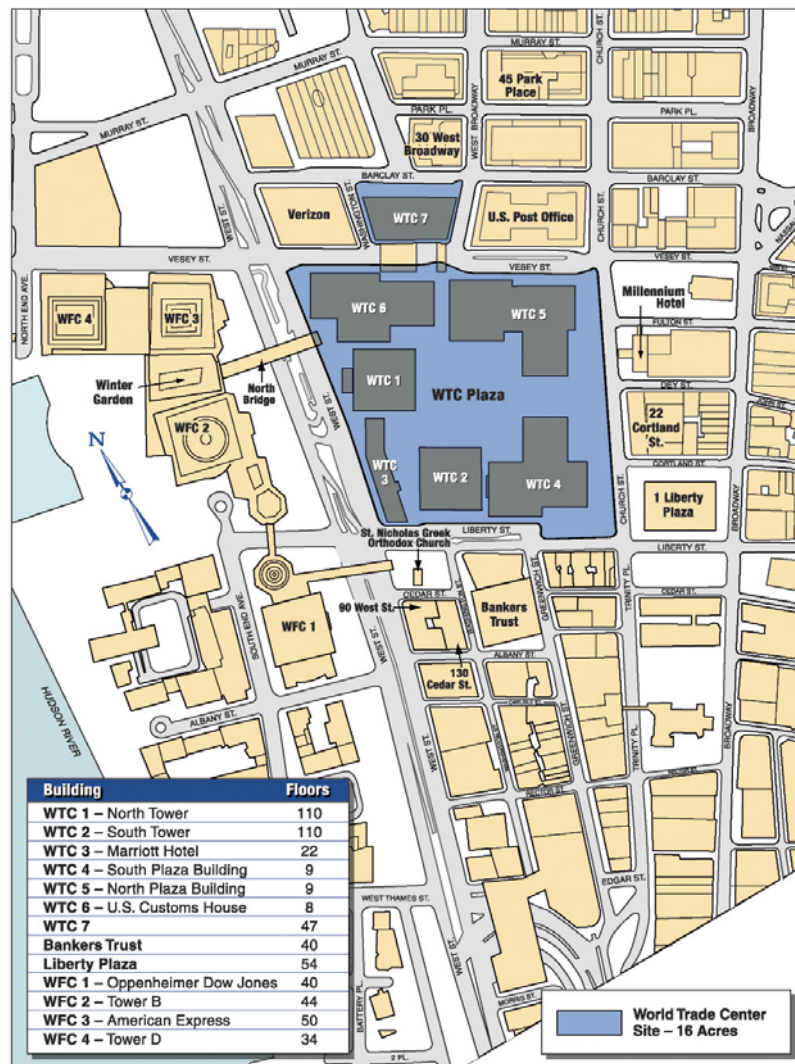
The steel-framed towers of the World Trade Center complex were constructed in the early 1970s. They were the focal point of a plaza that included five additional buildings ranging in height from 8 to 47 stories. None of the plaza buildings survived the disaster (Figure 1).

Figure 1 - Site Plan of World Trade Center Plaza and surrounding buildings
