The Grand-Place of Brussels

Paula Cordeiro

City of Brussels, Historical Heritage Department

ABSTRACT: The Grand-Place of Brussels has been on the UNESCO's world heritage list since December 1998.

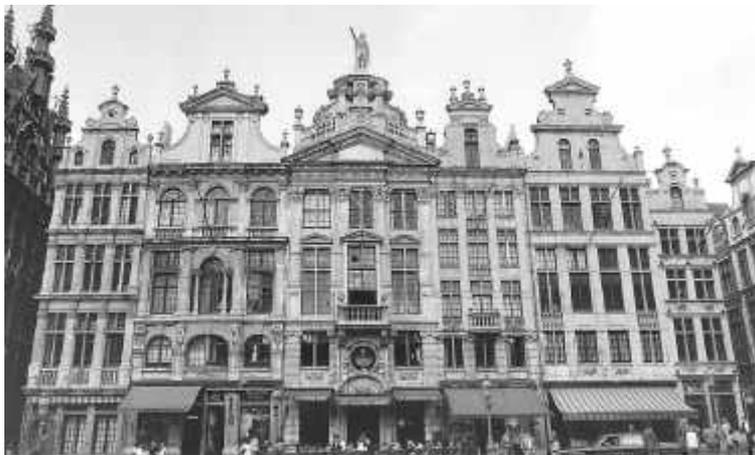
Block of houses n° 20-28

Figure 5 - Picture around 1895 showing the situation before the 19th century works.
