## Rehabilitation of the Minho line's Areosa and Afife masonry railway bridges

**ABSTRACT:** The Areosa and Afife Bridges, sited respectively at PKs° 85.619 and 91.487 of the Minho Line, are two of that Line's most beautiful and emblematic Bridges of this kind. Built in 1890, they are two masonry structures made of stone elements, forming an abated arch vault with an approximate span of 14 and 12 metres respectively.

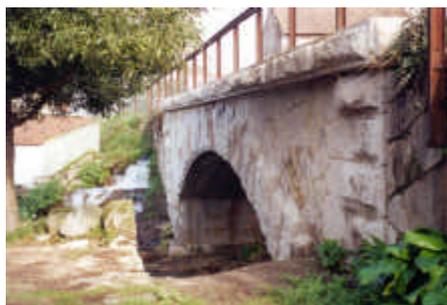
Figure 1: Areosa Bridge

Both structures showed evident signs of degradation with cracks in all of the intrados of the vault, standing out two greater sized cracks that followed the structure in a longitudinal direction causing the detachment of the frames. Even thus, the masonry elements of those lateral faces were perfectly levelled between themselves. In the Areosa Bridge, the one showing greater damage, a slight subsiding of the inside of the vault could be seen, with some individually displaced stones.

The gradual subsiding of the inside of the vault was a consequence of the detachment of the frames, in its place caused by the dragging of fine coating material from the interior of the strongbox outwards.

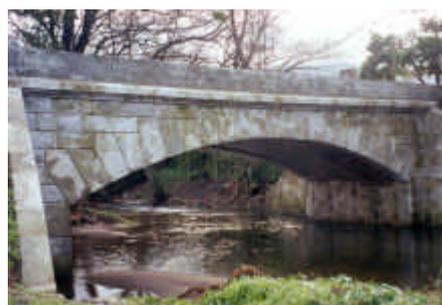
Figure 2: Afife Bridge

At the Afife Bridge, the rehabilitation process was practically identical to that carried out with the Areosa Bridge, though without the application of beams and pegs, as it did not show problems of the same degree of seriousness. Thus, the improvement consisted basely in bettering its structural behaviour by filling up and closing the existing cracks with cement solution.
