Actions implanted to promote the restoration of emperor D. Pedro II's Palace in the city of Itapura - S.P. - Brazil

3 RESTORATION AND REFORM OF "THE EMPEROR'S PALACE"

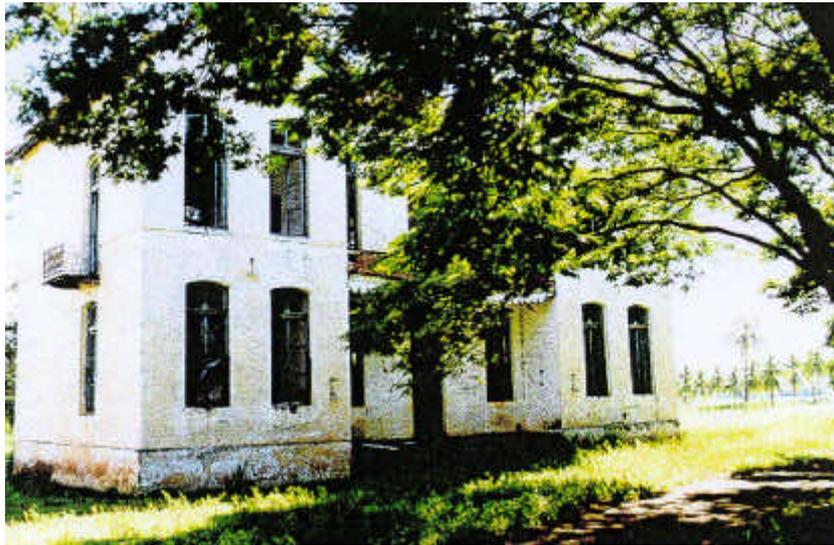
Figure 1: Front Facade.

Nowadays the building is completely abandoned and, consequently, victim of repetitive acts of vandalism even though supposedly protected by CONDEPHAAT.

The Emperor's Palace is a two-store building formed by a central block and two smaller lateral blocks, in solid earthenware bricks with structural function.
