## Study, diagnosis and rehabilitation of the wooden slabs of two palace houses in Seville

C. Rodríguez Liñan, P. Rubio de Hita, J.C. Gómez de Cózar

*University of Seville, Technical School of Architecture, Department of Architectonic Constructions, Seville, Spain*

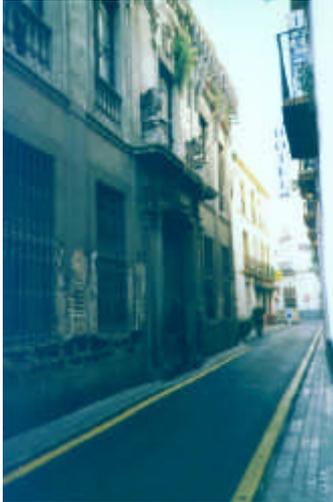
Figure 1: House of Águilas

The house of Las Águilas (Fig.1) located in the old quarter of the city of Seville in the parish of San Esteban, is nowadays a building that has undergone many alterations and transformations throughout its history though it preserves most of the wooden slabs of its original structure. Its ground plan (Fig.2) adapts to the neighbouring party walls by arranging all the rooms around two main patios. It has two floors for noblemen and the third one for servants at the flat roof level.

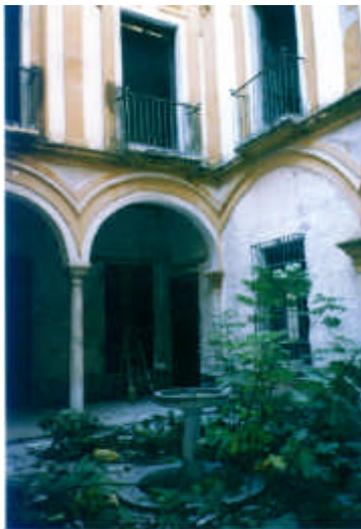
Figure 3: House of Viejos St.

The House of Viejos Street (Fig.3) is an old palace of the 17<sup>th</sup> century also located in the old quarter of the city of Seville. This three storeys building arranged around a main patio preserves almost entirely the wooden rafters of its slabs and covers. The turret, which crowns the building with an angle, was completely ruined as well as some of the covers formed by rafters and collar

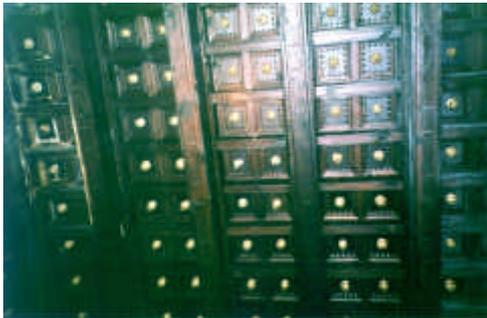
Figure 5: Coffered ceiling pineapple (Águilas)

Formed by three orders of superimposed beams that lead to a set of two soffits between the main beams. These are squares surrounded by a moulding and with an ornamental golden pineapple in the centre. (Fig.5).

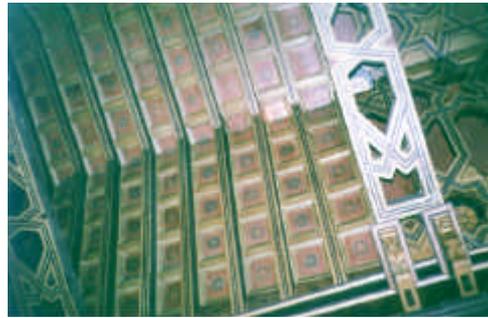
Figure 6: Cover of rafters and collar joints

In the house of Viejos street there are several spaces in the second floor assigned to storage and servants covered with wooden structures of rafters and collar joints with *almizate* (plane formed by the collar beams), with bracing every three metres by means of tie beams. The rafters, tie beams and strips are decorated with its surface carved like the rest of the beams of the building.
