The Reconstruction of the Timber Roof of the “Pieve” in Cavalese

M. Piazza and M. Riggio

University of Trento, Department of Mechanical and Structural Engineering, Trento, Italy

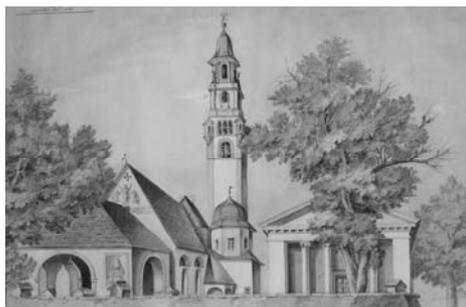
Figure 1 : The “Pieve” in Cavalese

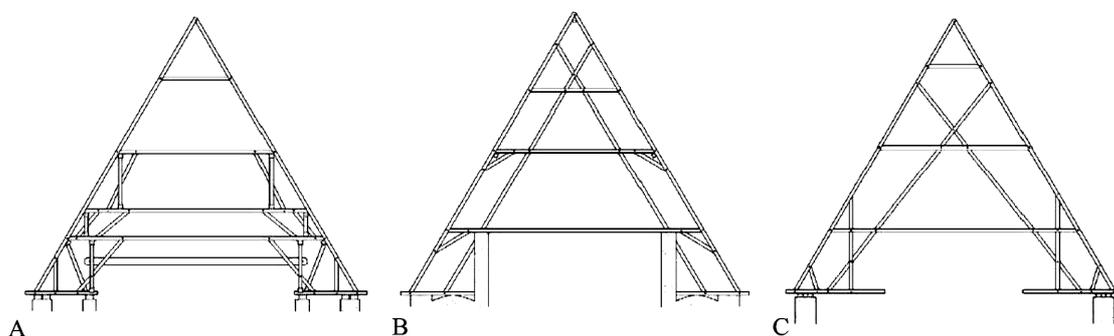
Figure 4 : Truss typologies for different churches in the neighbouring areas:
(a) "Nostra Signora" in Egna; (b) "Santi Martiri" in Sanzeno; (c) "San Giovanni" in Vigo di Fassa.

In Sanzeno and in Vigo di Fassa, scissors braced trusses are used to cover the vaulted nave, while in Egna the rafters are braced only by collar beams. All the trusses are closely spaced (about 90-100 cm). The spatial bracing system is provided either by boarding or by wind braces in the plane of the roof.
