Analysis, Intervention and Repair of Timber Structures

C. Rodríguez Liñán, P. Rubio de Hita, J.C. Gómez de Cózar and F. Pérez Gálvez
*University of Seville, Technical School of Architecture, Department of Architectonic Constructions,
Seville, Spai*

The aim of this paper is to get the state of damage and the bending strength capacity of the timber roof of the Monastery of Santa Clara's dining room in Carmona (Seville) by using this technology.

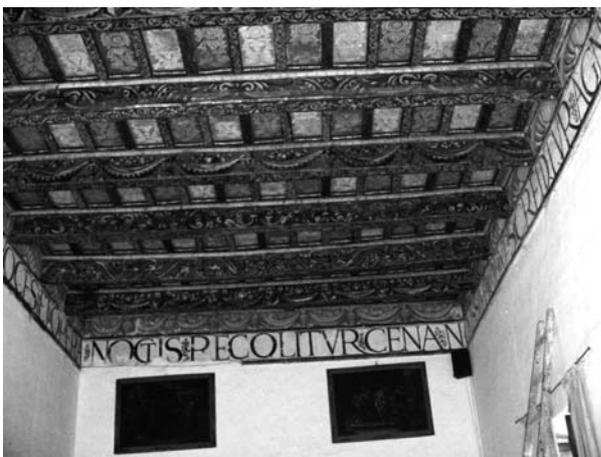
Figure 2 : General view of dining room's timber roof

From the results obtained about the bending strength capacity of the studied beams, it can be affirmed that the timber roof is not able to support safely enough the new use proposed.

Apart from the historical worth of this room and its coffered ceiling, there is an added artistic value because of its polychromy (Fig. 2).

Considering the historic and artistic importance of this timber roof, we propose as a restoration methodology based on hanging the roof through bolts from a reinforced concrete platform built-in the perimeter walls. This solution guarantees that the timber roof does not work, just adjusting the distance between the bolts.

One of the most widespread repairs is using flagstones supported in its perimeter (stonework wall) and fixed to the timber roof. This solution must not be mistaken with a mixed roof concrete-wood. Usually it is not possible to put the concrete flagstone on the existing roof because on the roof there are secondary elements (*rastreles*, *tocaduras*, bricks, etc.) that make a gap between beams and the flagstone. (Fig. 2)

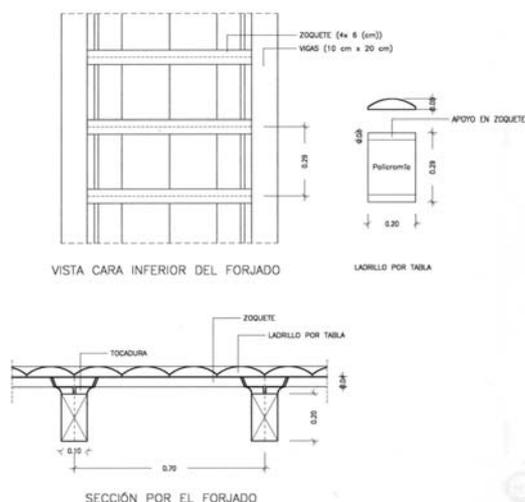
Figure 3 : Dining room's section

The dining room is located at the ground floor of the building and the entry is made through the monastery's cloister. Over it first floor has tile roof as it is shown in the constructive section. (Fig.3). Timber roof has 27 beams with section of $10 \text{ cm} \times 20 \text{ cm}$, $4,40 \text{ m}$ length and 70 cm of distance between axes. They support *zoquetes* of $6 \text{ cm} \times 4 \text{ cm}$. Over them, there are bricks of $20 \times 30 \times 4 \text{ cm}$ which are decorated in the underside (Fig. 4).

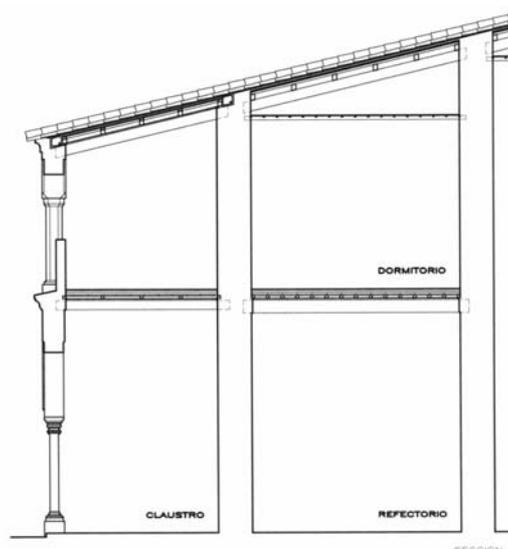
Figure 4 : Timber roof's constructive section.

Roof weight (just only beam + *zoquetes* + bricks, without filling and pavement) is $1,0 \text{ KN/ml}$ over each beam or $1,428 \text{ KN/m}^2$ as superficial load uniformly distributed on the roof.

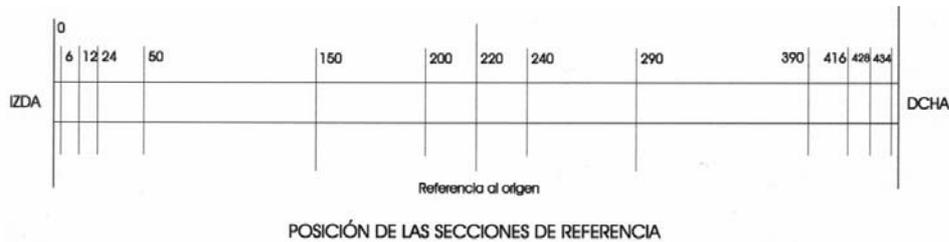
Figure 9 : Studied sections

Selection criterion has been obtaining data from some beams apparently in better conditions and data from those which are apparently more damaged. Two areas have been tested, the most damaged (the one propped up) to which beams number 2, 6 and 8 belong to and the least apparently damaged area to which beams number 20 and 25 belong to.

From each beam 13 sections have been tested. Four of them were next to edges and five in the centre area. Reference sections' position is shown in Fig. 9.
