Dynamic Identification of Detachment Conditions on Prehispanic Mural Paintings in Central Mexico

Juan Carlos Araiza Garaygordóbil, Hermann Rocha Escalante, Agustín Orduña Bustamante
University of Colima, Civil Engineering School México.

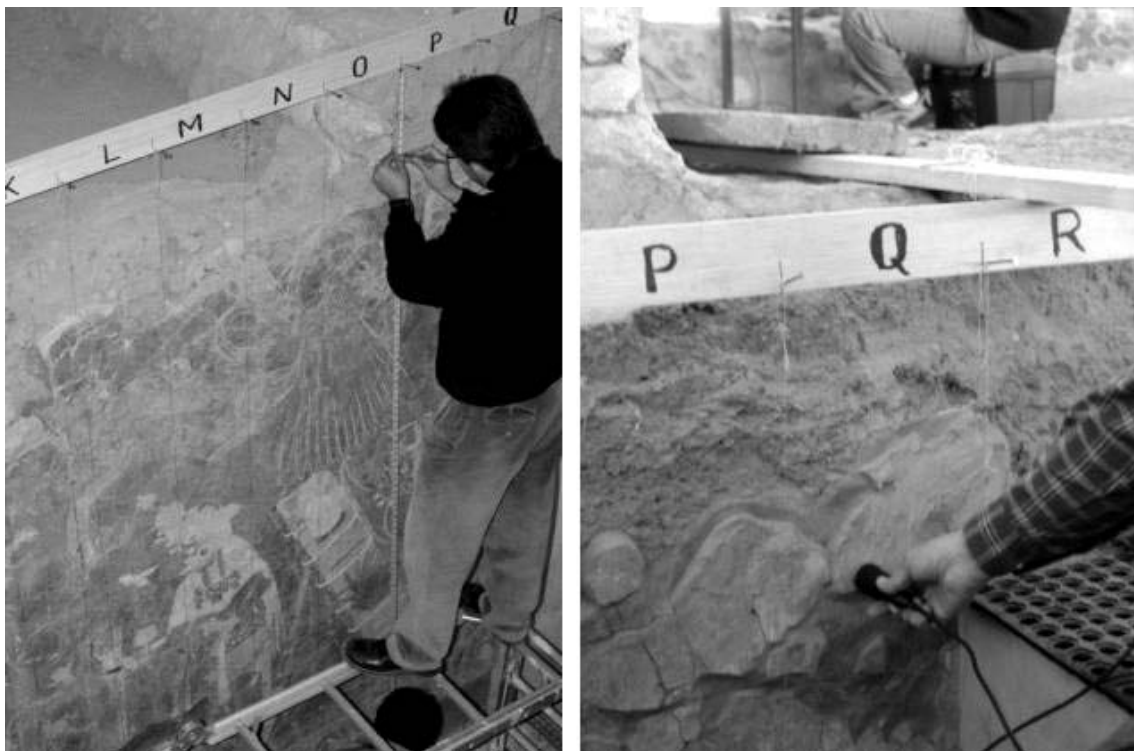
As described above, a series of dynamic tests were developed on every 20x20 cm. segment of the murals. A ceramic accelerometer was manually attached to the wall (Fig. 3) and a slight impact was applied next to the accelerometer with a rubber hammer. A sampling ratio of 10,000 points per second was used. The time response was recorded for three seconds. Four or five impacts were recorded in this time (Fig. 4). Afterwards, a Fast Fourier Transformed (FFT) was used to identify natural frequencies associates to the studied segment of the mural. The FFT was applied only to a section of the time signal, where the vibration was clearly associated to the impact. The test was performed several times until a clear frequency was identified after several repetitions.

Figure 3 : Dynamic characterization process.

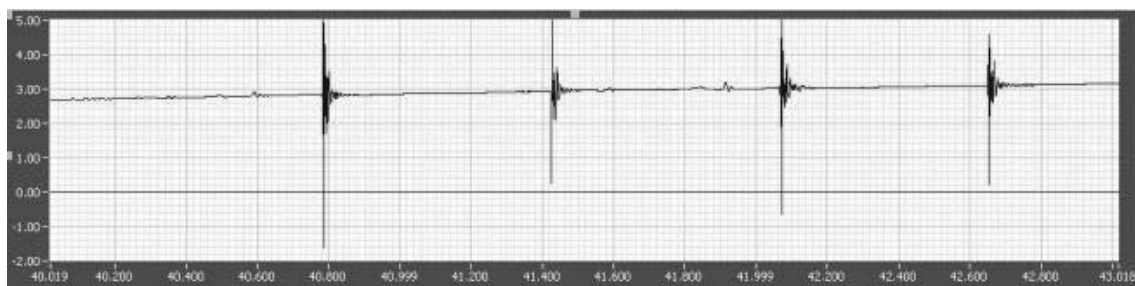
Figure 4 : Typical time domain response of a segment under four impacts.

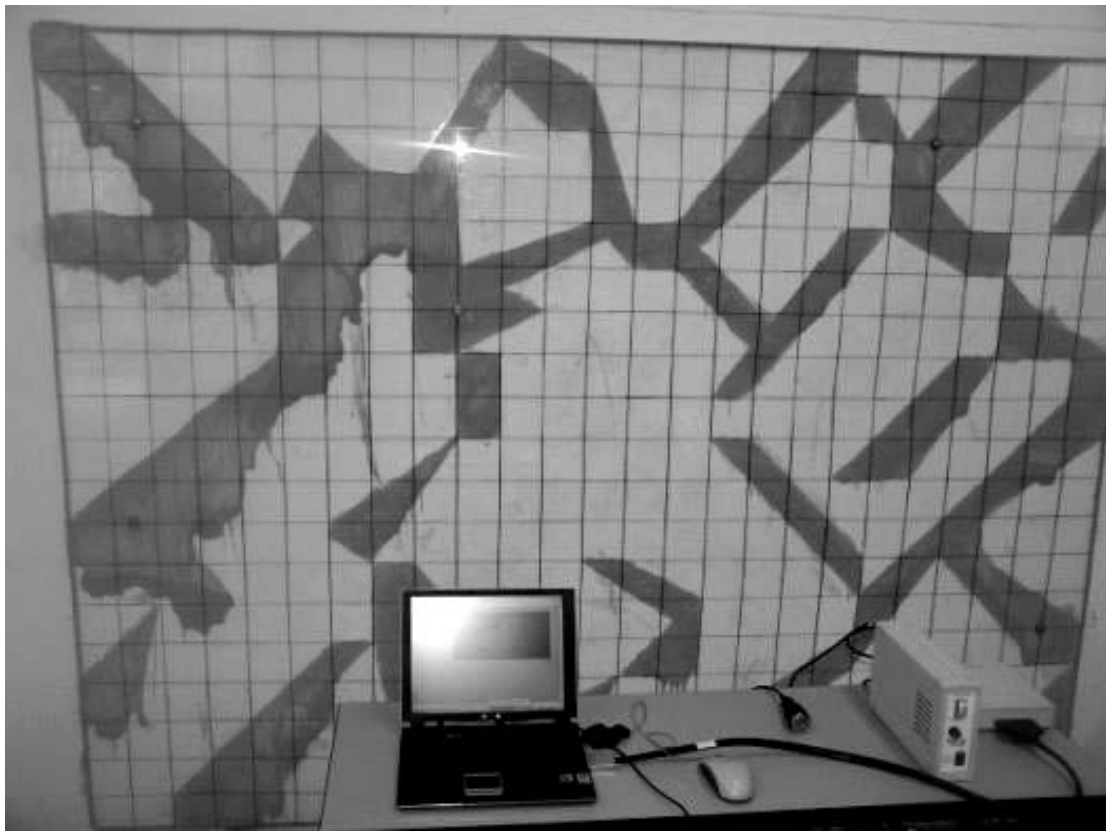
In order to validate the test data obtained in the mural, an artificial mural with induced detachments was constructed and tested. The mural was made of a 9 mm thick acrylic layer, attached partially to a concrete wall with glue (Fig. 9). The detached parts of the mural were separated 3mm of the concrete wall. The mural was divided into columns and rows and every 10x10 cm segment was dynamically tested. A ceramic accelerometer was again manually attached to the wall (Fig. 10) and a slight impact was applied next to the accelerometer with a rubber hammer. A sampling ratio of 10,000 points per second was used. The time response was recorded for three seconds. Four or five impacts were recorded in this time. Afterwards, a Fast Fourier Transformed (FFT) was used to identify natural frequencies associates to the studied segment of the mural. The FFT was applied using the same criteria of fieldworks.

Figure 9 : Laboratory validation of the technique.

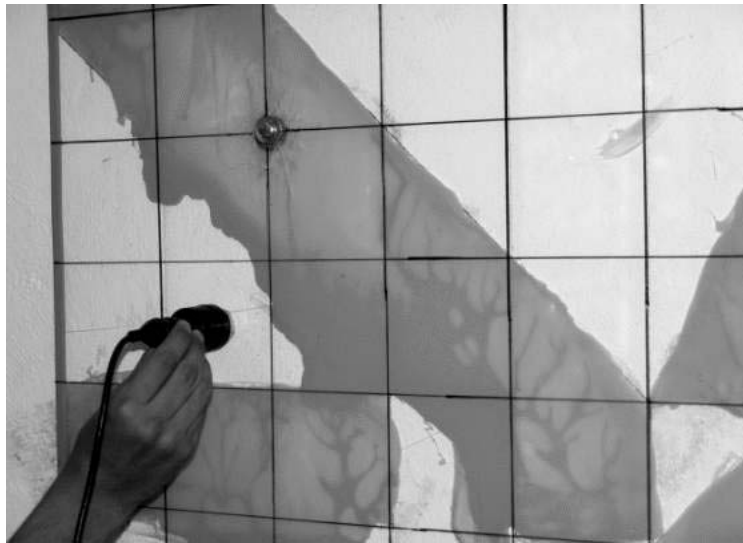
Figure 10 : Detail of dynamic testing of the laboratory specimen.

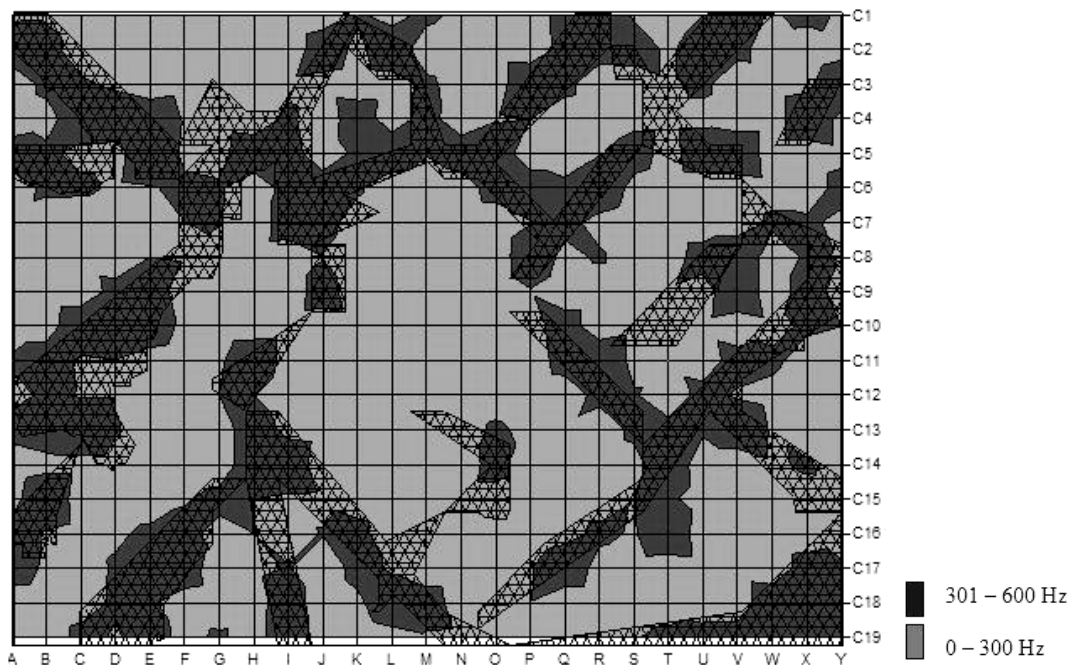
A contour diagram of iso-frequencies was again created to identify the trends and to create a hypotheses of the location of detachments. It was expected that for a low frequency certain level of detachment could be expected. Once again, a clear trend was observed, for segments that showed either high or low frequencies. A group of segment showed a first natural frequency between 180-250 Hz and were considered detached. Anther group of segments presented a first natural frequency greater than 300 Hz, and was considered as attached. In Fig. 11, the lighter colour represents lower frequencies and detached conditions. Darker colour shows a higher frequency and a better attachment level.

Figure 11 : Iso-frequencies contour (solid colours) and actual connection scheme (triangular hatch).
