## Reinforcement and In Situ Testing of the Upper-Choir of Pópulo Church in Braga, Portugal

**ABSTRACT:** This paper presents the structural intervention on the upper-choir of the Pópulo Church in Braga carried out by DREMN – Regional Directorate for Northern Buildings and Monuments of Portugal, under the technical consultancy of NCREP – Nucleus for the Conservation and Rehabilitation of Buildings and Built Heritage of the Faculty of Engineering of Porto University (FEUP). Besides describing the intervention, it also shows that renovation works to be carried out in old structures, although previously planned and projected according to the available data, may suffer relevant modifications during the preparation and implementation process, which must be regarded as part of the intervention process. In particular, this work involved the in situ testing of the upper-choir structure to evaluate its vertical loading capacity.

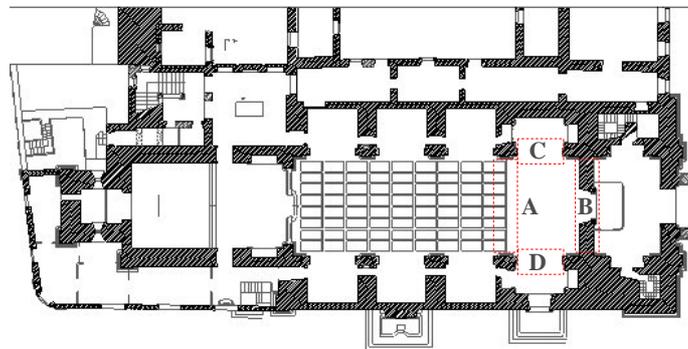
Figure 4 : Church plan with the location of arches A, B, C and D.

The two arches are 5.60m away from each other. The vault is made of regular stone masonry frames, with approx.  $(1.70 \times 1.70) \text{m}^2$  filled in with redbrick masonry. The vault follows the line

of the arches. On the sides, the vault lies upon regular stone masonry arches, with free span of approx. 4.60m, and referred to as arches C and D in Fig. 4.

In terms of damage, arch A exhibit vertical deformations with openings of joints at the key-stone. The upper-choir vault exhibits also vertical deformations, surface warping with double inverted curvature, with openings of joints reaching almost 10mm width. The arches B, C and D did not exhibit any deformation. Conclusions from the inspection and diagnosis that were carried out concerning arches C and D can be found elsewhere (Costa, 2000).
