Safety Assessment and Strengthening of Existing Steel Frames Containing Semi-Rigid Joints

ABSTRACT: Bund 18 is a historical building at the Bund of Shanghai. The structural system of the building consists of cast in-situ RC slabs, steel beams and columns, which is commonly used in other historical buildings in Shanghai. Through inspection and calculation for Bund 18, the safety state of the building is assessed. Based on the results of safety inspection and assessment, the strengthening and rehabilitation plan is proposed. By renovating some semi-rigid beam-column joints into rigid ones, adding some steel brace struts between the neighbouring columns and strengthening the masonry walls with single or double steel mesh reinforcement and cement mortar, the structural safety are substantially improved. The above strengthening plan is also applicable to other historical buildings which have the similar structural system.

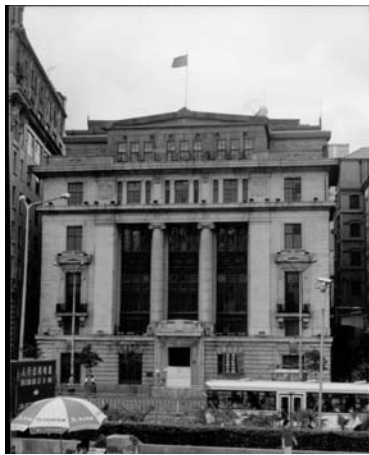
Figure 1 : Building of Bund 18

Beams and columns of the structure are surrounded with concrete and bricks respectively. The raft foundation of the building consists of RC slabs and wood piles which are all 7.62m long. Although used more than 80 years, the building still works well.

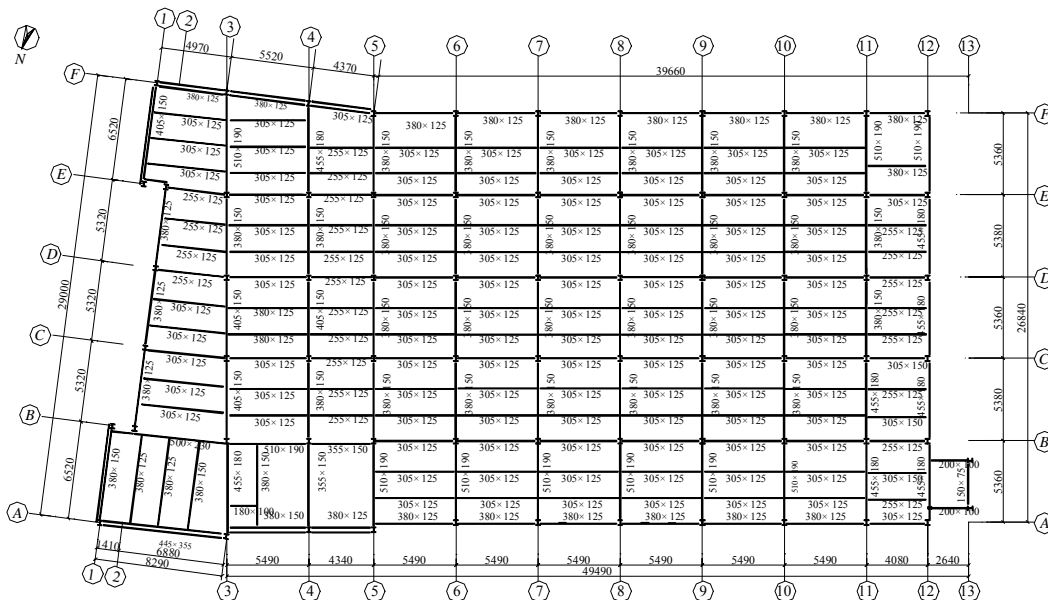
Figure 3 : Structural plane of the standard storey of the building

The drawings of the building are preserved well in Shanghai Urban Construction Archives, but information about the steel columns and beam-column joints are insufficient. It is necessary to survey all of the building drawings. The surveyed drawings for the east elevation, the structural plane of the building, beam-column joints, steel beams and the typical column are shown in Fig. 2 to Fig. 5 respectively. From the drawings, it can be seen that cast in-situ RC slabs, steel columns and beams form the structural system of the building.

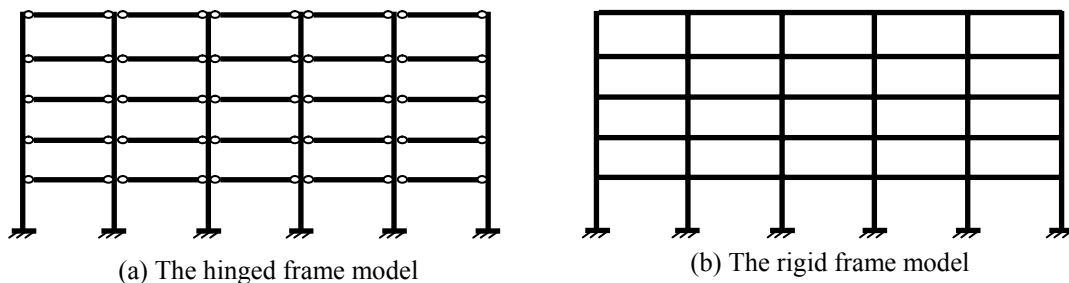
Figure 8 : Analysis models of the structure

Under the guideline of the Chinese code, the seismic performance of the building is also calculated in two extreme situations (Fig. 8). It is assumed that steel columns would not buckle due to the well surrounded bricks. Evidently, the internal forces of the steel columns calculated by the hinged frame model (Fig. 8a) are bigger than those calculated by the rigid frame model (Fig. 8a). The internal forces of the steel columns at the base floor by the rigid frame model are shown in Table 4.

From the table, it can be seen that the stress of the columns are all bigger than the strength of the steel (215MPa), which can not meet the needs of the bearing capacities.

The drifts of the building are also calculated as Table 5 shown. The calculation takes into account the contribution of surrounded bricks, while the drifts in the parenthesis are calculated by not considering the contribution. According to Chinese code, the limit value of elastic angular drift between adjacent floors is 1/550. From the table, taken as the hinged frame model, the drifts are much bigger than the limit value. However, taken as the rigid frame model, without the contribution of surrounded bricks considered, the drifts are also bigger than the limit value, while with the contribution of surrounded bricks considered, the drifts are smaller than the limit value.

The real situation of the structure can be taken as a semi-rigid frame between the hinged and the rigid one, as indicated above. By comparison of the calculation results in the Table 5, it can be inferred that the lateral rigidity can be improved efficiently by renovating the existing column-beam joints into rigid ones. In addition, it is feasible to reduce the drifts under action of the earthquake by making full use of the contribution of the surrounded bricks for the columns.
