Retrofitting and Reinforcement of a Wire Suspended Bridge in Portugal

ABSTRACT: This paper presents a study made on a particular structure, a pedestrian wire bridge. It describes the work performed by the Nucleus for the Conservation and Rehabilitation of Buildings and Built Heritage (NCREP) of the Faculty of Engineering of University of Porto (FEUP) to respond to the interest of the Association of Municipals of Baixo Tâmega in retrofitting that peculiar bridge located at the North of Portugal. After a brief introduction and illustrating some examples of these type of structures built in Portugal, the paper describes the intervention methodology, which involved *in-situ* inspections and a large experimental campaign for the material and structural characterisation of the bridge. These studies were carried out with the contribution of mechanical and metallurgical specialists and allowed fitting the mechanical properties that were used in the numerical model for the simulation of the bridge

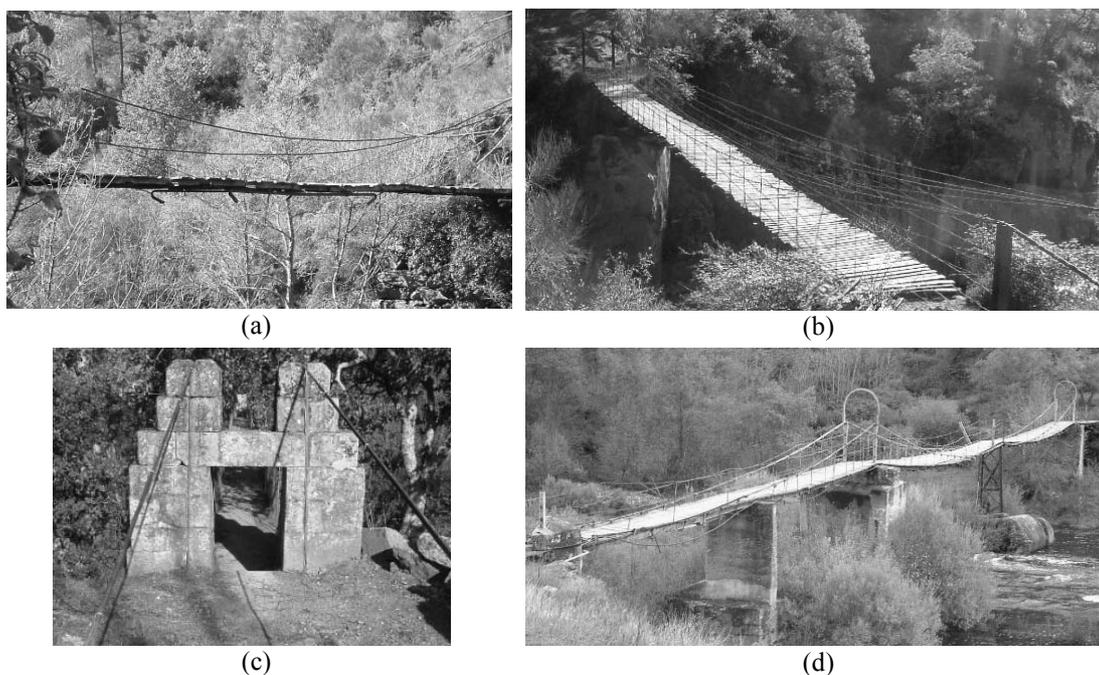
Figure 3 : (a) Gardunho bridge; (b) Veral bridge; (c) Santo Aleixo bridge; (d) Cabos bridge.

All these structures have a wooden deck. The longest one is the Cabos bridge (about 70m long) and the shortest one is the Gardunho bridge, 22m long. The width of these bridges is approximately the same, about 1,5m, exception made for the Gardunho bridge which is 2,5m wide.
