An Outline of the Seismic Behavior of Historical Structures in North Western Anatolia

A. Ilki, M. Ispir, C. Demir, N. Kumbasar and S. Akman
Istanbul Technical Univ., Civil Eng. Faculty, Istanbul, Turkey

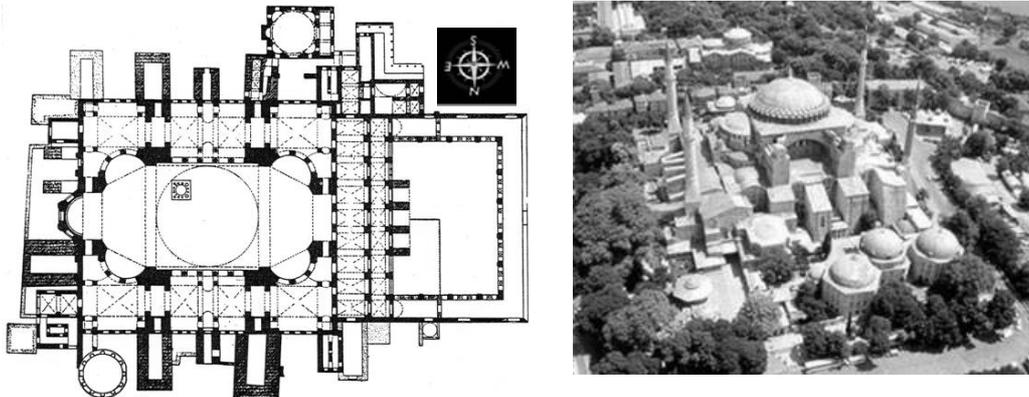
Figure 3 : Plan and aerial view of Hagia Sophia (Eyice 1994a) (aerial photo by Oguz Celik) .

The monument has undergone failures, reconstructions, enlargements, restorations, and transformations over years. According to Eyice (1994a) and Kleinbauer et al. (2004) several parts of the church and the main dome were ruined by devastating earthquakes. Required repairing was carried out after each of these earthquakes. Besides these reconstructions, massive exterior buttresses were built to support the north and east sides of the building in 1317. The four flying buttresses leaning against the upper narthex wall might have been constructed either after 869 or 989 (Kleinbauer et al. 2004). During the Ottoman period four minarets were added at the corners of the building.

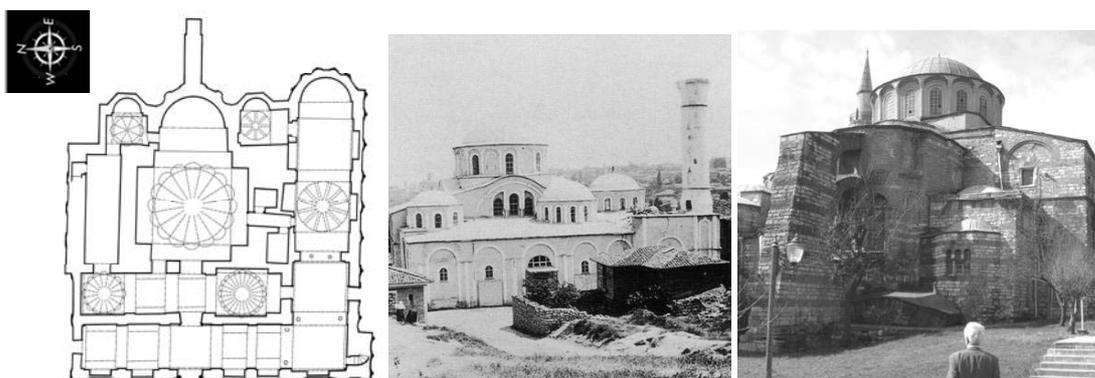
Figure 5 : The plan (Underwood 1966), post 1894 earthquake (Genc and Mazak 2001) and present day views of Chora Museum.

During the past centuries, Chora Museum faced several earthquakes. Unfortunately it is a challenging task to identify the level of damages occurred in those earthquakes. Damages, which could be identified in the literature, induced by the case earthquakes are summarized in Table 2.
