Constructive Analysis of the Arches and Ribs of the Vault on High Altar of “Santa Maria” Church of Tolosa (Basque Country)

Amaia Garay, Isabel Rodriguez-Maribona, Jorge Domingo and José A. Ibáñez
Labein, Building and territorial Development Unit, Derio, Spain

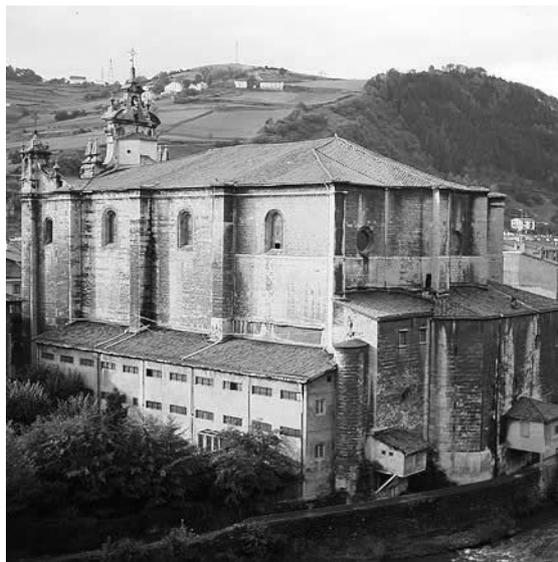
Figure 1 : General view of the church.

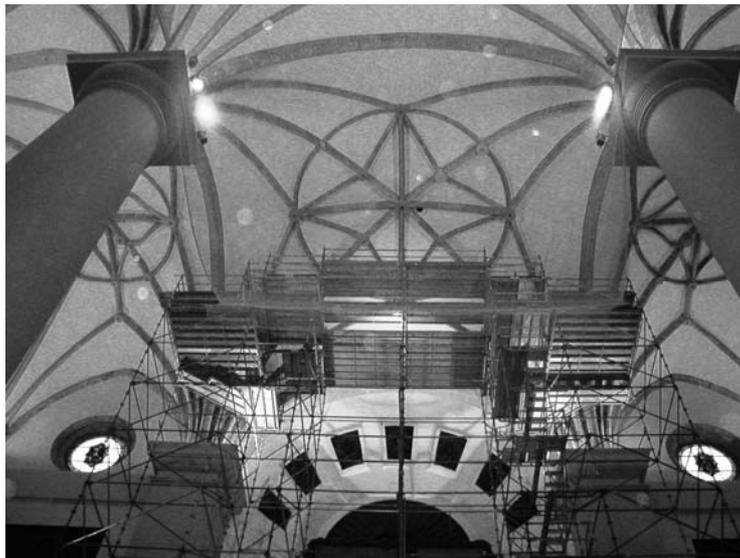
During one week, structural experts of Labein study in situ the problem. One detailed visual inspection was carried out in the affected vault. To see the damages of the vault close up it was necessary to set up a scaffold, see Fig. 4.

Figure 4 : Scaffold used in the study.
