Church of Saint-James at Leuven (B) – Structural Assessment and Consolidation Measures

ABSTRACT: The construction of the church dates back from 1220. During several subsequent building phases, the wooden roofs in the central and side naves were replaced with masonry vaults, and flying buttresses were added. The structure itself is located on a former swamp, resulting in large differential settlements. In the past, restoration works took place. However, due to the excessive cracks observed, it was decided in 1963 to close the church for service, to remove the severely cracked masonry vaults of the side naves and to shore up the pillars of the main nave. Additionally, in 2000, the remaining flying buttresses were removed and replaced by tie-rods. The focus of this paper is on the structural understanding of this historical building, to determine the most appropriate strengthening and consolidation measures, respecting the authenticity of the building and preserving it for the future.

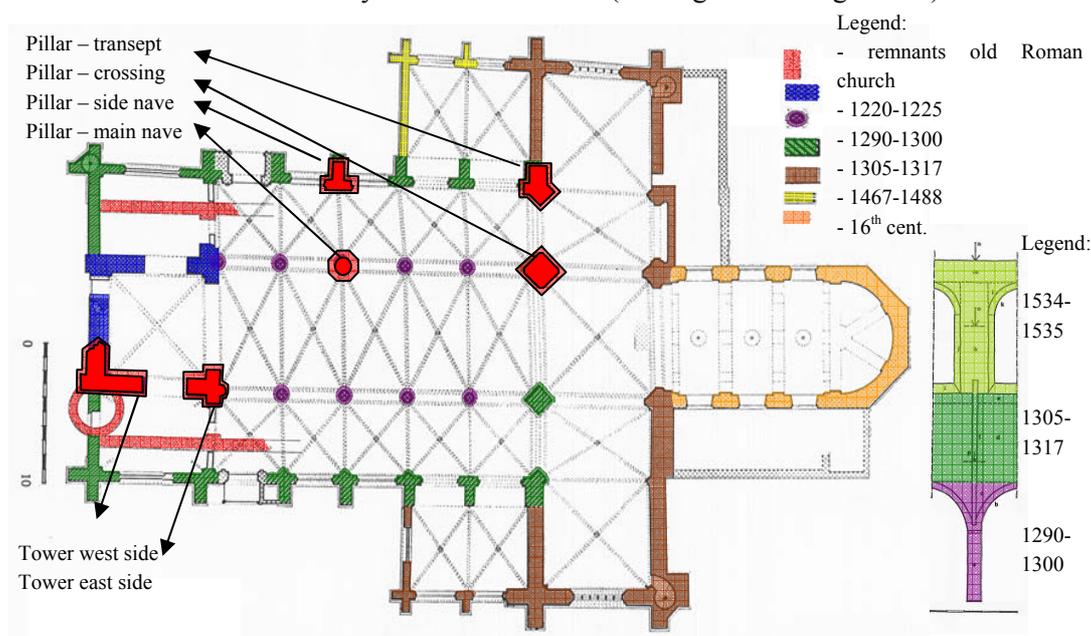
Figure 1 : Historical building phases

The history of this church reveals interesting items related to its structural problems. Therefore, the main building phases are briefly commented, Figure 1 (Van Balen et al., 1995):

- 1220: construction of the western tower of the church. The structure itself is located on a swamp, reclaimed by the monks at the time of construction;
- 1290-1300: construction of main pillars and arcades, intended for a flat wooden ceiling;
- 1305-1317: period of prosperity for the city of Leuven (B). Construction of wall in between arcades on top windows and construction of side naves + masonry vaults;
- 1465-1535: construction of wooden barrel vault above main nave;
- 1465-1488: construction of transept and columns at crossing of main nave and transept;
- 1485-1488: reconstruction of masonry vaults in side naves at both north and south side;
- 1534-1535: Construction of additional level with windows in main nave; construction of supports and abutments of flying buttresses; removal of wooden barrel vault and; construction of masonry vault in main nave (arching: Gobertange stone).

Already during history, structural problems were encountered at regular time intervals:

- 1485-1487: vaults of side naves rebuilt – cracking due to large differential settlements urged for dismantling of original vaults;
- 1806: the pillars are strengthened with steel rings;
- 1963: the church is closed down for service;
- 1965-1971: phase 1 of restoration 1961-1974, see further;
- 2000: dismantling of flying buttresses.
