Partial Collapse of a XII Century Church due to a Wrong Retrofit

Nicola Augenti

University Federico II, Department of Structural Analysis and Design, Napoli, Italy

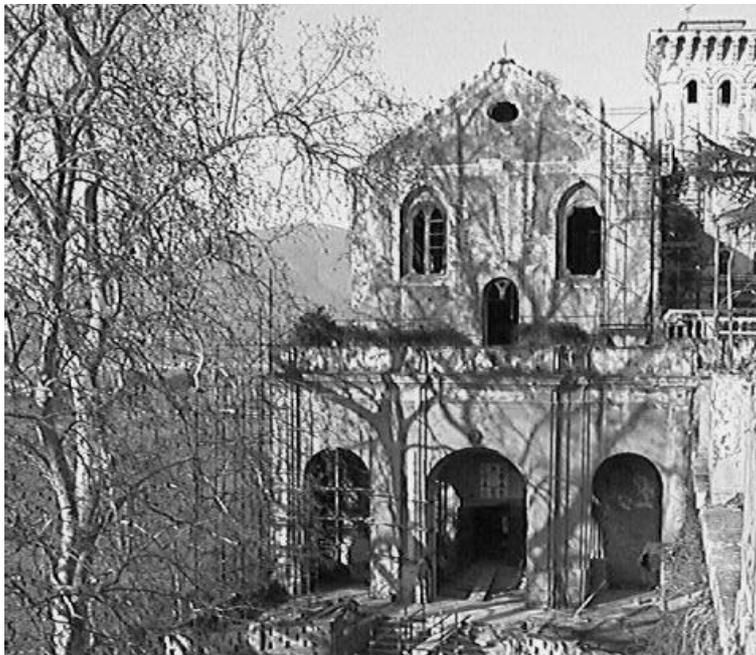
Figure 4 : Church's main façade.

The main façade had a galilee with three big arcades and a magnificent baroque stair in the rococò style, see Fig.4.

Because of the campano-lucano earthquake in 1980, on the 23rd of November, the structure of the Church had some static damages: deep cracks in correspondence of the galilee, the triumphal arch and the apse vaults occurred.
