## Structural Analysis of Historic Temple of Augustus in Ankara, Turkey

A. Turer and T. Eroglu

**ABSTRACT:** The Temple of Augustus, one of the invaluable monuments survived from the Roman age, is located in Central Anatolia in the capital city of Turkey, Ankara. Ruins of the approximately 20 centuries old temple has reached to recent times with structural instability and expedited stone deterioration due to environmental conditions. Some of the inscriptions have been disappeared and the remaining ones are in danger of disappearing. Stability of the North wall of the temple is another major concern. Studies on temporary roof protection, stone conservation, site restoration, and structural monitoring are being studied by a multi-national and interdisciplinary team. This paper discusses structural concerns, nondestructive (ambient monitoring) testing results, and 3-D Finite Element Model (FEM) based analysis aspects of the project. Some retrofitting schemes are also suggested based on the structural problems.

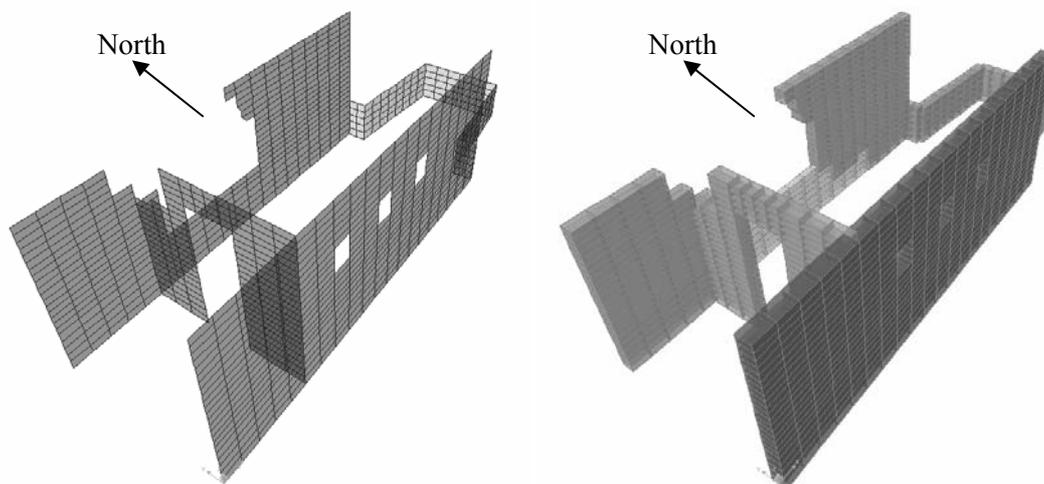
Figure 4 : General view of the FE model of Augustus Temple

The analytical model of the Temple of Augustus was constructed using shell elements and available SAP2000 analysis software of CSI (1995). The generated model successfully represents the simple geometry of the structure and distinguishes the thickness differences between the major parts of the monument. As seen in Fig 3, the North wall is composed of two parts, the lower part having smaller thickness than the upper part.

The structural analysis of the Augustus Temple showed that the main modes of the two walls can be successfully obtained and calibrated against the experimentally obtained periods. Table 2 shows the analytically obtained periods which compare nicely with the experimental periods listed in Table 1. The analytically obtained mode shapes that correspond to the generated vibration periods in Table 2 are shown in Fig. 5. The first four modes of the calibrated analytical model indicate torsional, first bending, and second bending modes of the walls. Two additional bending modes found from the analytical model are also listed in Fig. 5.
