Structural Intervention in a Historical Chapel

ABSTRACT: The chapel of “S. Jorge de Aljubarrota” was erected in 1393, after the victory in the battle of Aljubarrota, one of the most important battles in Portuguese History because it settled the national independence in relation to Castile. The chapel was built exactly where, on the 14th of August of 1385, the standard of general D. Nuno Álvares Pereira was positioned. Since the foundation, the chapel has experienced several interventions and morphological changes, accurately registered from 1872 to the present time. During the most recent inspection, in 2003, it was observed that the vault of the main altar was severely deteriorated. It was decided to perform a research to identify the possible causes of the observed anomalies; to evaluate the structural safety of the construction; and to propose a solution. Taken into account that consolidation of stone blocks is not possible and that the structural safety of the vault is not assured, minimum intervention is not a choice and a reversible action presents major disadvantages. As a result, the total substitution of the vault is the projected intervention.

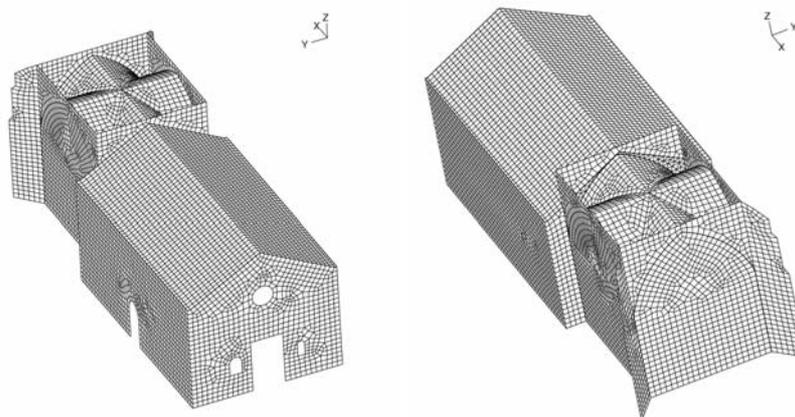
Figure 6 : Finite element model of the chapel.

The structural stability of the chapel was analysed with a commercial finite element software, considering the structure subjected to the static action of its dead weight and also when subjected to a seismic action, determined according to the Portuguese safety code (RSA 1983). Due to the objectives of the analysis and to the uncertainty in relation to important parameters such as soil and walls mechanical characteristics, a non-linear numerical analysis (Lourenço 2002) was not considered justified. Therefore, it was assumed a linear elastic material behaviour in this analysis. The structure was modelled using shell elements for walls; main altar vault; and nave roof; beam elements for columns; visible parts of the nervures of the main altar vault; and linear elements for the steel cables of the nave roof (Fig. 6).

The most conservative scenario was considered, corresponding to total lost of cohesion and strength of the stone blocks of the vault. Therefore, the analysis of the structural stability of the vault was performed only considering the cement based mortar, covering the intrados of the vault with an average width of 30 mm, and the visible part of the stone nervures as structural material. As support conditions of the structural model, it was assumed that all displacements of ground nodes were restricted and all rotations were free.
