The Monumental Bridge of Monte Carmelo (Italy): Strategies for the Historical and Architectonical Preservation

Chiara Calderini, Sergio Lagomarsino and Sonia Resemini

University of Genoa, Department of Structural and Geotechnical Engineering, Italy

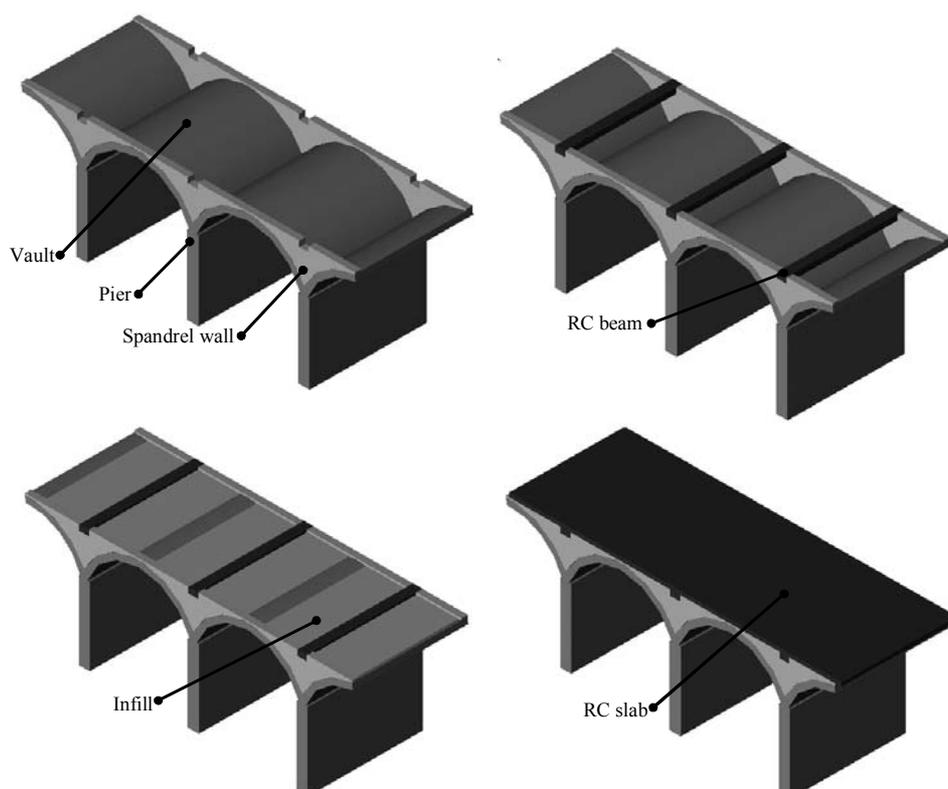
Figure 3 : Scheme of the current structural elements of the bridge.

Besides the above described structural intervention, a reinforced concrete parapet has been introduced, replacing the original masonry one. Fig. 3 synthetically shows the current structural configuration of the bridge.

During the inspection of the bridge, the poor quality of the infill, characterized by a strong decohesion (sand, gravel, loose soil) has been observed. It has not been possible to analyse the nature of the backfill. The estimated average arch thickness is about 0.3 m.
