Altarpieces Constructive Systems and Material Characterization, SC, Brazil

Maria A. Nunes, Ângela do Valle and Sérgio C.B. Nappi
Federal University of Santa Catarina (UFSC), Florianopolis, SC, Brazil

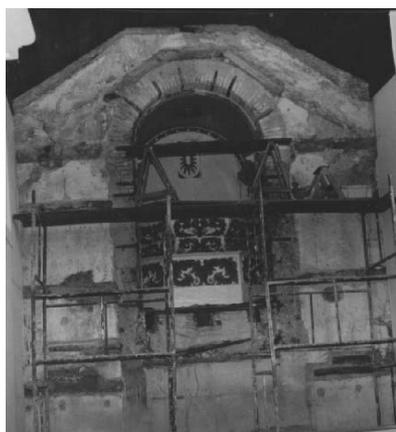
The assemblage of wood pieces that compounds the support structure of altarpiece has the purpose of guarantee the system equilibrium of the constructive elements, in order to avoid structure displacements. According to Aguilar (2003), the anchorage system classification could be divided in: wall dependent system; wall independent system and merged system. In the wall dependent system, the altarpiece structure is supported by mean of embedding wood supports that are projected from the walls, see Fig. 1.

Figure 1 : Nossa Senhora das Conceição altarpiece anchorage system, Florianopolis-SC, Brazil.

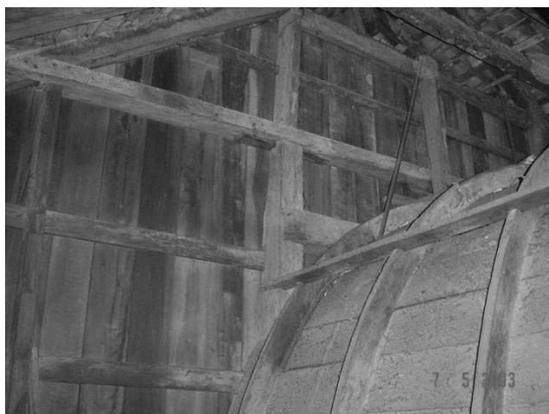
The independent system is composed by struts supported by the floor and by beams usually placed at entablature position of each element of the altarpieces, without connection with walls and, the merged or semi wall system presents the struts carried by the floor in order to sustain the altarpiece structure, while the beams are supported by the walls in the height of the entablatures and inserted to the struts, see Fig. 2.

Figure 2 : High-altarpiece back of São Francisco da Penitência Church, Florianópolis-SC, Brazil.
