## Structural assessment of earthen walls and techniques for onsite consolidation and conservation

Sandeep Sikka

*Superstructures (Architects + Engineers), New York, USA*

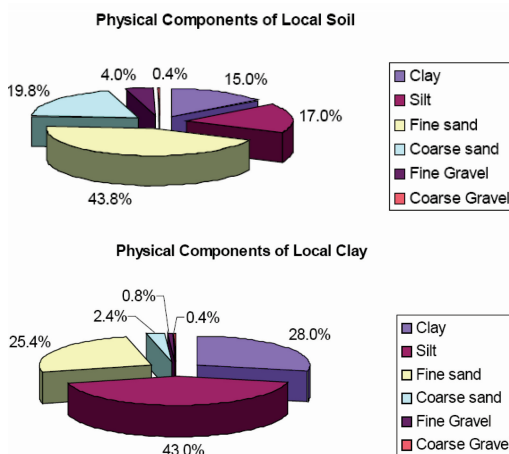
An apparatus designed specifically for measuring the strength of the adobe in the field was used for determining the 3-point flexural strength (See figure 4). The 3-point loading was applied using series of compressed earth blocks each weighing 7Kg. The particle size analysis (see figure 7) of the local soil and clay indicated that the percentage of sand content in the soil was far more than the required quantity. Therefore to increase the strength it is essential to increase the quantity of the binder in appropriate proportion. The mix thus prepared with various binders like cement, lime and locally available clay for extra strength were then put to test. Four kinds of adobe samples were then prepared with relatively dry mixes, wet compacted inside the moulds and were left to dry for four weeks.

Figure 7. Particle size analysis of local soil and local clay.
