The restoration of the foundation in the north side of the temple of Apollo Epikourios

K. Papadopoulos

Technical Team for the Restoration of the Temple of Apollo Epikourios, Bassai, Greece

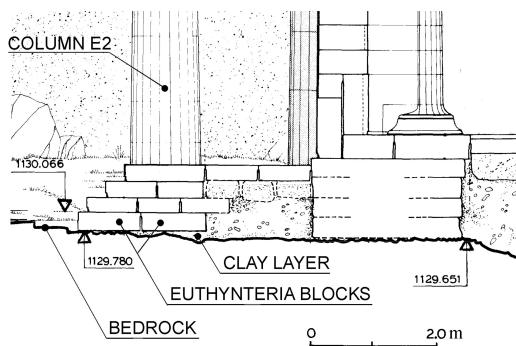
Figure 2. The foundation in the east side of the temple (cross section very close to the north side, Svolopoulos 1995).

The temple foundation consists of two rectangular systems: the external, under the colonnade in the perimeter of the building, and the internal, under the walls of the cella (Fig. 2). Along most part of the north side of the temple (as along the east side) the bedrock is very close to the superstructure. Hence, the foundation in that area of the monument is formed solely by one layer of stone-blocks, the euthynteria. Between the euthynteria and the bedrock the ancient builders had placed a layer consisting of clay fill mixed with stone flakes, of varying thickness (from zero to few tens of centimeters). This layer seems to serve as a convenient way to give each euthynteria block a firm and continuous contact with the rough bedrock surface below (Fig. 2).

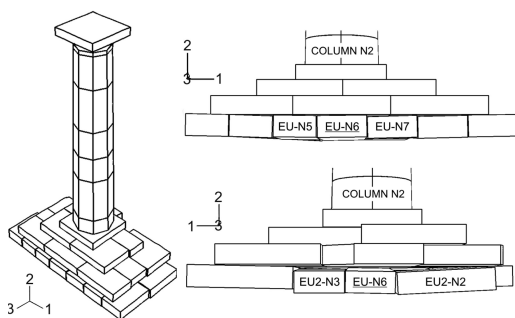
Figure 9. Left: The numerical model. Right: North (up) and south (down) views of the model lowermost part.

(ii) The stones based on thick clay have settled significantly, inclined in every case toward the side where the below clay layer was thicker. This was very clear in the euthynteria blocks placed above the bedrock cavity (Figs 7, 9 right). (iii) The blocks based partly on bedrock and partly on clay were fractured across the base condition differentiation line, with their fragments based on clay suffering the larger settlements. The latter was quite obvious in the reused block placed beside the group of subfoundation stones (Fig. 7), and in the north stones of the subeuthynteria course (Fig. 8).

On the contrary, the euthynteria blocks were simulated inclined and displaced (Fig. 9 right), so as to represent the documented in-situ settled positions of the corresponding temple blocks. The aim was to include in the analysis the deformations of the temple foundation, for finding out what damages will appear in the superstructure, as a consequence of the deformed foundation. In order to succeed that, the euthynteria blocks were fully constrained, while the rest of the model was free to deform nonlinearly in any direction under its own weight.

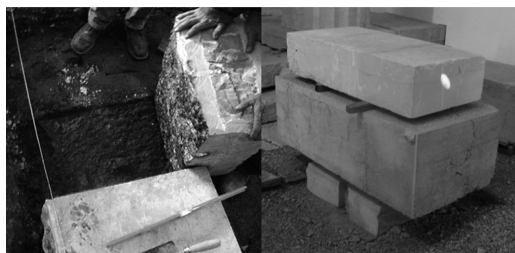
The diminutive layer settlement, in combination with observations made during the preparation of the stabilized material and the laying of the stones (such as they were no voids between the stones and the layer, Fig. 12 left), led to the overall conclusion that stabilized clay exhibited satisfactory behaviour in its test implementation and it can be used in the restoration work of the temple.

Figure 12. Left: The two stones placed on the stabilized clay layer. Right: Loads upon the stabilized layer.

The stones were in shape and in size similar to the temple euthynteria blocks (Fig. 12 left). On top of the stones, large blocks were placed (Fig. 12 right) for further loading of the stabilized layer. The loading was applied for over a year, gradually increasing, achieving at its peak, 90 kPa compressive stress at the layer (value larger than the loading which the stabilized layer will bear in the restored state of the monument); during that time, periodic altitudes measurements were taken, which showed that the stabilized layer settled, about, 1 mm.
