Experimental assessment of historic building safety: The case of the Isso Tower in Castelleone, Italy

L. Binda, P. Condoleo, A. Saisi, C. Tiraboschi & L. Zanzi

DIS-Department of Structural Engineering, Politecnico of Milan, Milan, Italy

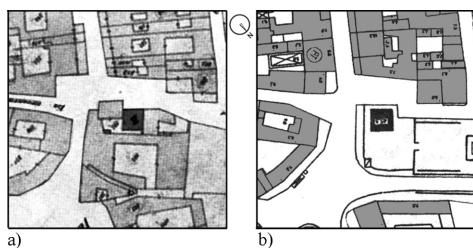
Figure 2. Layout of the Isso Tower area in a map of Castellone of the 1901 and recent.

The Isso Tower, dating back to 11th-12th century, was used during 20th century as the container of the water tank for the city aqueduct. The tank was built in r.c. at about 20.5 m only supported by 3 walls of the Tower. Furthermore, until 1919 several buildings were adjacent to the base of the Tower (Fig. 2).
