## Relation between sub-soil and masonry structure of Angkor monument

S. Yamada, M. Araya & T. Nagai

**ABSTRACT:** This paper is composed of two parts. One is a survey at Bayon, Angkor Thom. The other is an application of a discontinuum structural analysis to dry masonry. Preceding a structural analysis of Bayon, we apply the discontinuum structural analysis to Prasat Suor Prat and verify the structural stability of the monument in order to verify the influence of the masonry construction as well as the character of sub-soil layer in wet condition. We purpose to evaluate a risk level of the structure and suggest the policy and procedure for the restoration of Bayon, using the information obtained through JSA restoration.

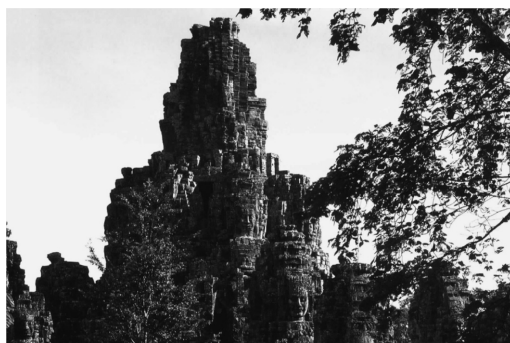
Figure 1. Bayon outside view © JSA.

We surveyed the severe level of the damage to Bayon. By observing the state of the towers, many stones have cracks, lacks, gaps and outwards. Bayon is constructed of dry masonry, the drop of one critical stone will cause the collapse of upper structure. And the critical damaged area which should be reinforced urgently was founded at Tower 14 and 15, shown in Figure 2. Now, we are planning the urgent reinforcement at Tower 14 and 15.

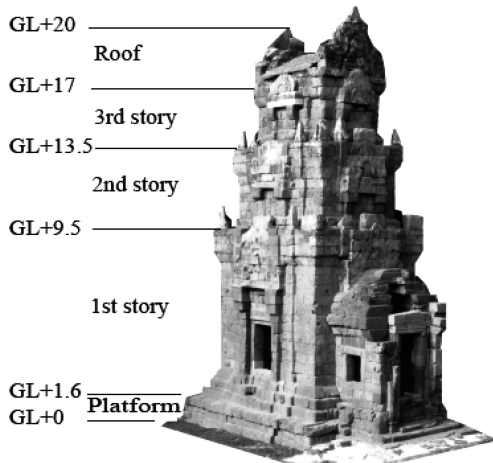
Figure 3. Prasat Suor Prat Tower N1 (after restoration)  
© JSA.

JSA selected Tower N1 as the most dangerous tower. Then, JSA began the repair and dismantling of Prasat Suor Prat Tower N1 from 2002 and have finished the restoration in 2005. The restoration work was conducted by complete dismantling the structural elements, restoring the damaged elements, platform and foundation, and reassembling them to be the original appearance of the tower.

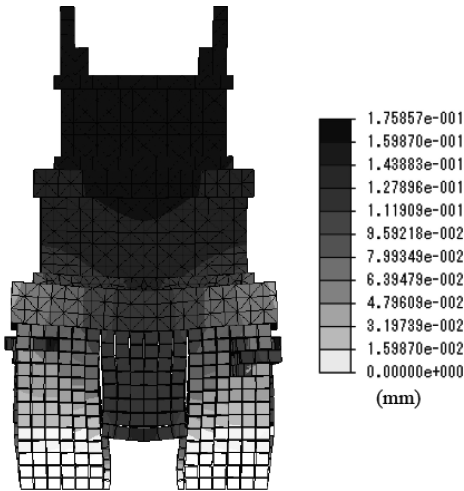
Figure 9. Deformation image.

The result is as follows. (1) Different behavior between a part over the window and adjoining wall is observed. (2) Tendency of outward-swinging is observed. (3) Concentration of stress at the jumb is observed.

The above result generally agrees with the observed state of Prasat Suor Prat, shown in Figure 5.

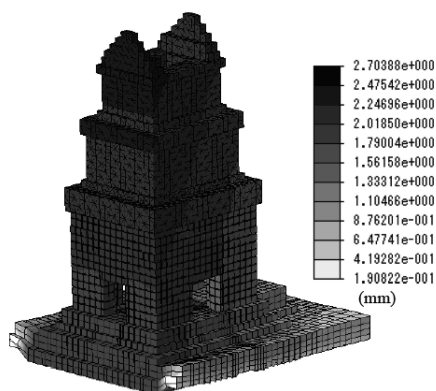
Figure 14. Deformation image including platform.

The result is as follows. (1) On the inclination of the upper structure, there is no so difference between the discontinuum model and continuum model. (2) The parts of corners, walls and stones over the window behave independently while mutually affecting the others.
