Maria Birnbaum – Construction history, conservation history

R. Barthel, H. Maus & C. Kayser

Barthel & Maus – Beratende Ingenieure, Munich, Germany

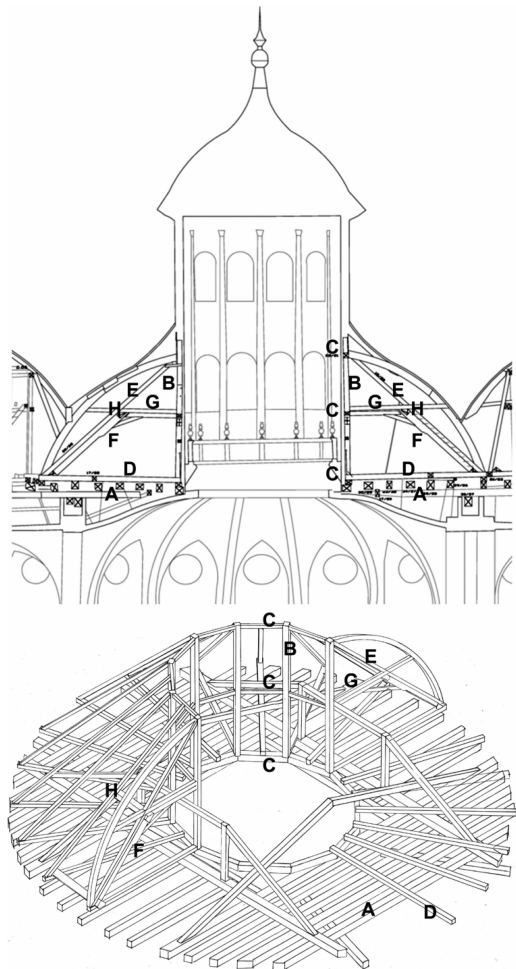
Figure 3. Top: longitudinal section through roof structure and tower, bottom: isometric view of the main roof. A: ground beams, B: tower posts, C: wooden rings, D: tie beams, E: rafters, F: truss post, G: collar beam, H: intermediate purlin.

A restoration of the interior was planned after some minor damage on plaster and stucco. In preparation to the works, the roof structure was assessed by the authors. Basis of the analysis was a detailed, true-to-deformation survey. With these large-scaled plans, every single knot of the roof structure was assessed. The extent of the damage is grave: about half (48%) of the ground beams' (A) head parts are badly decayed.

One third (32%) of the tie beams' (D) heads and about 60% of the joints of rafters (F) and upper pressure ring (C) are damaged by mould, humidity or pests. Additionally, a large number of joints of the roof trusses is deformed.
