Strengthening of a wooden covering built in the 18th century

N. Augenti

Department of Structural Engineering, University of Naples Federico II, Naples, Italy

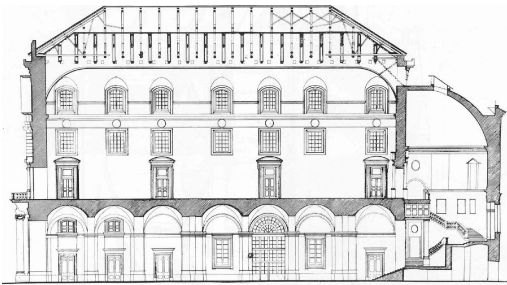
Figure 3. Longitudinal section of the Big Hall.

In Figure 2 the first floor plan of the building is showed: the Big Hall is placed in the middle. A longitudinal section of the Big Hall with the roofing structure is showed in Figure 3.

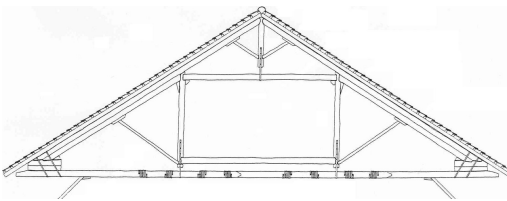
Figure 4. Typical upper roof truss.

two roofing orders are formed by chestnut wooden elements and nailed connections. The upper roof is constituted by Palladian trusses, which are composed by two 33° inclined-pitch struts and a tie beam with span of about 23.10 m (Fig. 4).

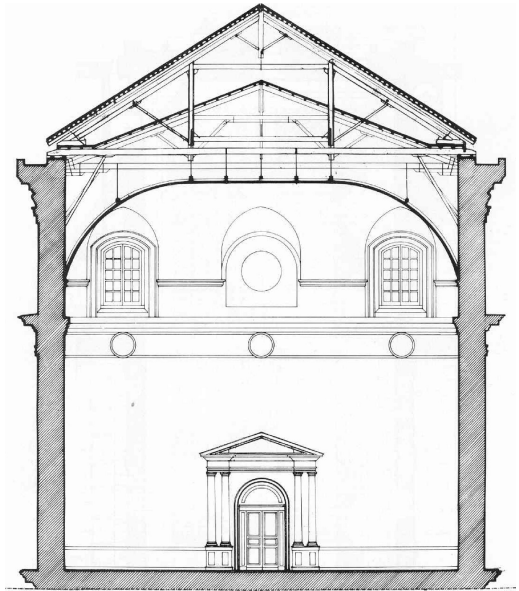
Figure 6. Transverse section of the Big Hall.

connected themselves by distributing fillets having cross-sectional area of 10×5 cm. The ceiling of the vault has thickness of 6 cm and was supported by the ribs lattice through iron wires. The three covering orders were designed to accomplish different functions. The upper roof, having four pitches, is the real covering and had to protect the underlying works by atmospheric events. The pitches inclination of about 33° allowed smaller axial forces in truss elements and minimized the wind effects. The intermediate roof has an impost height smaller of about 80 cm with respect to the overlying one and staggered trusses. The pitches, having an inclination of about 22° , supported a lapilli protecting layer to avoid that possible water infiltrations from the upper roof can reach the vault. The structural function of the second roof was to carry the wooden flat vault, that was in turn the ceiling of the Big Hall: fillers and fresco paintings of high value were realized on its intrados. The three covering orders can be observed in the transverse section of Figure 6.
