## The XIX century opera theatre of Catania: Conservation and seismic strengthening interventions

**ABSTRACT:** This paper presents a study carried out on the dome which covers the horseshoe shaped hall of the Massimo Bellini Theatre in Catania. The dome's painted surface shows a set of cracks whose pattern, probably come out as a consequence of a seismic action, seems to be depending on some features of its structural behavior which are related to its geometrical configuration. The structural behavior of the trussed dome is at present the subject of a numerical (via f.e.) analysis with the purpose to clarify the importance of the different mechanical parameters and, in case, to recognize potential weak points of the assembly. But a preliminary attempt has been made to understand, by means of simply logical reasoning and on the basis of the observation of the structure and of its damages, the mechanisms of the structural behaviour. The results of such an effort have been used as a guide in defining consistent intervention criteria.

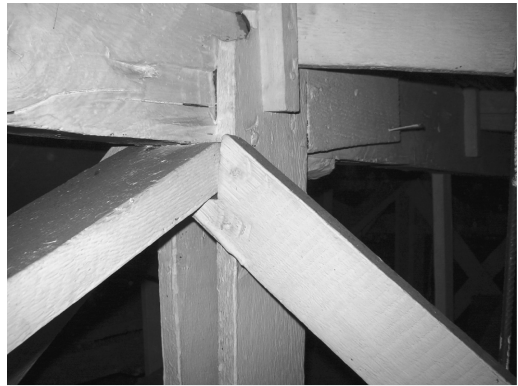
Figure 10. Typical connections observed in the reticular structure of the dome.

The apparent simplicity of the connections between the elements, simply supported or nailed together, makes it difficult to understand how the machine works and introduces practically insurmountable problems in numerical analysis (figure 10).
