Structural inspection and analysis of former British Consulate in Shanghai

ABSTRACT: The building of former British Consulate in Shanghai is a protective historical building. The 2-story building is a composite structure of masonry and timber. The aged building has been used for more than one hundred years. Several retrofits have been performed and the structure has been partially changed. To ensure the safety of the current building and protect the building efficiently, structural inspection and analysis were performed based on the inspection techniques and the theoretical method developed by the authors. It was indicated by the inspection and the analysis results that most of the load bearing members are safe, however, some indispensable structural measures demanded by the current code to ensure the seismic capacities are missed, and proper retrofit is needed to realize these measures on the structure without affecting the original profile of the building.

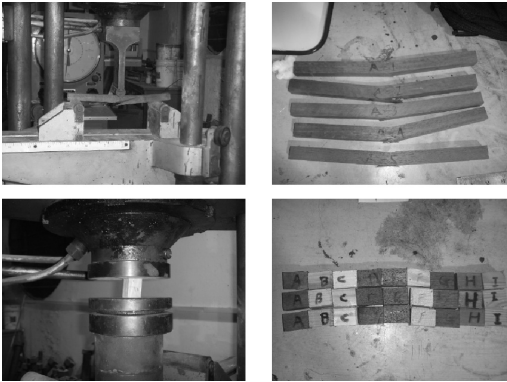
Bending strength and compression strength parallel to the grain of the timber were determined by random sampling test. The samples were chosen from all load-bearing timber members mentioned above. 5 bending samples of $300 \times 20 \times 20$ mm and 3 compression samples of $30 \times 20 \times 20$ mm were prepared for the test. After the percentage of water content had been determined, the bending tests were performed by simply supporting the sample and loading on the mid-span, and the compression tests were performed by putting the samples directly in the test machine (Figure 12). The test results for the strength of timber material are listed in Table 1, which have been converted to the values of the strength for timber materials under the percentage of water of 12% for the purpose of computation.

Figure 12. Bending and compression test for timber materials.

Location	Type of wood	Bending strength (N/mm ²)	Compression strength (N/mm ²)
2nd Floor	Lauan	96.2	35.0
2nd Floor	Lauan	66.0	36.1
Roof	Red deal	55.6	23.2
Roof	Red deal	46.0	42.6

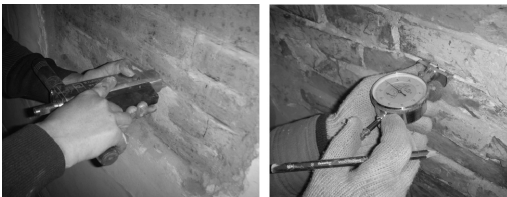
Figure 13. Testing of the strength of the mortar.

Mortar strength was determined by penetration resistance method. Eight and seven pieces of wall panel on the 1st and the 2nd story were chosen respectively for the test. On each panel, 8 mortar beds with thickness greater than 7 mm were tested. The rendering coat was demolished and the surface of the wall panel was smoothed before the test, and then the probe pin was penetrated into the mortar bed. The penetration depth was measured after clearing the mill dust in the penetration hole (Figure 13). According to the penetration depth, the compressive strength of the mortar was calculated using Equation 1, which was proposed and calibrated by Jiang & Chen (2005).

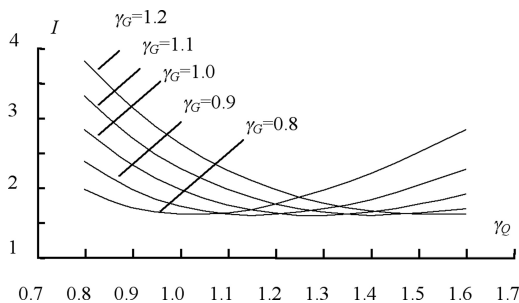
Figure 15. Determination of partial factors for dead and live load.

According to the probability models of the load and the resistance for existing building structures, optimal analysis was done to typical structural members taking into account of different ratios of live load effect to dead load effect and 3 types of simple load combinations for dead load and live load for the determination of the partial load factors. The typical results are shown in Figure 15. In Figure 15, vertical axis “ I ” refers to the error between the assessment result by using probability analysis directly and the assessment result calculated by Equation 3. From the results shown in Figure 15, it can be concluded that the optimal value of partial factor for dead load γ_G is 1.0, and the optimal value of partial factor for live load γ_Q is 1.3. Based on the suggested load partial factors, resistance partial factors, γ_R , for different kinds of structural members, was determined by further optimal analysis. The calculation results are shown in Table 6.
