The Restoration of a Wood-Frame House in Anatolia, The Yakup Ağa Mansion

ERDEM Ayten^{1, a} and ÖZAKIN Rabia^{2, b}

In this paper, the consolidation, completion and reconstruction interventions carried out to preserve the wooden mansion will be analysed, with the aim of determining the degree of conservation of the aesthetic, historical evidence and authenticity values of the building.

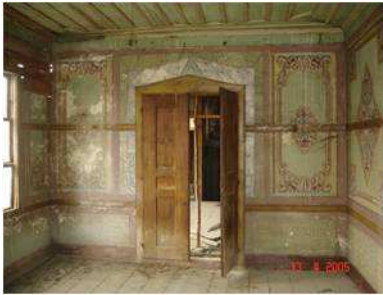
Figure 20: Before restoration

Restoration Evaluation In restoration of Yakup Ağa Mansion, primary target was preserving the building without destructing it wholly, and this target was achieved, though partly. However, preservation of more original materials did not become possible due to the deficiencies starting in the phase of project designing. It is seen that before the reparation, analytical building survey involving period, structure, material and deterioration analyses of the building was not made, decorations were not documented via photograph and stamping method, and parts to be rebuilt, parts to be preserved and ways of intervention were not mentioned in the restoration project. Due to these deficiencies, the parts experiencing greatest destruction in the reparation made at the discretion of the masters came to be decorated walls. Even though it was possible to separate parts which had to be structurally renewed but which had their decorated plasters on them from timber frame and to preserve them in a different place and then to put them on renewed wall, decorations were considered as unimportant elements which could be formed again (Fig. 20, Fig. 21, Fig. 23, Fig. 24). Original color tone was not paid attention in painting the ceilings (Fig. 22, Fig. 25), and also original covering dimensions were not paid attention in floor covering.
