Interventions on the Gothic Roof Structure of the Nave at the Lutheran Church in Bistrița (Romania)

Keywords: Lutheran Church in Bistrița, Gothic roof structure, restoration works

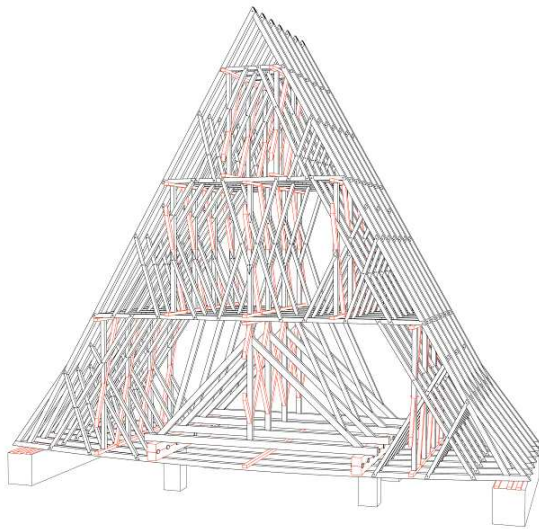
The trusses located next to the tower have missing parts, as there is no joint connection between the tie beam and rafter, since the tower wall located in the prolongation of the nave's longitudinal diaphragm does not allow the two truss elements to cross each another. There have been at least two major interventions on the nave's roof structure, which altered the roof structure's structural behaviour: in 1897 (when two longitudinal compound beams were mounted, resting upon the heightened intermediary columns, as well as the straining devices in the main trusses up to truss no.

23) and in 1926 (when straining systems were mounted in some of the secondary trusses, starting with truss no. 26).

Figure 5: The roof structure – axonometric view and the intervention in 1897

The second section (trusses 9-23), less affected by the fire but severely damaged as a consequence of unprofessional interventions along the years, reinforced in 1897 (by introducing some Eclectic type timber straining devices at the first level of the roof structure), was restored preserving the intervention of 1897.

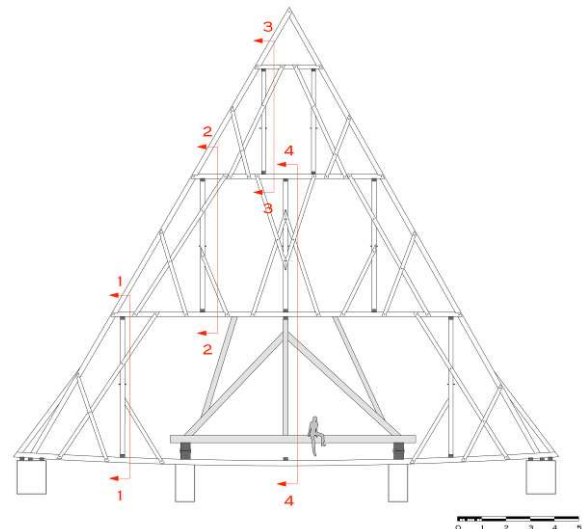
Figure 6: The main truss – with the straining device (built in 1897)

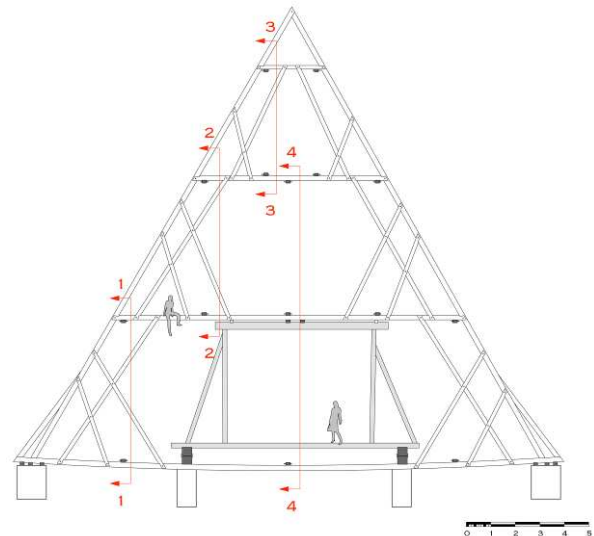
Figure 8: The secondary truss with the intervention from 1926

The third section (trusses 24-38), also strengthened in 1926 (through insertion of straining trusses at the first level of the roof structure, supported by the longitudinal compound beams), was restored according to the initial shape, that of 1559-1563, by replacing missing elements and the burnt parts,

discarding the interventions of 1926. Once more, many angle braces and compound rafters were partially replaced or completely rebuilt, as previously explained.
