## Geotechnical Aspects of the N1 Tower, Prasat Sour Prat, Angkor Thom, Cambodia

**Abstract** This paper presents a case study of foundation of an inclined independent masonry tower in Angkor. One of the Prasat Sour Prat towers had been dismantled before reconstruction for conservation. The foundation was inclined as the same as the upper structure of the tower and spreading outwards. The inclination was considered caused by foundation failure with some differential settlements of the ground. During dismantling, the soil layers exposed on the trenched section were found rather horizontal than the inclined state that had been expected. Laterite blocks of step slope stones was found to have slid down along the soil mound of the foundation. The mechanism might have been caused by weakening of soil strength by wetting ground. Without dismantling, the real mechanism of the inclination was never known as well as the corresponding counter measures.

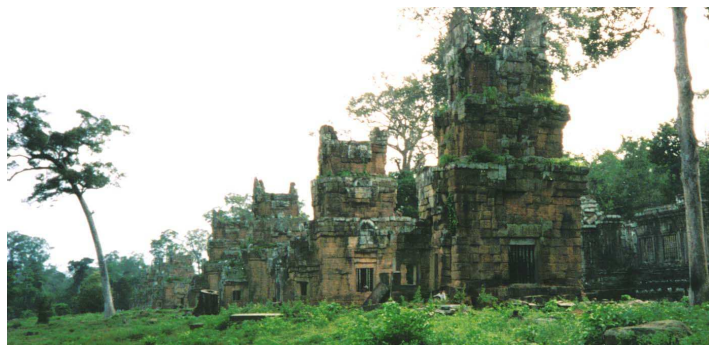
*Photo 1: Prasat Sour Prat*

**Inclination of the Outer Wall of Prasat Sour Prat** There are 12 towers called Prasat Sour Prat and shown in Photo 1. The angles of inclination of the outer surface of the towers were measured and

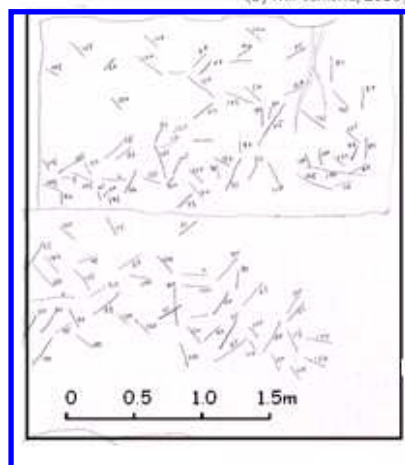
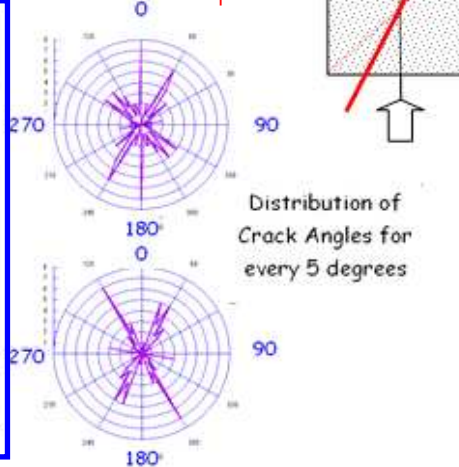
Figure 9:  
Trenched section

Distribution of Cracks on the Trench Wall  
(by M. Yoshoka, 2005)

$$\theta = 45 \pm \phi/2$$

$$\theta = \pm 30^\circ$$

rectangle in red  
(see Fig.10)

rectangle in black  
(bearing failure)

In Fig.10, it is clearly understood that the upper three laterite blocks at the outermost position were situated at lower height than the corresponding inner blocks. The compacted fill behind the laterite blocks was inclined outwards direction as shown in Fig.9 as well as Fig.10. Another deformation should be noted at the lowest part (rectangle in black, Fig.9) of the laterite block where the large downwards deformation of the ground was caused by probable bearing failure.

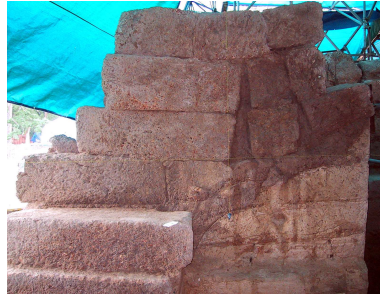
Figure 10: Laterite blocks of step slope

**Deformation of Step Slope** Fig.10 shows the vertical section of the soil mound beneath the foundation(Fukuda 2005). The compacted soil layer was found rather horizontal than inclined state that was expected by the deformations of the tower structure and the foundations. We realized that we had fallen in a pitfall of the difference between the speculation before dismantling and the exposed real section after trench. The speculation was based upon the experiences and the theory of geotechnical engineering. The pit fall was rather deep and not easy to be filled up. At the northend of the foundation mound, a step slope was found under a peculiar deformation as shown in Fig.10.
