The Structural Analysis of The Historical Constructions of West China Campus-Sichuan University

LUO L L^{1,a}, XIE Z T¹, WU T¹, WANG Y W¹, XIAO C B¹ and LING C J¹

¹Sichuan Institute of Building Research, Chengdu, China

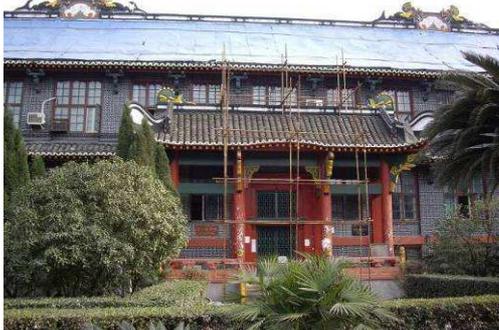
Name	Area and Age	Structural type	Function	Elevation photos
Atherton Building for Biology and preventive Medicine	Construction area is 3450 m ² . Built in 1924. Experienced maintenance and reconstruction.	The three storey building were constructed with timber and brick, which is 56.05 m in length, 30.93m in width, 16.17m in height(from outdoor level ground to ridge crest elevation)	Classroom

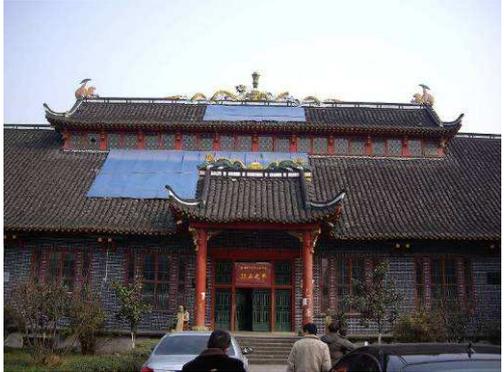
Name	Area and Age	Structural type	Function	Elevation photos
Lamont Library and Harvard-Yenching Museum	Construction area is 2688 m ² . Built in 1926. Experienced maintenance and reconstruction	The three storey building (partial three storey) were constructed with timber and brick, which is 53.87m in length, 47.84 in width, 15.74 in height for two storey part, 12.93m in height for three storey part(both measured from outdoor level ground to ridge crest elevation)	Classroom

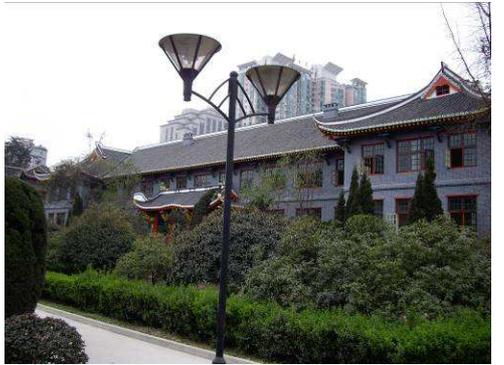
Su-Tao Pu Memorial	Construction area is 3600 m ² . Built in 1941. Experienced maintenance and reconstruction	The three storey building (loft from the fourth floor) were constructed with timber and brick, which is 56.48m in length, 27.55m in width, 10.45m in height (from outdoor level ground to eaves elevation)	Classroom

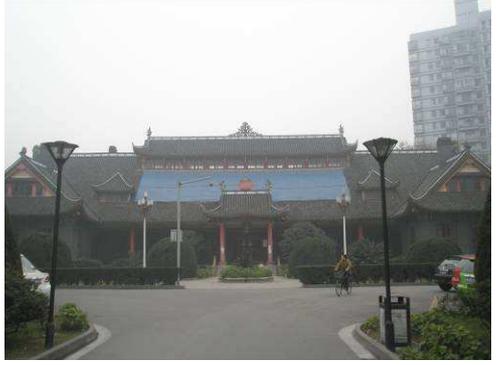
Whiting Memorial Administration Building	Construction area is 2618m ² . Built in 1915. Experienced maintenance and reconstruction.	The two storey building were constructed with timber and brick, which is 55.45m in length, 27.88m in width, 12.890m in ridge crest height, the indoor floor level is 0.8 m above outdoor ground level.	Office

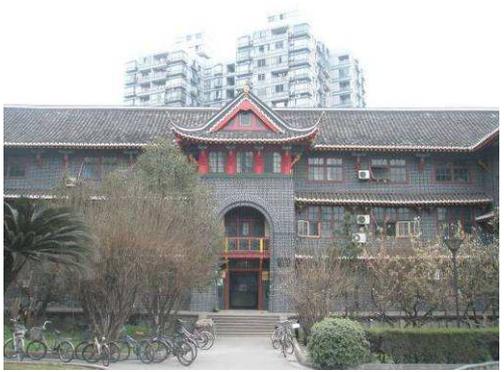
No. 5 Classroom	Construction area is 3000m ² . The eastern part was built in 1928, the western part was built in 1948. Experienced maintenance and reconstruction	The three storey building were constructed with timber and brick (loft from the fourth floor), which is 53.3m in length, 30.8m in width, 11.1m in height (from outdoor ground level to eaves level)	Classroom
